Volume II

Appendix D.15

Maintenance, Material, and Management Inputs

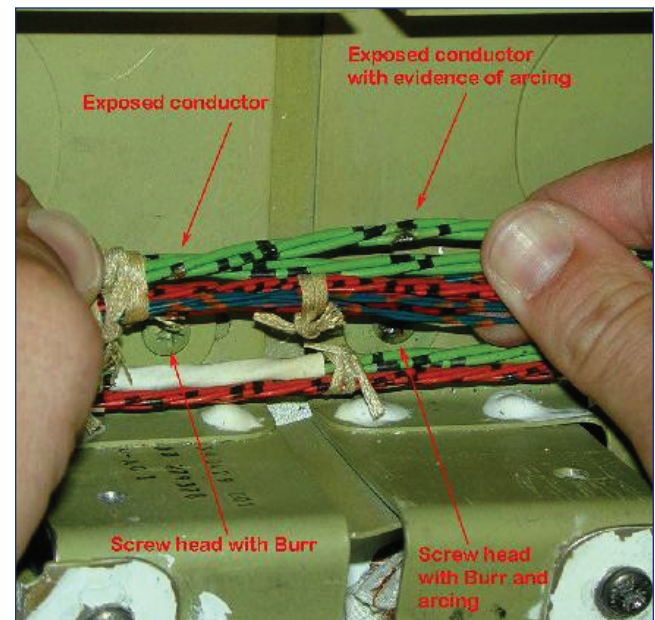
Arc-tracking is the propagation of carbonization/insulation damage along the length of wire and to adjacent wires. When Kapton wiring experiences arc tracking, the insulation carbonizes at temperatures ranging from 1,100 to 1,200 degrees Fahrenheit. An important distinction must be made between carbonization and flammability. During tests (not related to the *Columbia* accident), Kapton wiring subjected to an open flame did not continue to burn when removed from the flame. However, carbonized Kapton becomes a

conductor, leading to what is referred to as a “soft short.” Systems with a “soft short,” as a result of carbonized wiring, do not necessarily drop off line in a clear, abrupt, or obvious manner, but may continue to operate in a degraded fashion. Figure 1.1.1 displays arc-tracking.

Figure 1.1.1. Picture of Kapton damage.

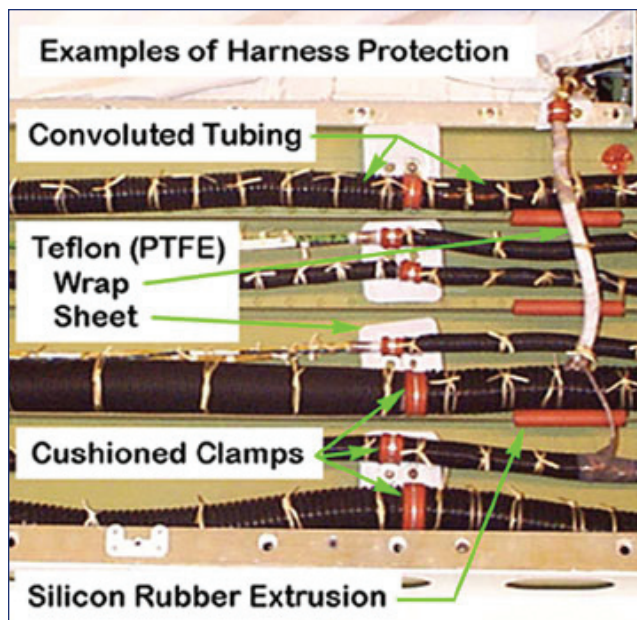
Figure 1.1.2. Examples of Harness Protection.

Wiring nonconformances can be corrected several ways: re-routing, reclamping, or installation of additional insulation (convoluted tubing, insulating tape, insulating sheets, heat shrink sleeving, abrasion pads, and so forth). (See Figure 1.1.2) Additionally, testing of Orbiter wiring under normal operating loads has shown arc tracking in bundles usually stops due to wire separation (as opposed to circuit protection devices tripping). Further testing under conditions approximating the Shuttle wiring environment also showed that, after separation, arc tracking did not progress beyond six inches. Based on these results, Boeing recommended NASA separate all critical paths from larger wire bundles and individually protect them. This protection should extend a minimum of six inches beyond the confluence of critical paths.³ This is being implemented during OMMs.

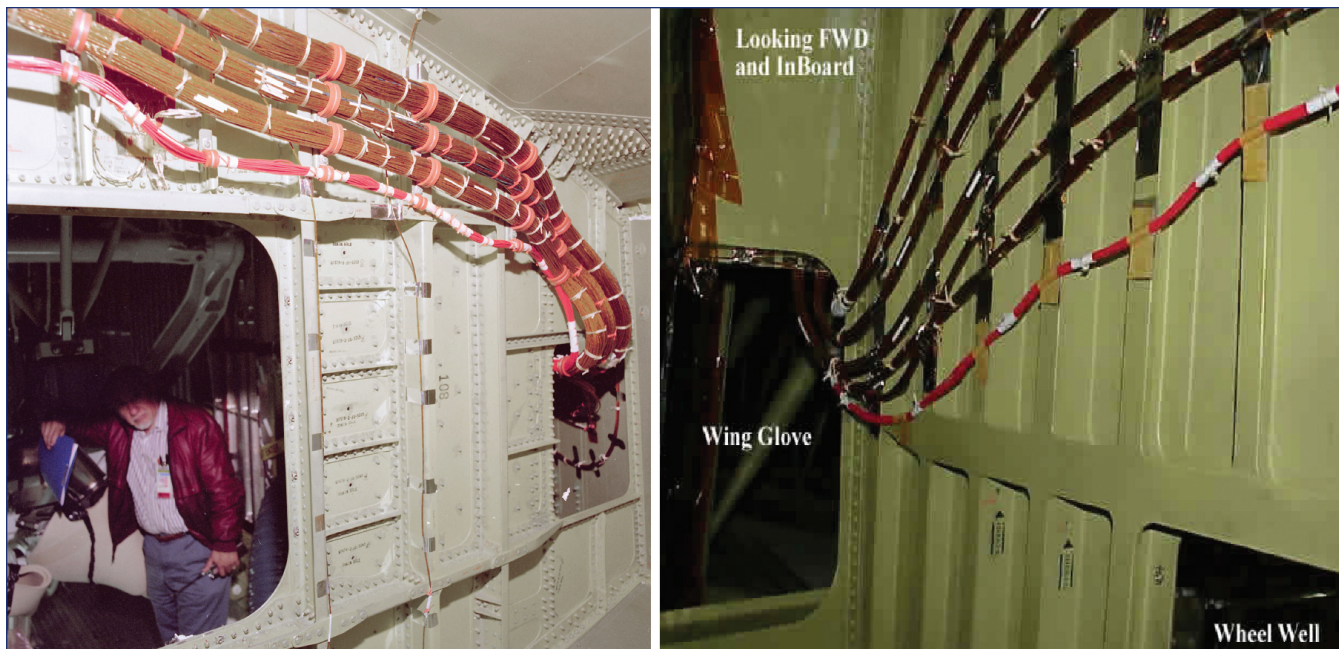
Figure 1.1.3. Wire Bundle Comparison.

oven, blowtorch, and arc jet), verified these failure signature analyses. Finally, extensive testing and analysis for years prior to STS-107 showed that, given the low voltages and low currents associated with the Orbiter's instrumentation system (such as those in the left wing), the probability of arc tracking is commensurately low.

Based on the extensive wiring inspections, pre-STs-107 maintenance and modifications, analysis of sensor/wiring failure signatures, and the lack of alignment of catastrophic wiring failure with any of the likely failure modes, the presence of Kapton wiring in *Columbia* is highly unlikely to be causal.

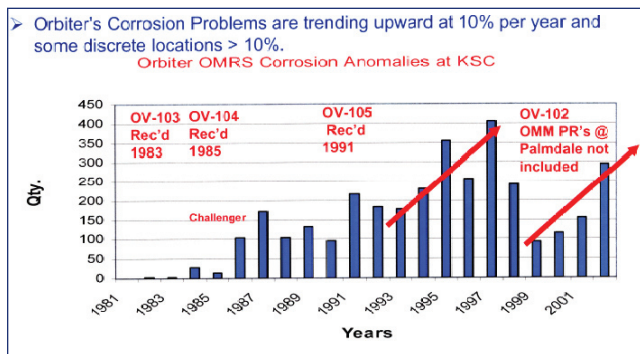
The environment at KSC is about as challenging, from a corrosion perspective, as exists. The necessity to control exposure is reflected in the amount of work needed to keep the Orbiters in a mission-ready condition. Corrosion, in general, is trending upward for the Orbiter fleet by 10 percent annually, and there is a marked increase in corrosion in areas such as the body flap cove (one of the lowest points when the Orbiter is in a vertical orientation). Figures 1.3.6 and 1.3.7 show these corrosion increases, one classic symptom of aging aircraft.

Figure 1.3.6. Increasing orbiter corrosion trends.

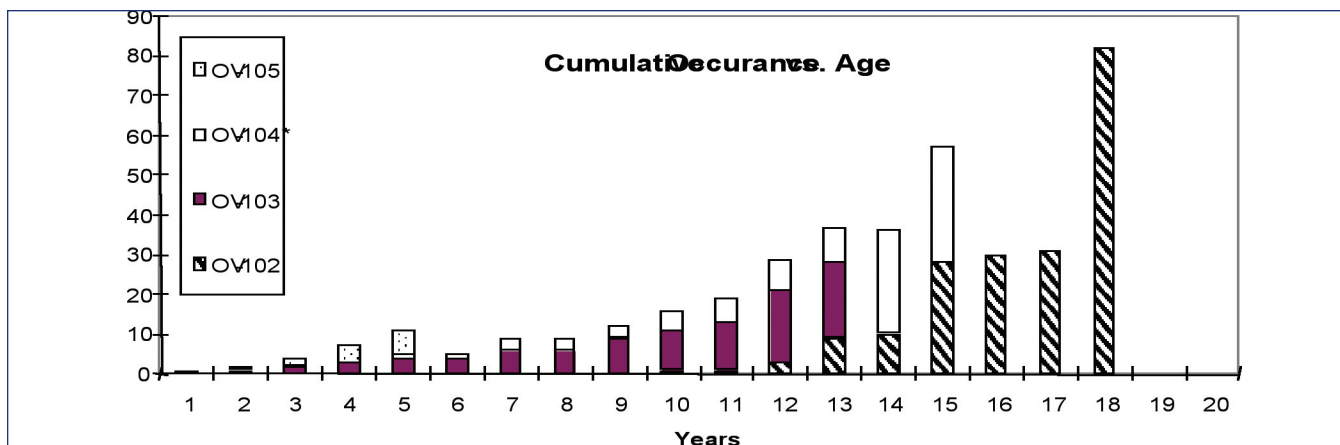
While corrosion is symptomatic of normal aging, in the Orbiter's case, its location at the aft (lowest point in its launch configuration) shows the effect of launch pad exposure. The body flap cove and surrounding area, as well as associated hardware, are showing significant growth in man-hour consumption to grind out corrosion pits. Components, such as the body flap actuator, illustrate the increasing challenge posed by corrosion and the impact on logistics and spare parts availability. Over the last several years, body flap actuators have been removed for corrosion. During repair, internal corrosion has also been discovered, with some piece parts being beyond repair. Manufacturing new piece parts entails extensive lead times, in some cases years. Status of body flap actuators at the end of April 2003 was seven in inventory, with four installed; two had been removed and were in the repair cycle, along with the only spare; the first serviceable spare was projected to be available in June 2003.

Figure 1.3.7. Fleet corrosion in body flap cove area.

Corrosion is a problem in both military and commercial aviation. Due to the Shuttle's critical mission and limited design life (originally projected to be between 10 and 20 years), as well as its now projected use for as much as another 20 years, strict adherence to existing guidance must be reemphasized on an ongoing basis. Furthermore, every opportunity to avoid/minimize/reduce exposure must be taken. Ground Operations should review launches where exposure was more than one standard deviation above or below the mean (Figure 1.3.5.) for lessons that may be applied to reduce exposure. Finally, as some amount of exposure is unavoidable, the Space Shuttle Program must have an intensive corrosion program of inspection, treatment, and prevention. Such a program will factor into the fledgling Service Life Extension Program.

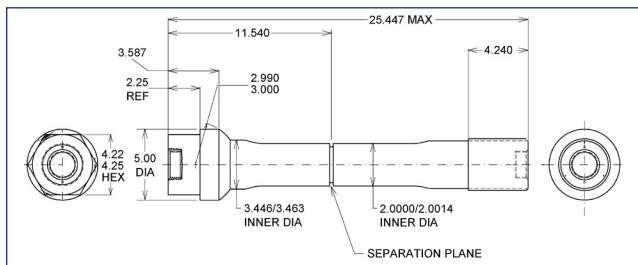
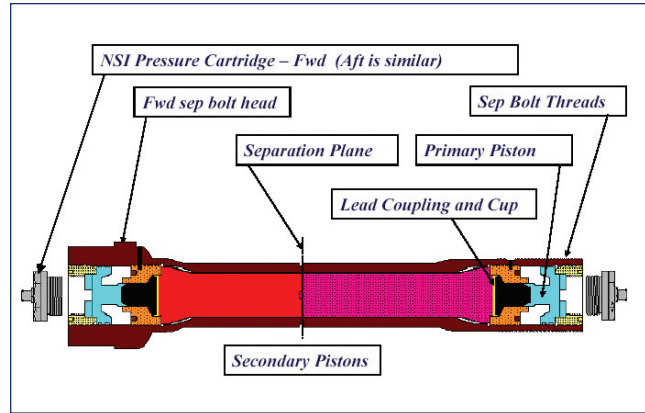
Figure 1.6.1. Separation Bolt.

Figure 1.6.2. Separation bolt cross section.

been done without adequate NDI (magnetic particle) of the internal bore. (See Figures 1.6.1 and 1.6.2.)

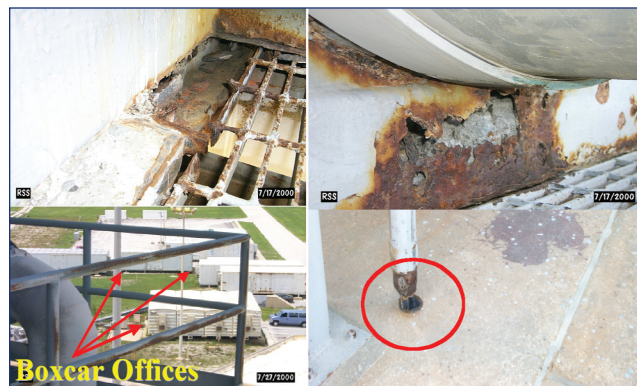
structure, which serves as the core of the Fixed Service Structure (FSS), was designed and built in the Apollo era and incorporates older designs which trap fluids, including corrosives, even after post-launch wash downs, as well as precipitation. To their credit, ground systems support personnel and engineers recognized these design problems a long time ago, and newer modifications/replacements, such as the Rotating Service Structure (RSS), are better designed, without fluid traps. As the pads have aged and modifications/upgrades have been incorporated, many of the older systems have been abandoned in place; there is evidence of old clamps, conduits, mounting brackets, and other hardware that continue to corrode. This can be problematic, as continued degradation of these abandoned systems can contribute to loose debris during launch, posing a hazard to the shuttle. Again, to the ground support systems management's credit, they have recognized this and have lobbied for/received funding to remove formerly abandoned-in-place hardware; while much has been done, much remains and efforts are continuing. On each pad's RSS, the Payload Changeout Room's walls of foam core sandwich construction are deteriorating due to acoustic loads during launch. While repairs have been accomplished using a multitude of through-bolts, these are at best temporary and add needless weight to the movable structure. A more permanent repair will require serious consideration of an alternative design to ensure durability. There is also extensive concrete deterioration at the pad base and blast deflector areas; these are repaired from launch to launch. KSC has 83 railroad boxcars at pads 39A and 39B. These were procured for their durability and are used as offices and work centers for support personnel. Unfortunately, they are extensively corroded and ceiling leaks/buckled floors can be seen in various locations. To KSC's credit, they are correcting this situation with the construction of new facilities at each launch pad that will completely replace the boxcars; move-in is scheduled for FY2003.

Figure 3.2.1. Launch Pad Corrosion and Boxcar Facilities.

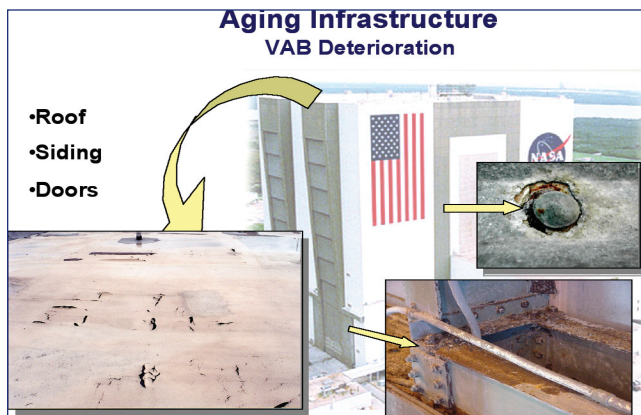
Figure 3.2.2. Vehicle Assembly Building.

winds; repairs are scheduled for FY2006. Several of the VAB’s massive multi-panel doors require extensive corrosion repair. The structure’s overhead bridge cranes are a mix of 1960s and 1990s vintage equipment, but are effectively sustained through regular maintenance due to their critical role in mating/demating operations.

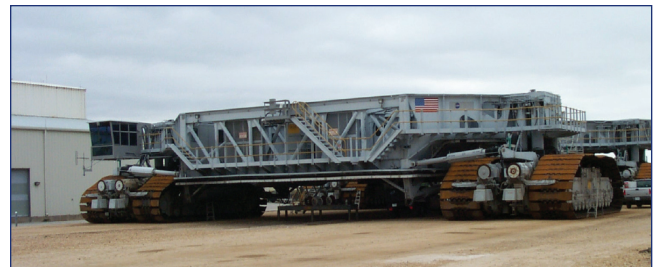
Example 3: Two of the Shuttle Program’s most critical pieces of equipment, the Crawler/Transporter (CT) systems, pose a significant technical sustainment challenge. (See Figure 3.2.3) These unique vehicles are necessary to move the stacked Space Shuttle to and from the launch pads. During hurricane season – roughly half of the year starting in early summer – both must be up and running in the event Shuttles must be moved from the pad back to the VAB for “safe haven.” This precludes extensive maintenance during this entire period. Built in 1965, the CTs each average over 1,700 miles. They have received incremental capability upgrades over the years, including a laser docking system, computerized control stations, and replacement control cabs. The massive hydraulic actuators used to jack, level, and carry the Mobile Launch Platform (MLP) and Shuttle Stack were recently refurbished for the first time. Obsolescence of purpose-built components poses a major challenge, and will continue to need correction through upgrades. Corrosion is a significant problem due to no sheltered storage, and maintenance is frequently suspended due to severe weather. As support costs rise due to aging and obsolescence, it was noted that managers track resources expended (costs of modifications/parts/labor) over time, but do not do so per unit of output (miles driven or operating hours). While costs over time will always increase, a more valuable metric is cost per unit of output, as this can be used for analysis and trending and can help in more clearly comparing the cost/benefit tradeoffs of inaction, modification, or replacement.

Figure 3.2.3. Crawler Transporter (CT).
