STS-107 Image Analysis Team Final Report

This Appendix contains NSTS-37384, STS-107 Image Analysis Team Final Report in support of the *Columbia* Accident Investigation, 30 June 2003.

STS-107 Image Analysis Team
Final Report
in support of the
***Columbia* Accident Investigation**

June 30, 2003

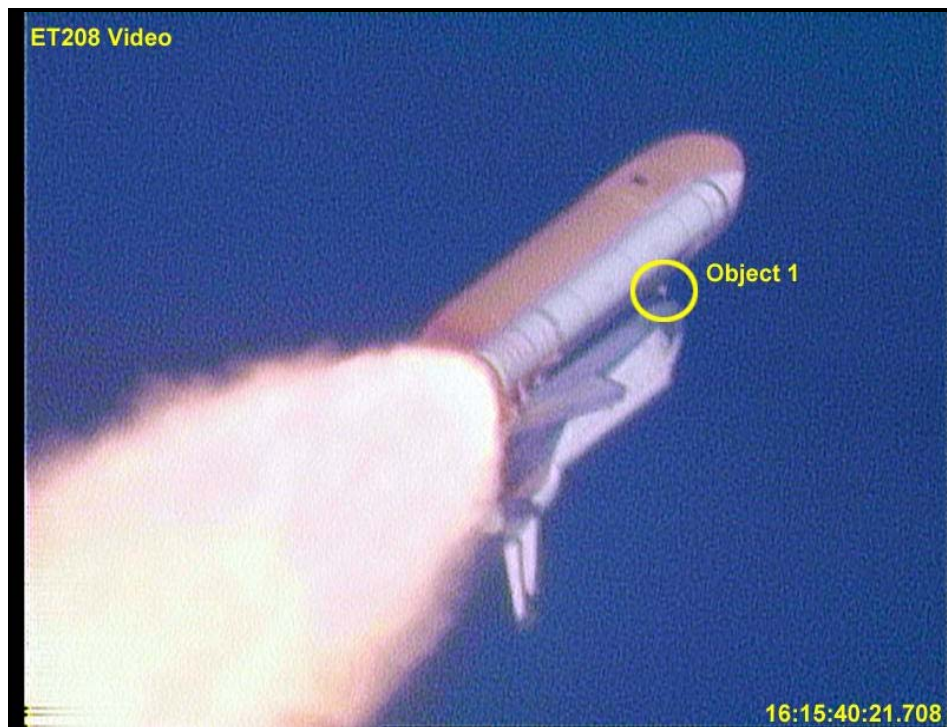
A single piece of light-colored debris was first seen on ET-208 imagery near the ET/Orbiter -Y bipod attach area at 016:15:40:21.674 UTC. Figure 4.3.2.1a is a good view of the debris after it becomes more clearly visible. The debris traveled outboard in a -Y direction (Orbiter structural coordinate system) before falling aft. Figure 4.3.2.1b shows the debris just after it struck the wing (the moment of impact was between video images). The location of the debris was mapped from frame to frame to build a trajectory from the approximate source to impact as viewed by Camera ET-208, shown in Figure 4.3.2.1c.

Figure 4.3.2.1a ET-208 View of the debris near point of origin

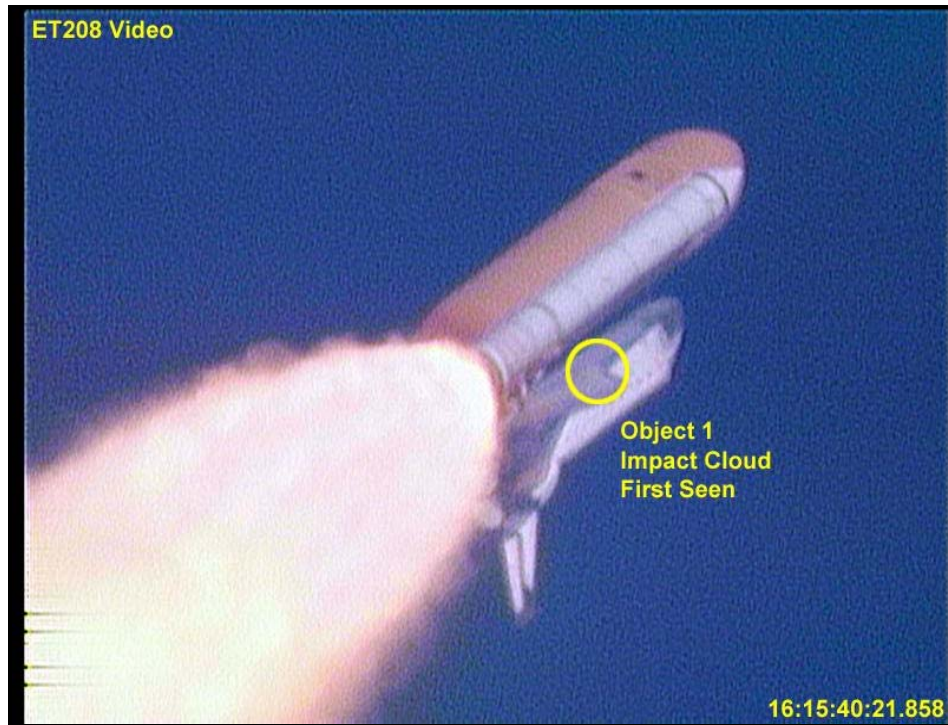
Figure 4.3.2.1b ET-208 View of the debris at 016:15:40:21.858 UTC just after impact with the underside of the leading edge of left wing

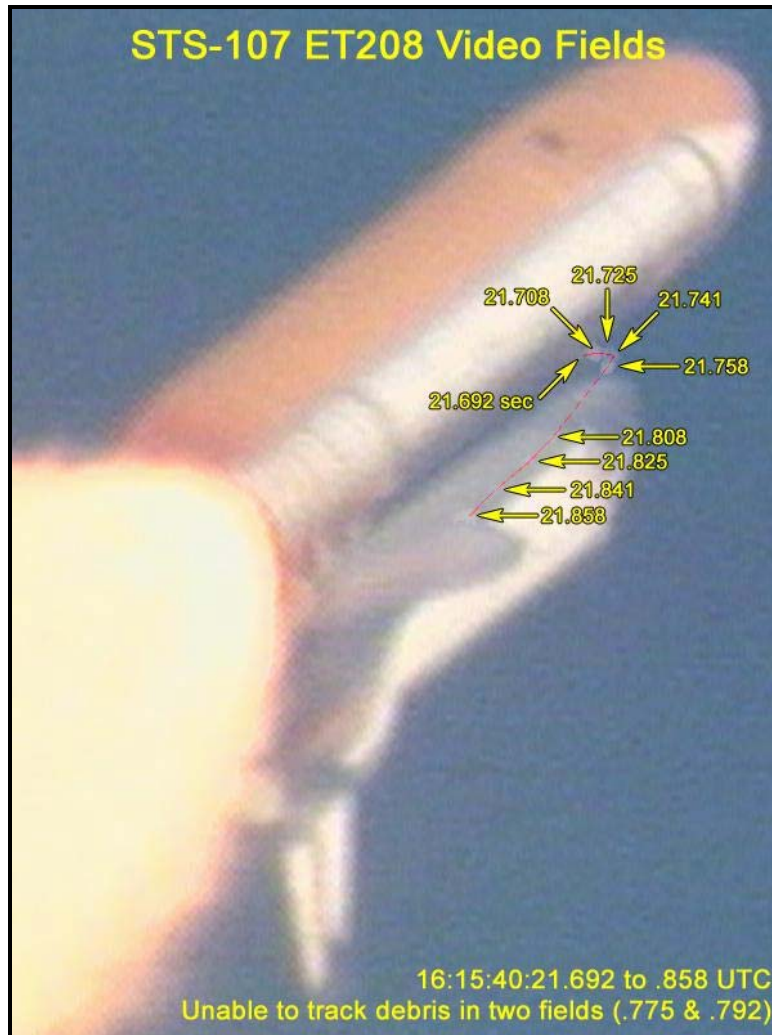
Figure 4.3.2.1c ET-208 Composite with trajectory of debris (times are in seconds after 16:15:40 UTC)

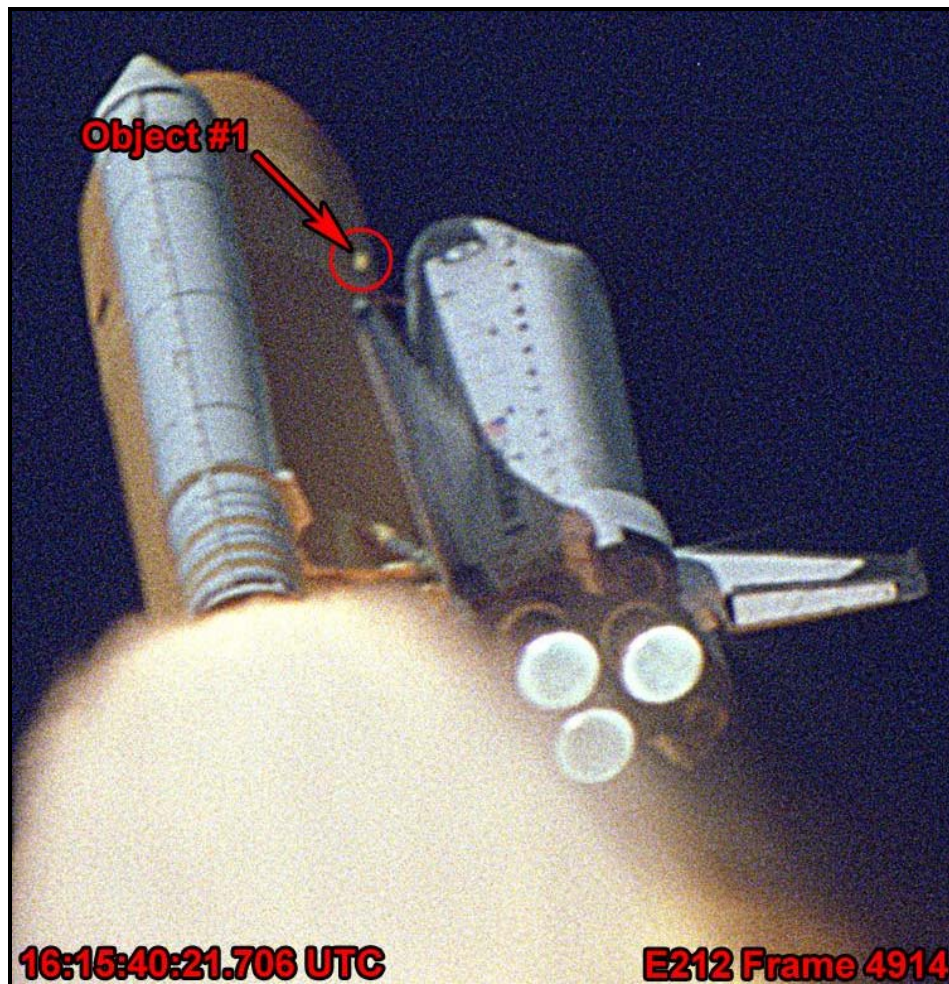
Figure 4.3.2.1d Debris object in full illumination (E-212, Frame 4914)

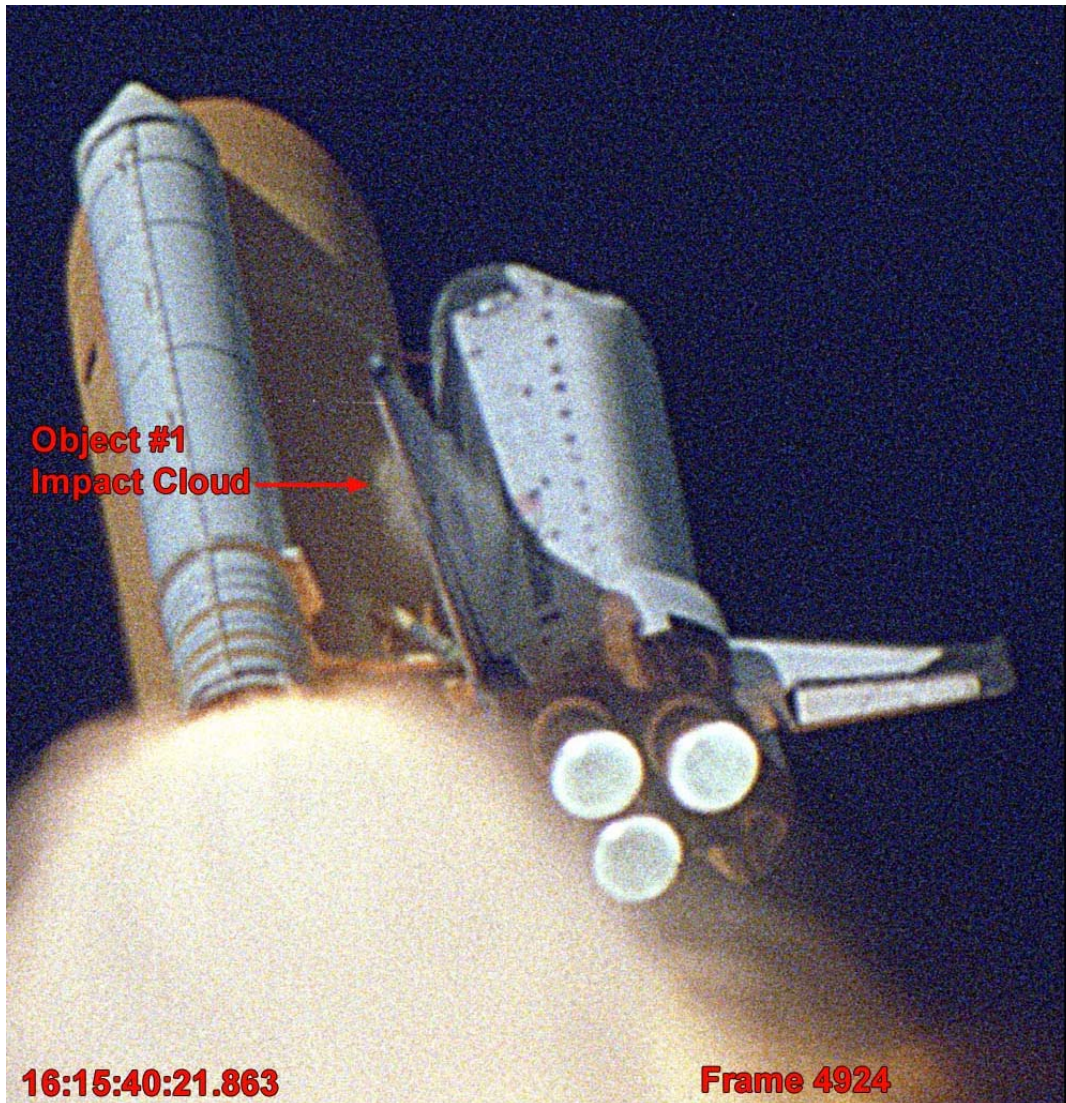
Only Object 1 was confirmed to impact the left wing. There is no conclusive evidence of more than one debris impact to the Orbiter. A large, light-colored cloud, which emanated from the underside of the left wing due to debris impact (Figure 4.3.2.1f), was first observed at 016:15:40:21.863 UTC. Within the post-impact cloud, at least two large pieces of debris were observed and measured (see Section 4.3.2.6). There is no conclusive visual evidence of post-impact debris flowing over the top of the wing.

Figure 4.3.2.1f Debris impact cloud seen on E-212 (Frame 4924)

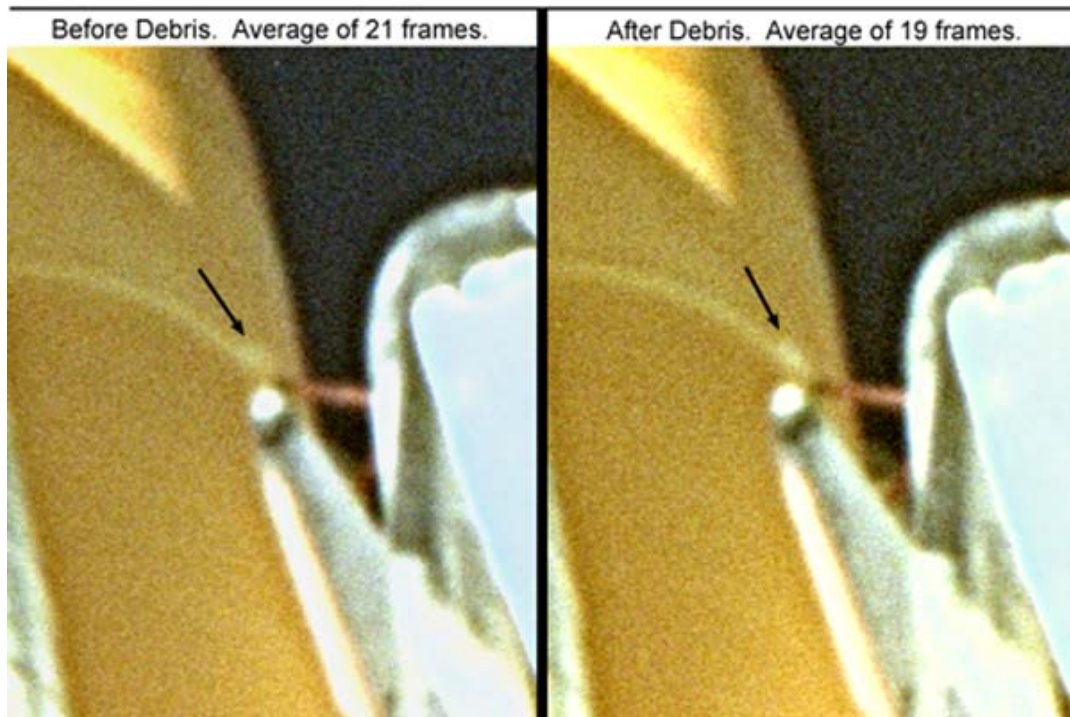
Figure 4.3.2.2a Enhanced images of the ET forward bipod ramp area before and after the debris shedding event

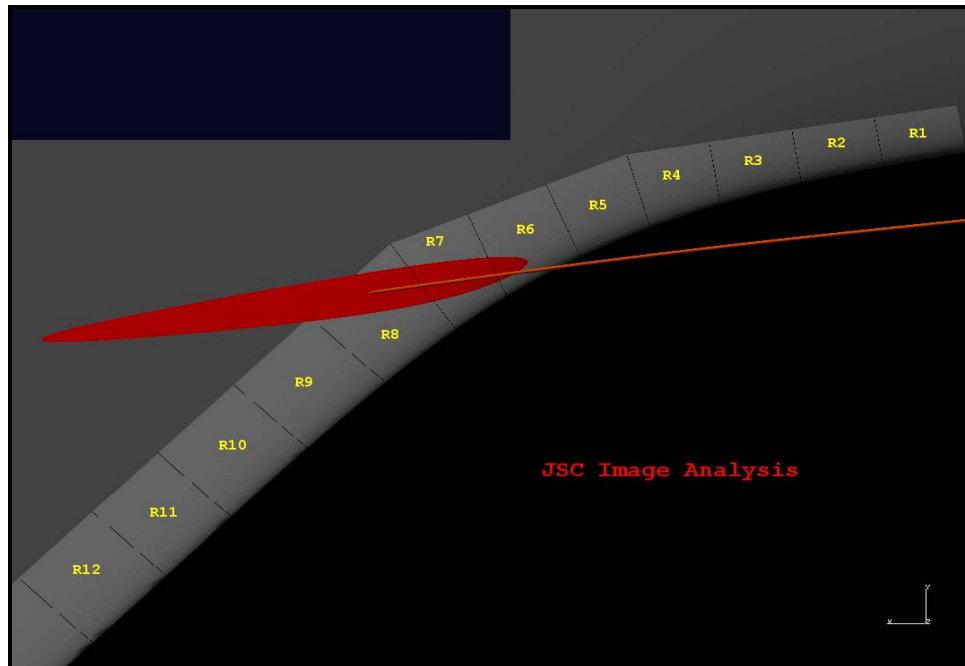
acreage aft of the leading edge panels, no damage to the tiles was observed in the imagery (see Section 4.3.2.7). Figure 4.3.2.5b shows the impact area on the Orbiter left wing as predicted by one example trajectory analysis.

Figure 4.3.2.5b Debris trajectory analysis — impact area on Orbiter left wing. A 1-foot-radius, trajectory tube projected onto the left wing, showing probable impact to the panel 6, 7, 8 area.

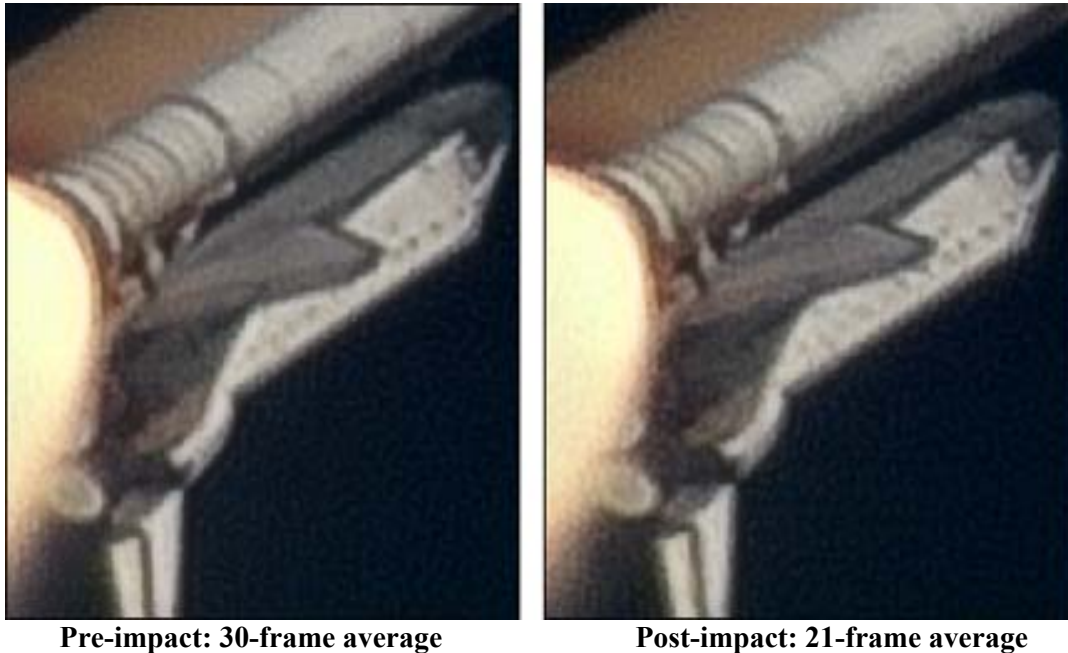
No visible damage to the left wing was detected in the imagery from camera ET-208, which was determined to be the camera with the best view of the debris impact. Figure 4.3.2.6a shows frame-averaged image enhancements of the underside of the left wing from before and after the impact event. There is no conclusive, detectable change in the impact area. In the “before” image, a relatively bright area on the wing is observed just aft of the leading edge, which is attributed to an area of lighter-colored tile acreage, as verified in the Orbiter close-out photos. The “after” image shows a slight brightening to this area, but in the noise level of the image. The brightening may be attributed to a lighting effect caused by slight changes in the Orbiter orientation, or is simply an artifact of the image processing.

A constraint to this analysis is the low resolution of the ET-208 imagery; a damage area smaller than an area of approximately 2 feet by 1 foot (in Orbiter X and Y respectively) would be undetectable in the imagery.

Figure 4.3.2.6a Comparison of images from before and after the debris impact

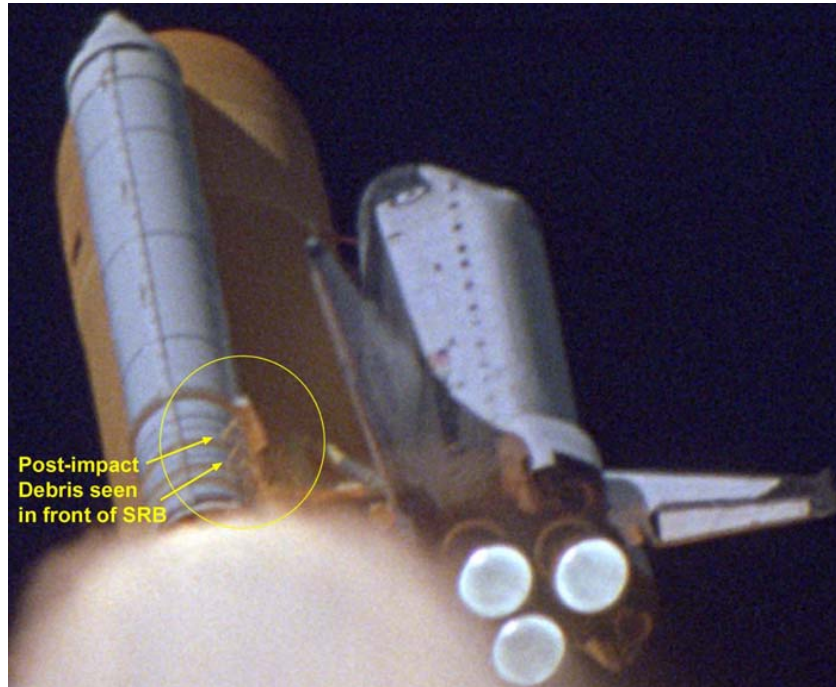
Figure 4.3.2.6b Post-impact debris fragments (E-212 frame 4927)

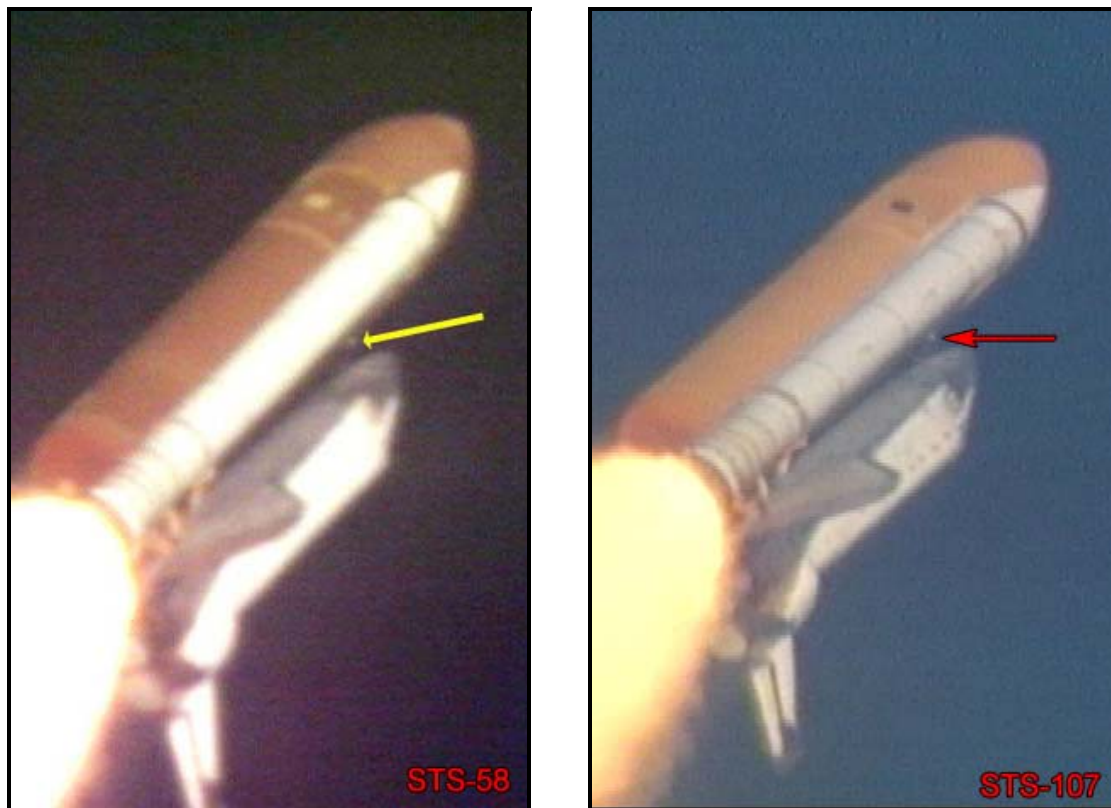
Figure 4.4.1 Comparison of bright spot near bipod on STS-58 and STS-107

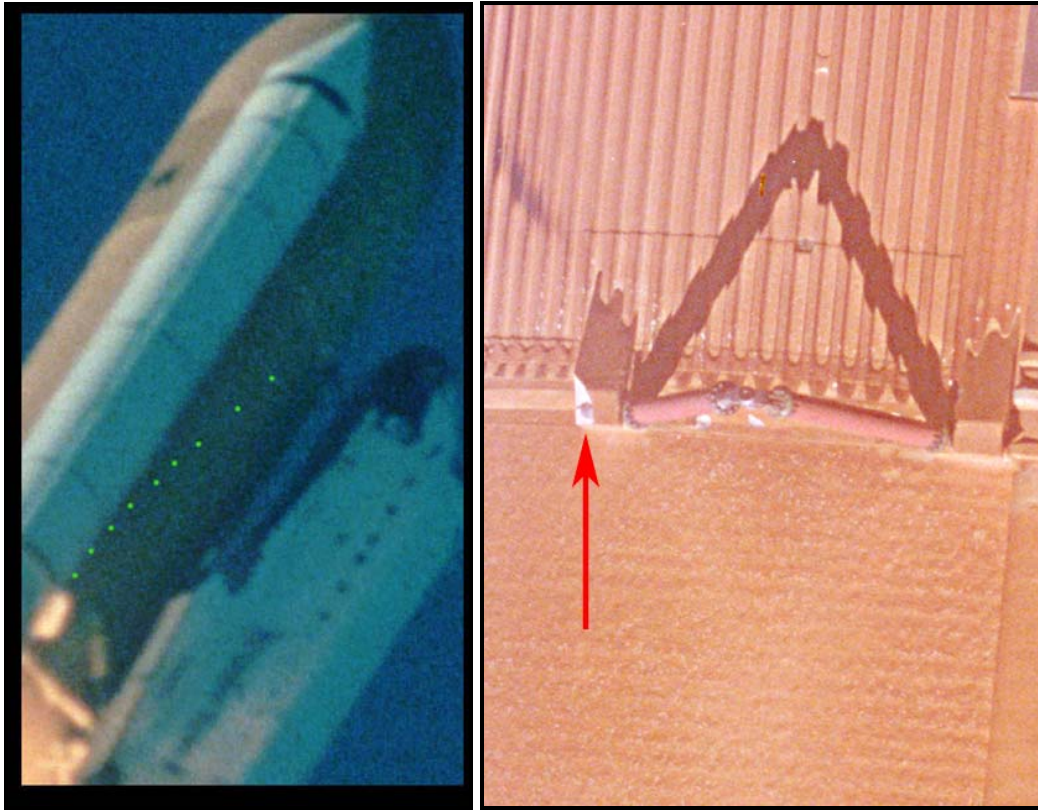
When the ET imagery from the on-board umbilical well camera was examined after landing, it revealed that a large portion of the ramp adjacent to the ET/Orbiter -Y bipod attach was missing and bipod substrate material was visible. The damaged area was measured on the film to be approximately 6 x 12 inches (Figure 4.4.5.1).

Figure 4.4.5.1 STS-112 debris trajectory and umbilical well image of damage near ET bipod ramp

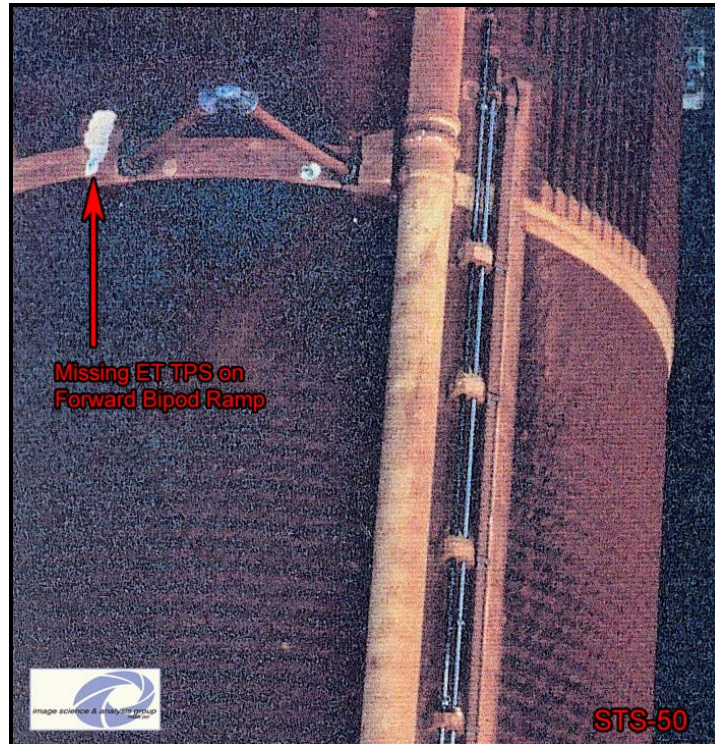
Examination of the STS-50 umbilical well imagery revealed that approximately 60 percent of the ramp adjacent to the ET/Orbiter -Y bipod attach was missing (Figure 4.4.5.2a). The damage area was of sufficient depth that a portion of the bipod spindle housing appeared to be exposed. A portion of the intertank acreage foam at the leading edge of the ramp was also missing. The damage site measured approximately 26x10 inches. Because clouds and haze obscured the STS-50 long range launch tracking camera views, no debris events were recorded on the STS-50 launch imagery that correlated to the damaged ET/Orbiter -Y bipod ramp.

Figure 4.4.5.2a STS-50 ET damage recorded on umbilical well camera

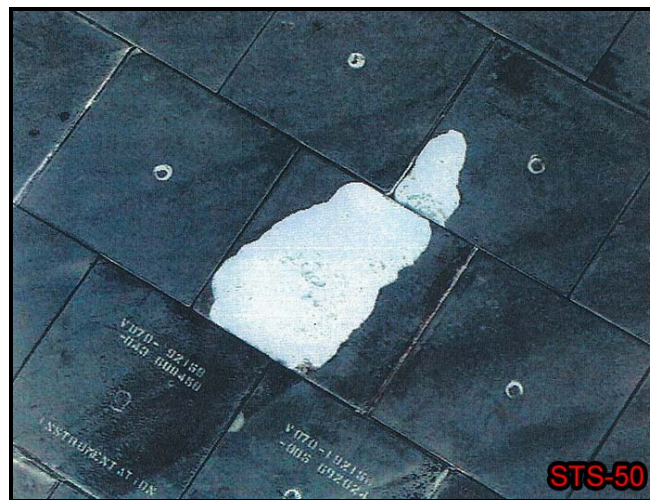
During the post-landing Orbiter inspection, KSC reported that a 9 x 4.5 x 0.5 inch damage site was found on the Orbiter lower left wing surface tiles (outboard of the left umbilical well) that may have been caused by the loss of the ET foam (Figure 4.4.5.2.b).

Figure 4.4.5.2b Detailed view of wing tile damage, STS-50

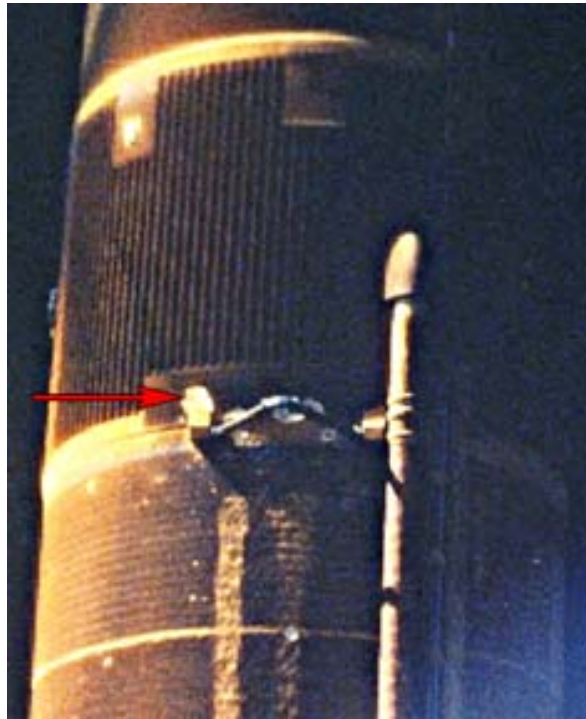
During the STS-32 launch, the launch tracking cameras KTV-5 and E-207 documented a large piece of debris near the SRB exhaust plume at approximately 83.9 seconds MET. The source of this debris was not imaged, however the time of this event was similar to the time of the STS-107 debris strike. After landing, the STS-32 on-board umbilical well camera film revealed five large divots on the External Tank intertank TPS just forward and between the ET/Orbiter-Y and +Y bipod attach ramps (Figure 4.4.5.3).

Figure 4.4.5.3 Image from STS-32 on-board umbilical well camera film showing damage to ET intertank TPS

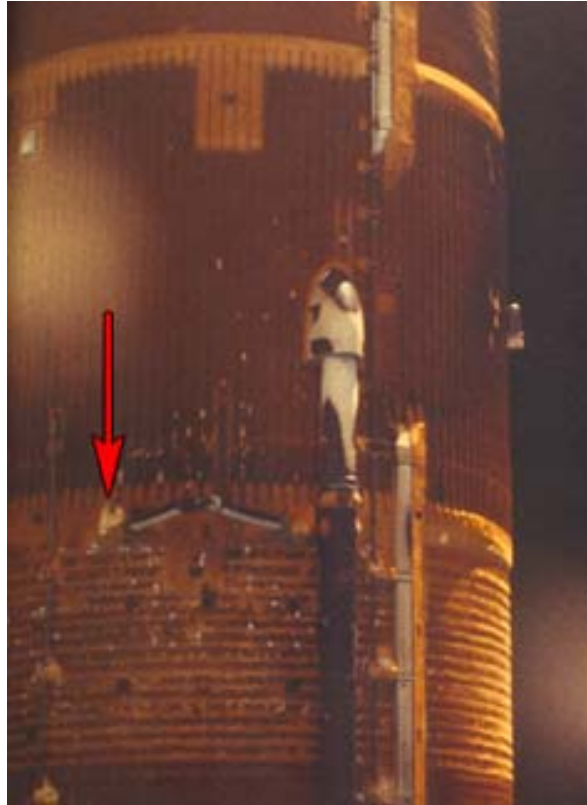
A portion of the STS-7 ET/Orbiter-Y bipod attach ramp was observed to be missing on the on-board umbilical well camera films (Figure 4.4.5.4). The damaged area was estimated to be approximately 18 x 12 inches in size using the umbilical photography. The bipod spindle was not exposed. It is not known if any launch debris was seen on STS-7 that was correlated to the missing bipod ramp.

Figure 4.4.5.4 Image from STS-7 On-board Umbilical Well Camera Film Showing Damage to ET -Y Bipod Ramp

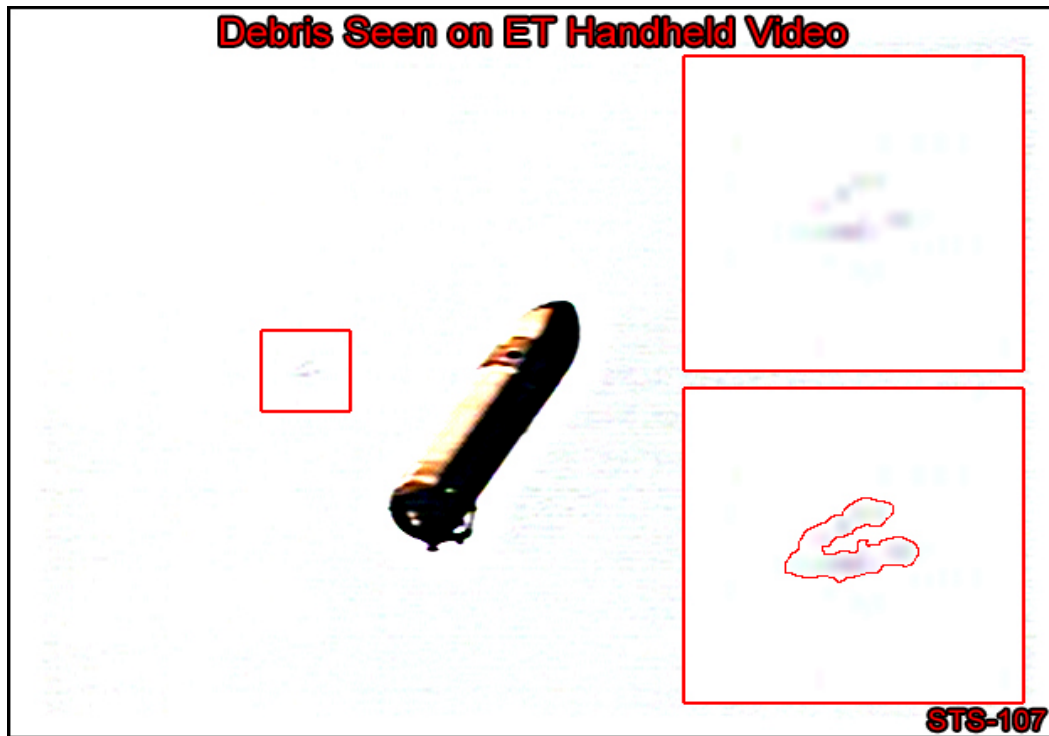
Figure 5.3.1 View from the STS-107 downlink video of the External Tank and the debris, including an enhancement of the debris on the right side of the frame.

The debris tumbled as it moved from the bottom of the video view upwards in the view past the ET. It was variably white-colored and dark, depending on the lighting and shadows. The shape of the debris in the imagery was also variable (linear, irregular, “c” shaped), and its texture did not appear to be smooth or machined. The size of the object could not be determined because the distance of the debris from the camera was not known. The debris appeared similar to the ice debris from the orifice of the 17 inch Liquid Hydrogen (LH₂) umbilical disconnect that has been observed on previous mission ET imagery. Engineering Directorate personnel were able to eliminate some of the possible hardware candidates for the debris based on appearance and other known engineering data. Although the team could not unequivocally eliminate all possible hardware fragments to explain the debris (hardware fragment from the wing, landing gear door, or the forward External Tank), the debris was determined NOT to be hardware from

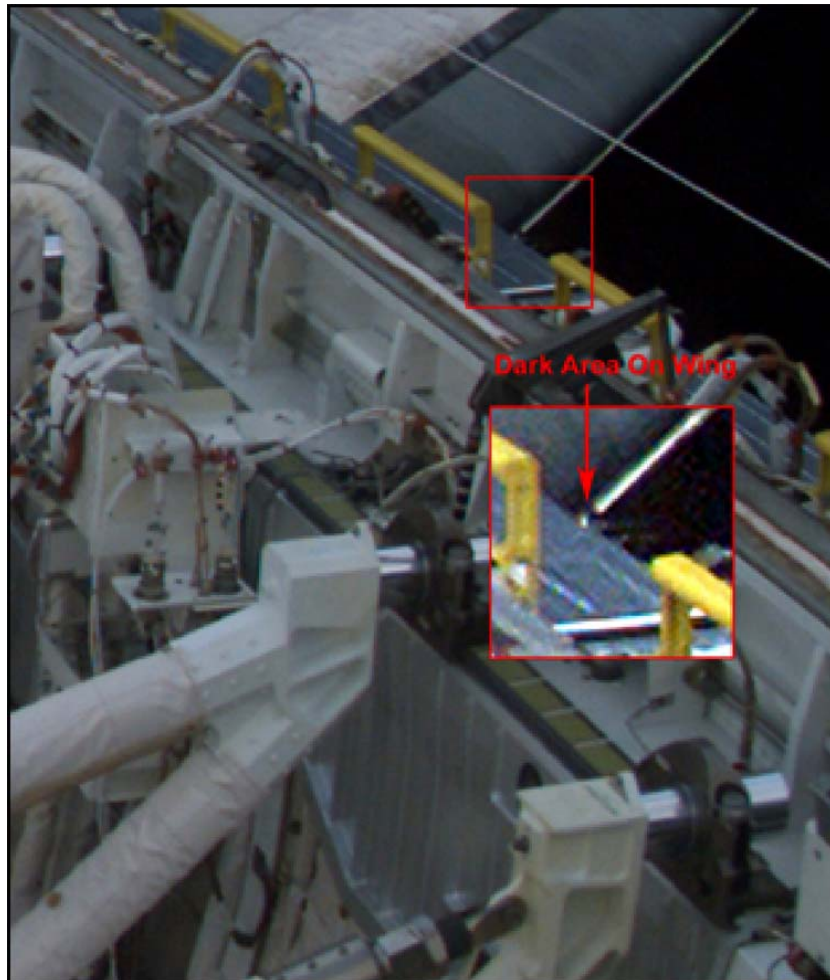
Figure 5.3.2.3a Dark spot seen on Columbia's left wing

that the dark feature was a portion of the payload bay latch mechanism, which extends to the side of the latch and partially obscures the leading edge of the wing in the view. The latches and rollers were identified and labeled as seen in Figure 5.3.2.3b. The same feature was observed in a previous mission image (STS-68) when the Shuttle was in a similar orientation and with a similar view and lighting of the left wing.

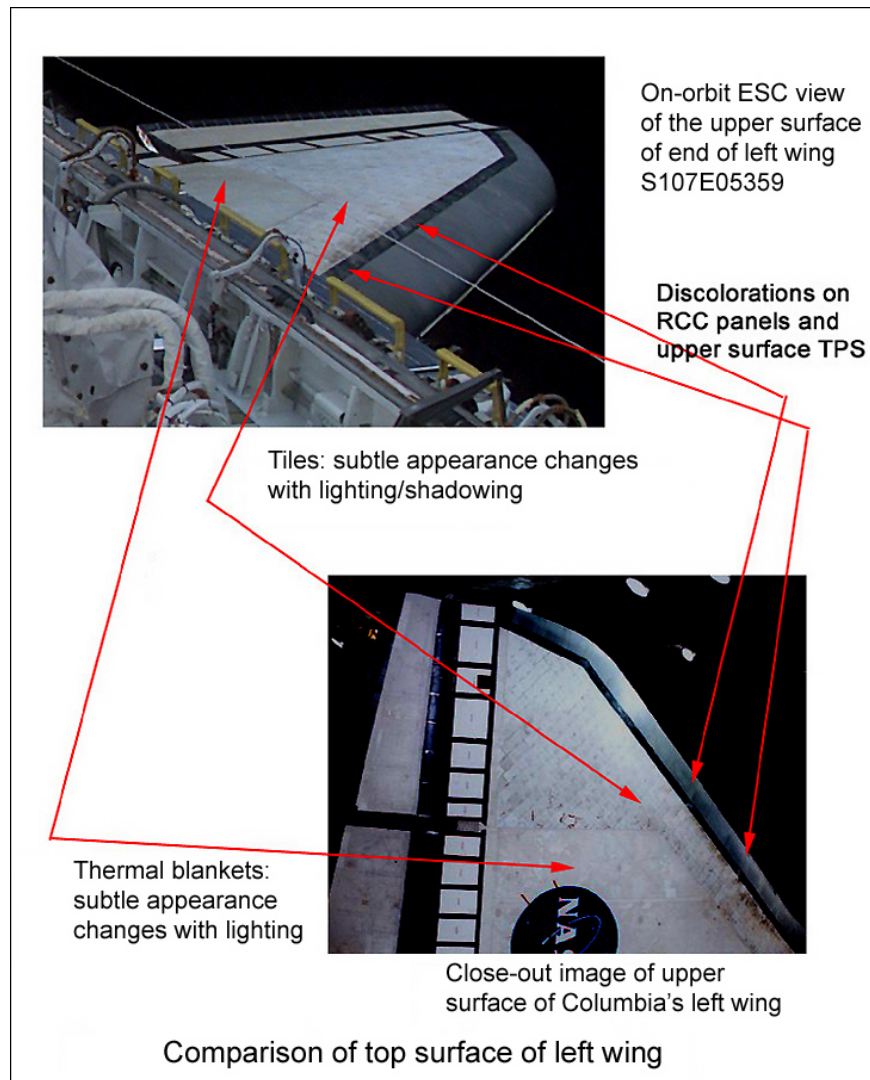
Figure 5.3.2.4a On-orbit and pre-launch views of left wing discolorations

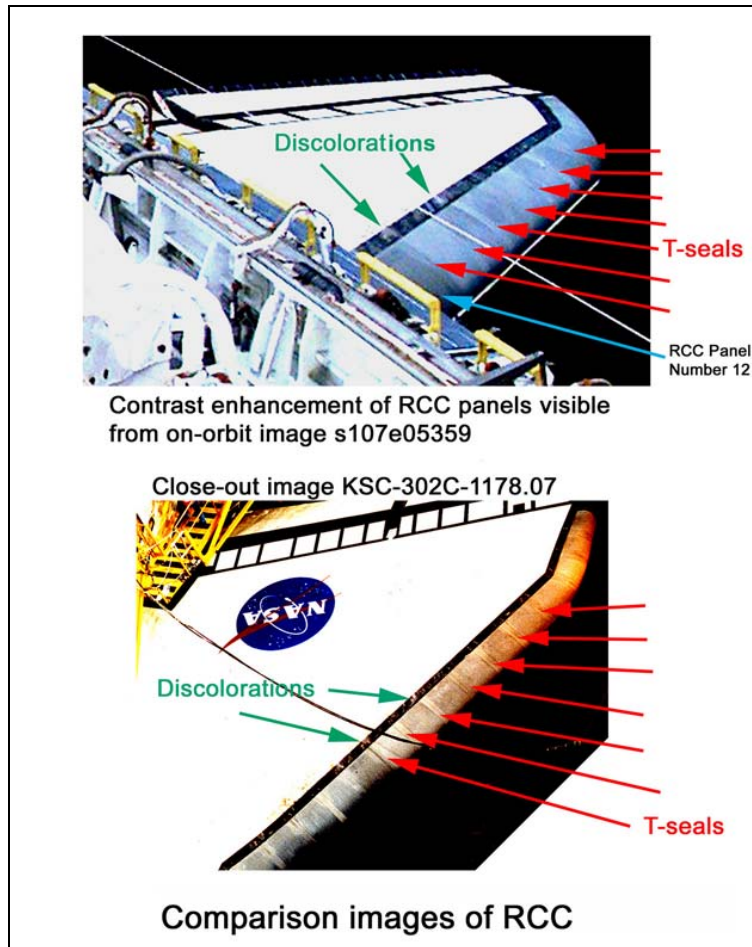
Figure 5.3.2.4b No detectable changes on left wing RCC panels, T-seals

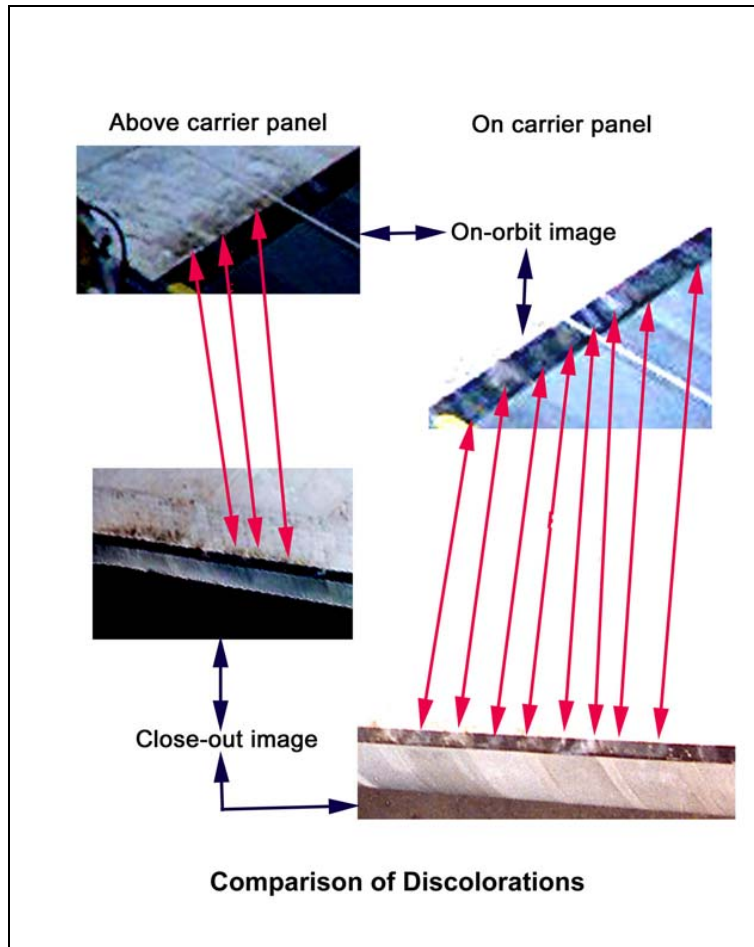
Figure 5.3.2.4c Discolorations on Columbia’s left wing carrier panels and adjacent tile surfaces

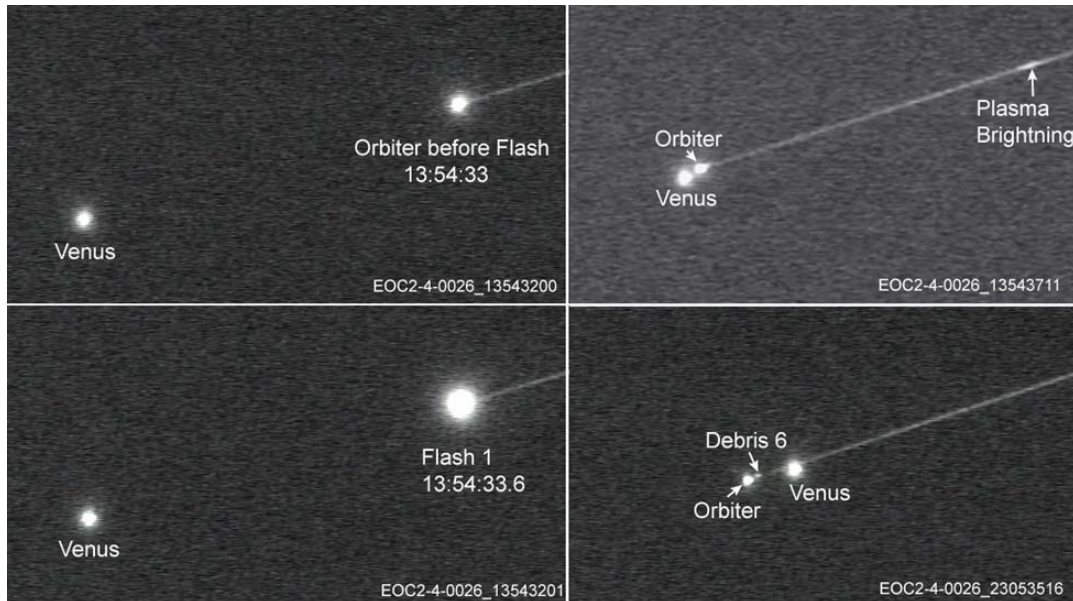
Figure 6.3.6a Frame grabs from the Sparks, NV video illustrating the Flash 1 event and the separation of Debris 6 from the luminous envelope of the Orbiter as it crosses Venus
