# Volume IV

## Appendix F.2

## “Follow the TPS”: An Analysis of What Occurred to the Thermal Protection System (TPS) During the Flight of Shuttle Columbia on STS 107

J. O. Arnold <sup>†</sup>, H. E. Goldstein <sup>‡</sup>, and D. J. Rigali <sup>λ</sup>

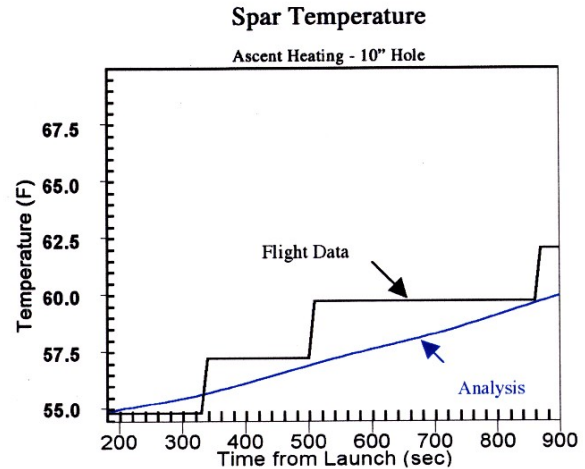
Figure 7: Data from OEX Thermocouple VO 9T9895 and Thermal Analysis by NASA (Reference 12).

One piece of evidence that corroborates that there was a breach in the wing at EI comes from the MADS/OEX thermocouple located behind the spar at the Panel 9 location. As discussed in References 4 and 12, there was “out-of-family” heating at this location during the STS 107 ascent. Figure 7 shows the time history of the measured thermocouple signal and the comparison of NASA’s thermal analysis (Reference 12) of the ascent event. As indicated on the figure, the “stepped” curve is the flight data while the blue-colored, smooth curve is the result of the NASA analysis. Note that the temperature readings are not large, owing to the facts that ascent heating is small, relative to that for entry, and that the thermocouple is behind the spar and the spar insulation. Detail of thermocouple locations will be discussed later.

NASA’s thermal analysis of the signal between 200 -> 900 seconds after launch suggests that ascent heating due to a hole of 6 – 10 inches in diameter in the wing leading edge can account for this anomalous heating. While this is not conclusive evidence that a breach existed after the foam strike at 82 seconds into the launch, it is quite consistent with the hypothesis.

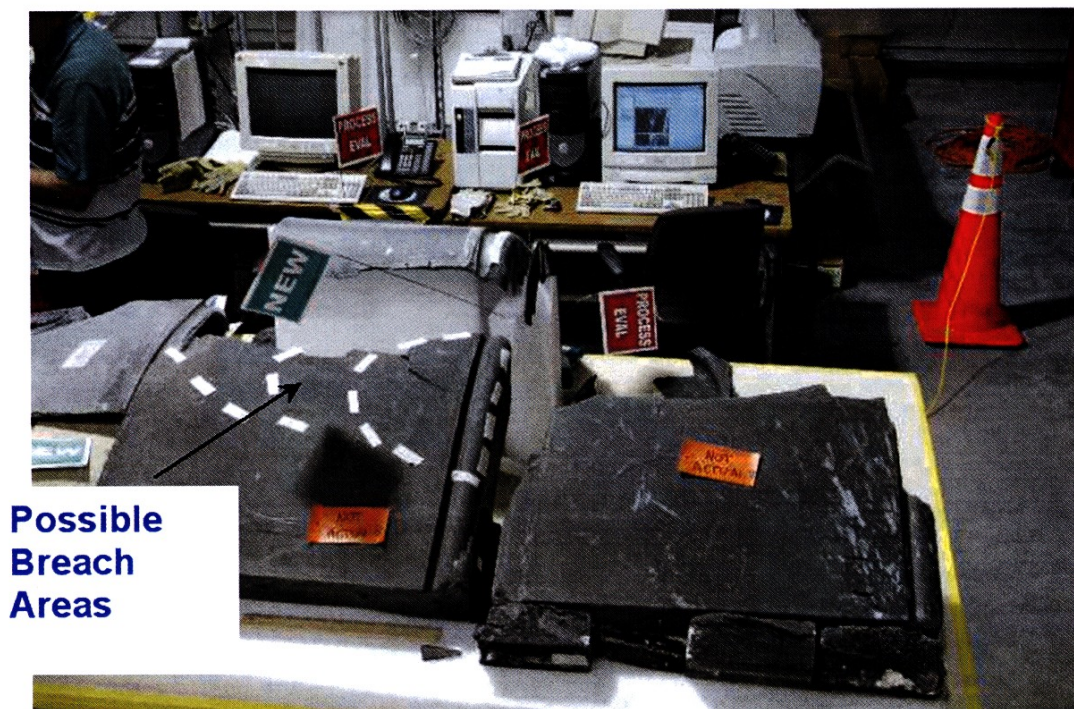
Figure 33: Probable Initial Breach in Panel 8.

Figure 33 shows the probable initial breach location on the lower Panel 8 area. The size of the hole is difficult to determine, but could be bounded by the three dotted locations outlined by white tape. Analysis by NASA discussed above suggests the damage is consistent with a hole of 6 → 10 inches in diameter. All of these are consistent with the flow patterning seen on the debris and the Computational Fluid Dynamics flow calculations to be discussed below. The authors note that areas this large would be consistent with the “piece” shown by DoD radar observations that “left” Columbia on day two of its orbital maneuvers. A part of a broken T-seal (possibly from Panel 8, located between Panels 8 and 9) could also account for the “piece” observed leaving the shuttle on day two of orbital operations. Note that on this photograph, the two recovered Panel 8 carrier panel tiles are not shown.

The authors believe that in addition to a breach in Panel 8, the upper part of the T-seal between Panels 8 and 9 must have been missing or severely misaligned for a major part of the entry. This is required to account for the severe erosion of the upper RCC Panel 8 outboard and Panel 9 inboard ribs shown in Figures 28 and 29 and discussed above. Flow patterns of the recovered upper Panel 8, suggest this happened as discussed in Reference 20.

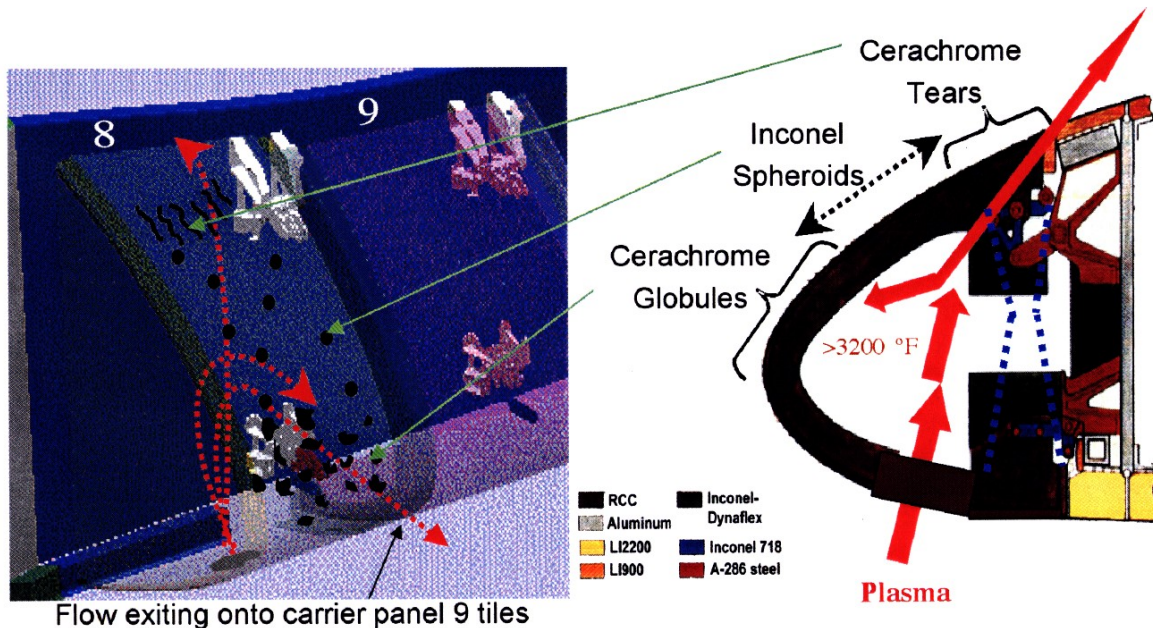
Figure 34: Wing Leading Edge Chemical Analysis of Panel 8 (Reference 20).

Figure 34, adopted from Reference 20 summarizes work by the NASA Forensics Team. The analysis of the slag deposited on the inside of RCC Panel 8 shows that cerachrome and Inconel were deposited first in the slag layer. Deposition of aluminum occurred last. This is consistent with the sequence of thermal damage seen in the MADS/OEX data and is additional proof that the damage moved from the RCC -> aft. There were large amounts of melted cerachrome in the slag, consistent with prolonged presence of superheated air, since the melting point of cerachrome is in excess of 3200 °F. The presence of Inconel in the slag proves there was hot gas impingement on the RCC spanner bars, insulation foil and RCC panel fittings made of this material.
