ET Cryoinsulation

ET cryoinsulation Power Point Slides presented 7 April 2003 at the CAIB Public Hearing: ET cryoinsulation, by Lee Foster and Scotty Sparks, MSFC.

CAIB Public Hearing: ET Cryoinsulation

April 7, 2003

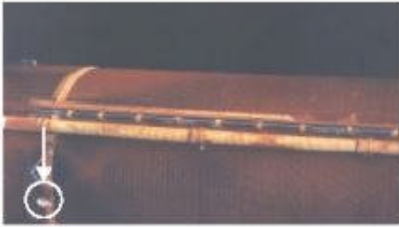
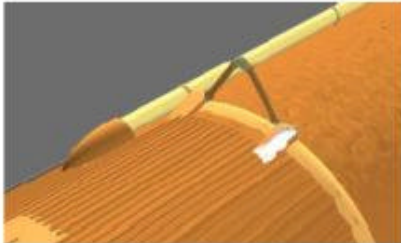
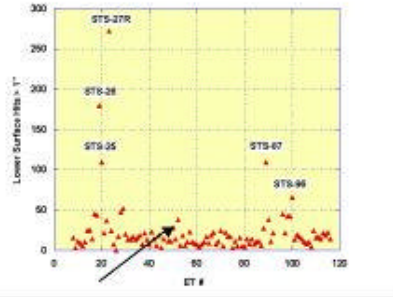
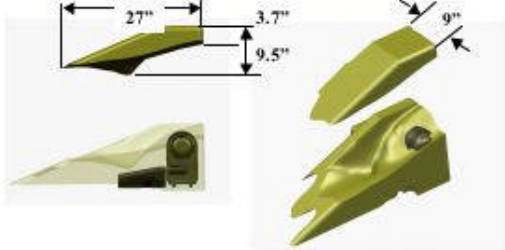
**STS-50
ET-50**

STS-50 28 Hits > 1"

Vol 700.5 cu in
Wetted Area 636.18 sq in
Wt 0.97 lbs

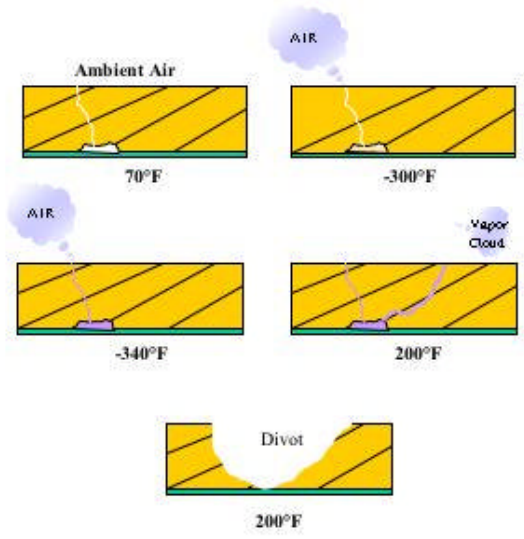
Cryopumping

- Transformation from a gas to a liquid at cryogenic temperatures
- Gases are condensed within a void or porous material at low temperatures
- Air in Cavities or Porous Material (SLA-561) Liquefies When in Contact With Structure Below -297°F for Oxygen and -320°F for Nitrogen
- Pressure is Reduced Locally Due to Gas to Liquid Volume Change and More Air Will be “Sucked” Into Area
- Process Continues Until Cavity or Porous Material is Filled With Liquid Air

- No Detrimental Effects While Structure Remains Cold
- When Structure Warms, Liquefied Air Returns to Gaseous State With Local Pressure Increase
 - Gas Can Escape With No Detrimental Effect if Leak Path Large – Condensation Cloud May Be Visible at Leak Exit
 - Pressure Can Crack TPS and Escape With No Divots – Condensation Cloud May Be Visible
 - Pressure Can Cause Divot if Leak Path Small

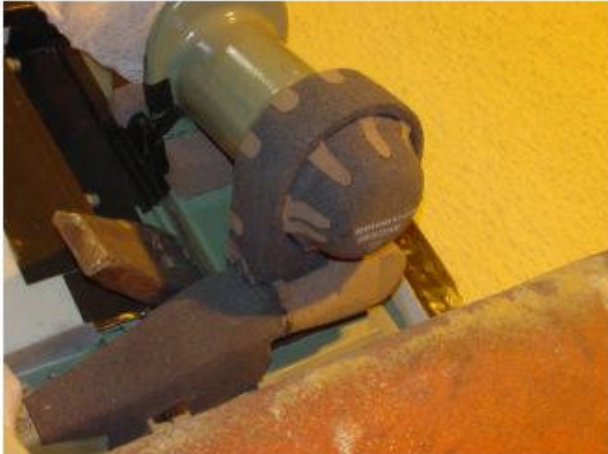
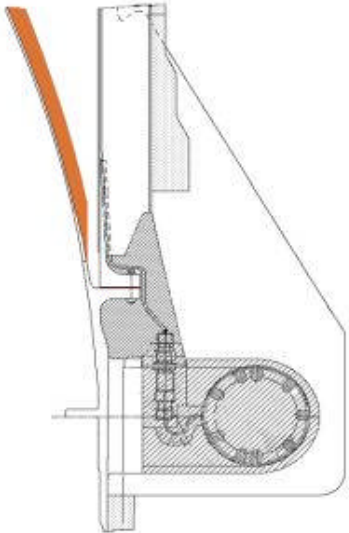
Postulated Cryo-ingestion

Bipod Schematic

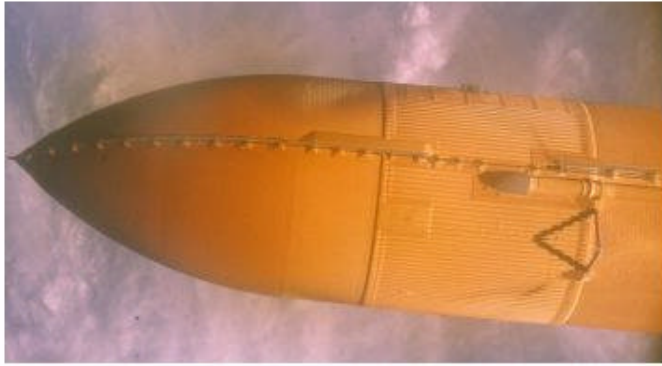
STS-7/ET-6 - All four foams CFC-11

STS-112/ET-115 - Three HCFC 141b foams with one CFC-11 foam

STS-112/ET-115 - Foam loss on bipod - CFC-11

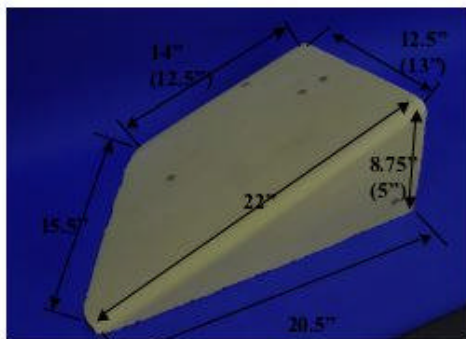
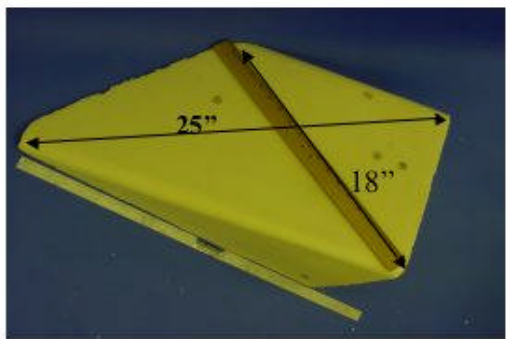
ET-120 Ramp From Dissection

- Measured Weight - 1.02 lbs

- One of at least three particles seen leaving bipod area
- 24" (+3") x 15" (+3") - from camera E212
- 5" (+1") - from trajectory analysis
 - Volume estimate - 0.58 to 1.68 cu. Ft.
 - Estimated weight - 1.04 to 4.37 lbs. (1.8 to 2.6 lbs./cu.ft)

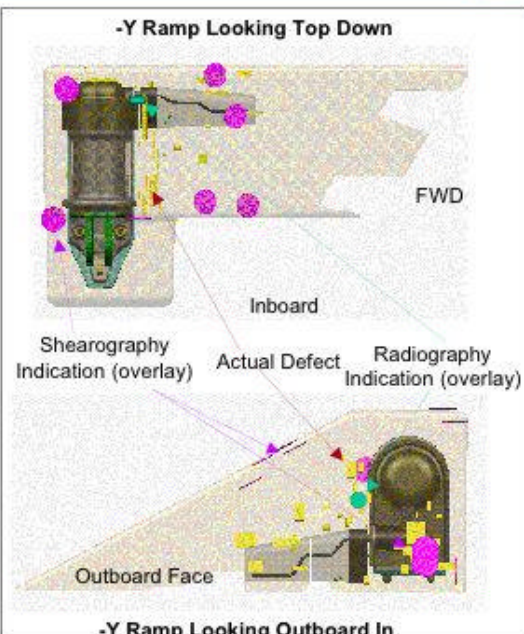
- ET120 -Y Bipod Results
 - Several indications were noted pre and post wedge removal which may be attributable to complex part geometry, density gradients, or defects
