# Volume V

## Appendix G.12

### Crew Survivability

## Crew Survivability Report

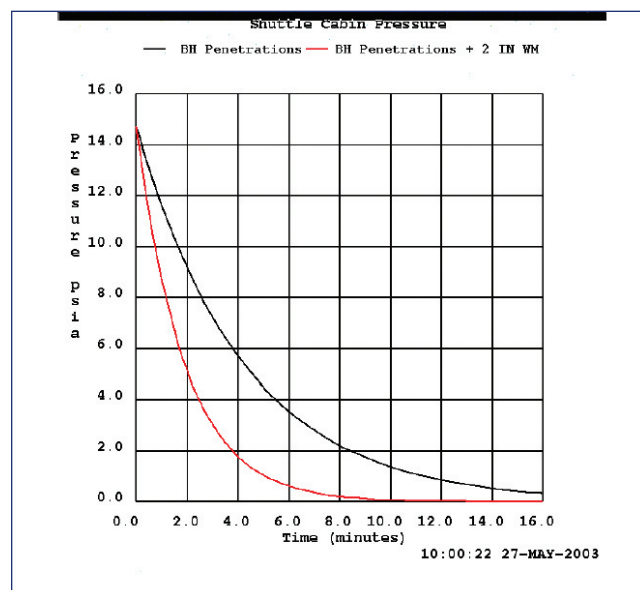
Figure XYZ Cabin Depressurization Cases (a) and (b).

Each case was selected to understand the range of possible depressurization rates, as a function of possible CM break-up scenario. Case (b) was selected as the WCS CCH ball was one of the furthest west CM item found. Case (c) was selected to simulated loss of the Airlock "A" hatch.

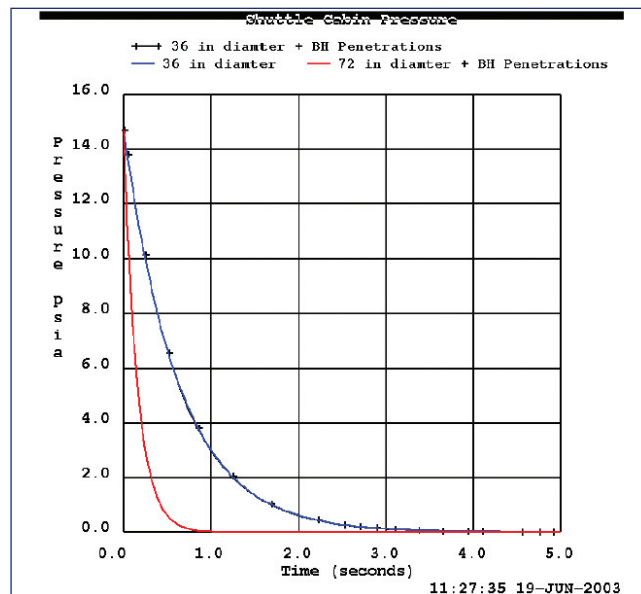
Figure XYZ Cabin Depressurization Cases (c), (d), and (e). Blue (or upper) curve contains both (c) and (d) cases.

The analysis results are reflected in the graph below. Clearly, depress rate significantly varies, from minutes to seconds of useful cabin atmosphere. The CSWG is still analyzing data and hardware in an attempt to, at a minimum bound the depress rate. Depending on the scenario chosen, one can conclude whether or not the crew had or did not have time to execute various malfunction/contingency procedures.

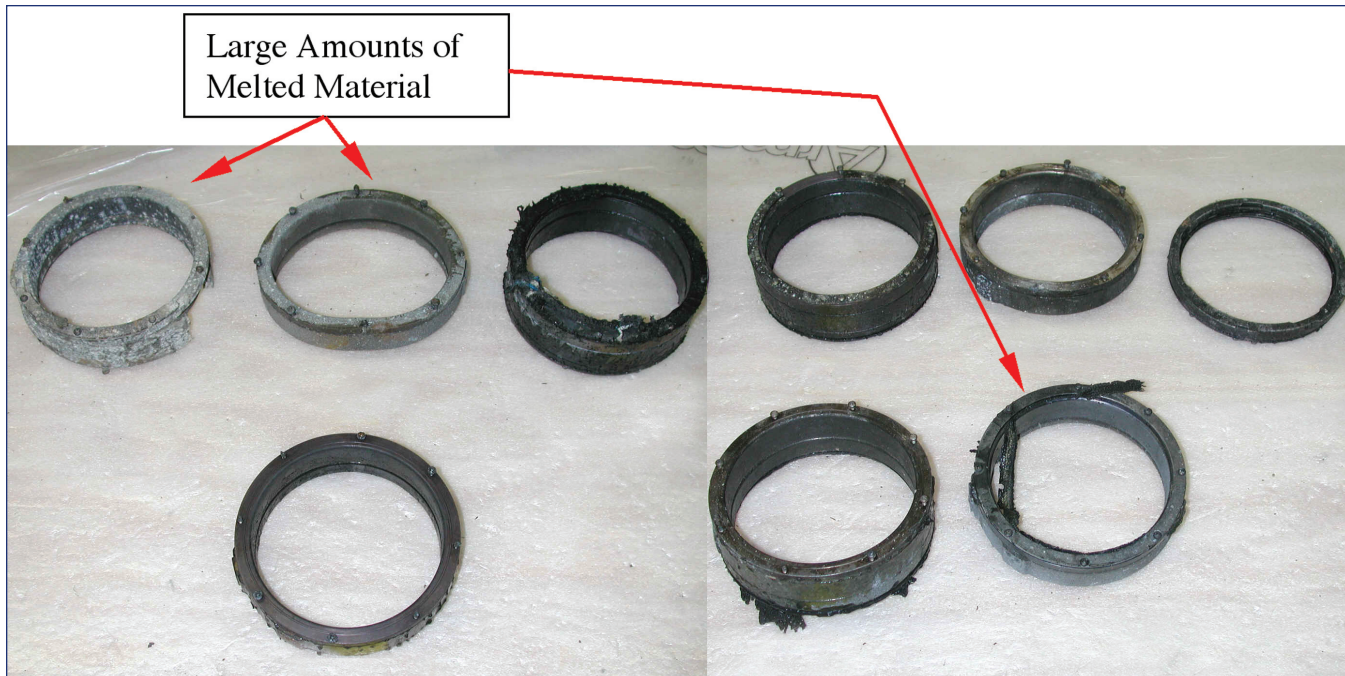
*Recovered Glove Disconnects.*

corresponding to six out of seven crewmembers. Exposure to entry heating environments is apparent throughout. However, the level of heating varied substantially from item to item. Items from some crewmembers experienced significantly greater heating than comparable items on other crewmembers. Also, significant differences in heating were noted from the left to right sides on some crewmembers equipment. Detailed inspection of recovered debris items suggests that three of the seven crewmembers did not have gloves properly installed during re-entry.

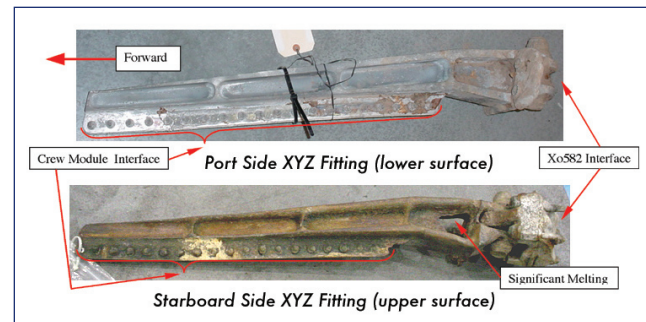
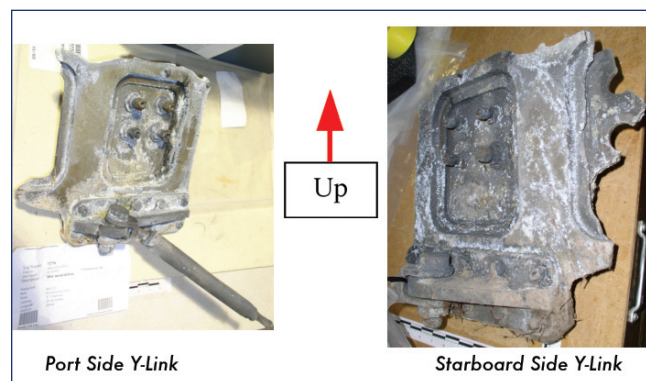
Both the port and starboard side XYZ fittings were recovered intact with evidence of high heating. Both titanium fittings experienced significant thermal exposure / melting, predominantly on the upper surfaces. In comparison, the starboard side fitting experienced significantly greater heating than the port side.

Each fitting exhibited failures at both its crew module interface and Xo582 frame interface. The crew module interface failed at the longeron tab on both the port and starboard sides. Fasteners along the joint remained intact. On the Xo582 frame interface, the port side experienced a lug tensile failure while the starboard side fittings pulled through the Xo582 frame.

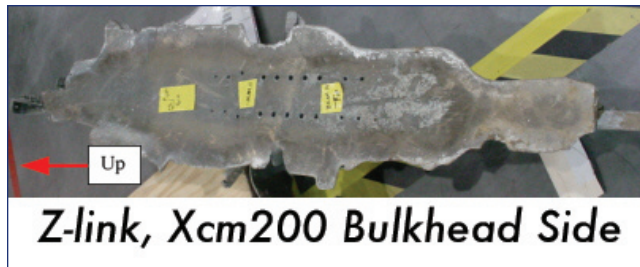
Both the port and starboard side Xo576 interfaces of the double strut Y-link assembly were recovered (the Xo582 side interface was not recovered). Both the port and starboard side struts of the Y-linkage failed in tension at the clevis end fittings. The port side failed in proximity to the Xo582 ring frame, the starboard side in proximity to the Xo576 bulkhead.

The Z-link failed at the attach point to the Xcm200 bulkhead. The joint failed by a combination of both fastener tensile failure and fastener insert pullout

Detailed inspection of each linkage failure suggests the failure mode was affected by a reduction in material properties associated with elevated temperatures.

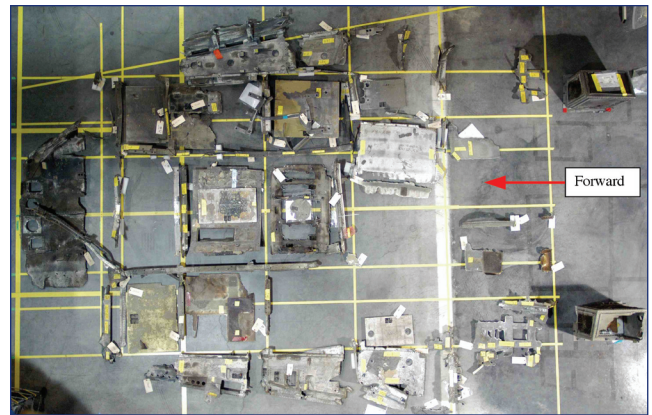
Mid Deck Floor Debris (looking down).

Heating patterns on all debris components appears to be independent of attachment to surrounding structure. This implies that the recovered debris items not only were released early, but that they separated quickly from the surrounding structure. Deceleration occurred quickly due to low mass/area ratios (ballistic numbers).

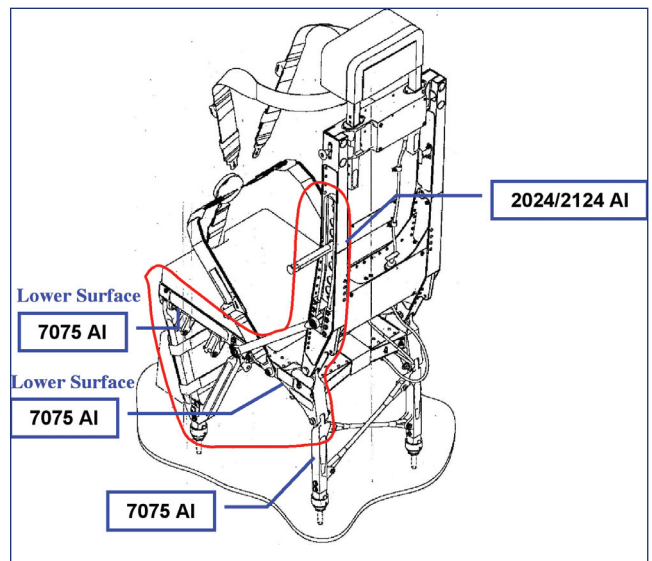
Mid Deck: Materials Sampling Analysis on Recovered Seat Debris Items.

deposits of melted aluminum consistent with the mid-deck floor panel they were attached to (verified by materials analysis and consistent with the flow direction). Materials

consistent with the surrounding pressure shell and/or structure were not found.

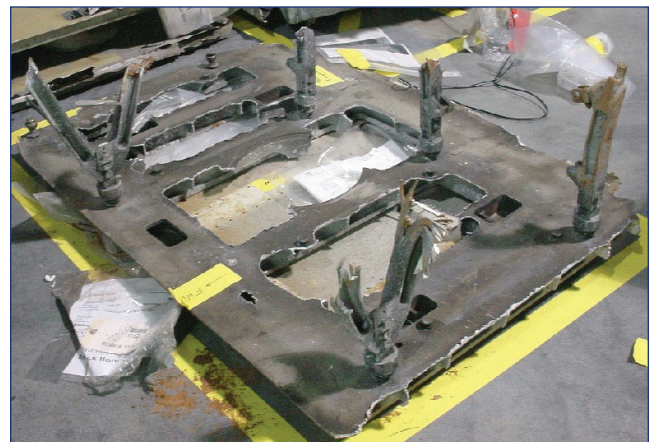
LiOH Door Floor Panel With Seat 6 & 7 Attach Points.

The only recovered mid deck floor item which experienced significant re-entry heating was the LiOH door floor panel, with the corresponding seat 6 and 7 attachments. The panel itself was highly melted, with thin sections completely missing. Detailed inspection of heat patterns suggest that directional heating occurred along a flow vector directed “bottom-up.” The mid deck seat 6 and 7 locations collected

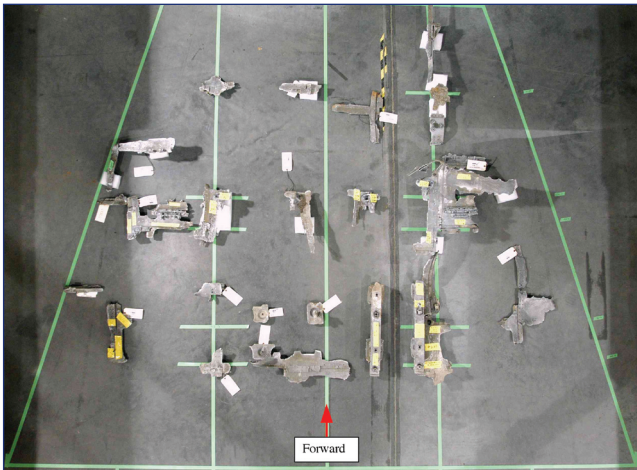
*Flight Deck Floor Debris (looking down).*

Unlike the mid deck floor, it is estimated that less than 10% of the flight deck floor was recovered. This is attributed to the substantial amount of heating experienced in this area.

Generally, only small portions of flight deck floor panels, structure, and seat components were recovered. In all cases, debris components are highly melted and/or deposited with splattered aluminum on all surfaces. None of the coating materials (topcoat or primer) survived.

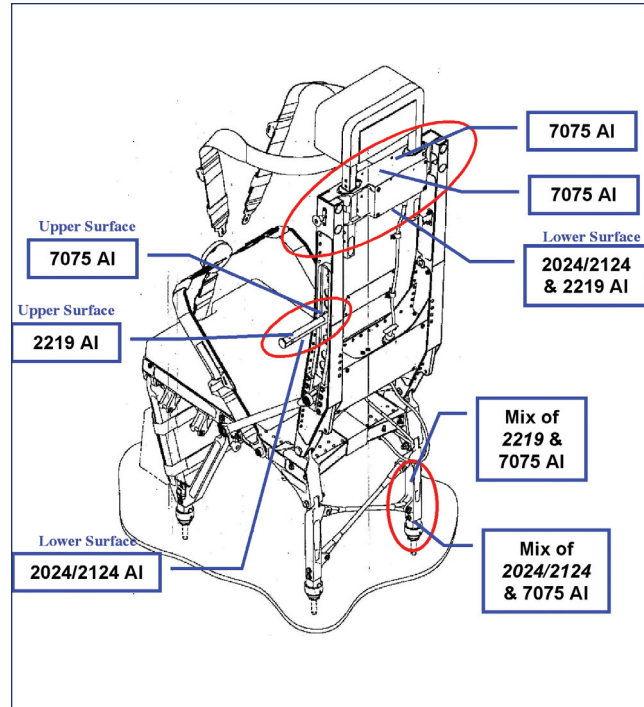
*Flight Deck: Materials Sampling Analysis on Recovered Seat Debris Items.*

The flight deck seat locations collected substantial deposits of melted aluminum from locations throughout the cabin area (verified by materials analysis). Materials consistent with the bulkheads and outer pressure shell (2219 aluminum), the surrounding primary and secondary structure (2219, 2024, 2124, and 7075 aluminum), and the seat itself (2024 and 7075 aluminum) were discovered on both upper and lower surfaces of recovered seat debris. See below for a description of findings:

Thus, the flight deck seats remained attached to both flight deck floor panels and surrounding structure during thermal exposure.

The magnitude and distribution of heating experienced by flight deck components suggests a prolonged attachment to

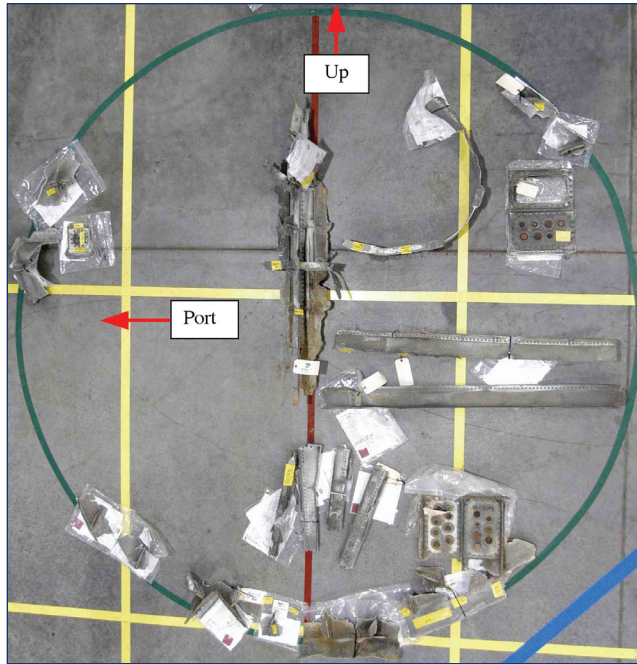
*Forward Bulkhead Debris (looking forward).*

Further Analysis of the forward bulkhead structural failure is still in work.

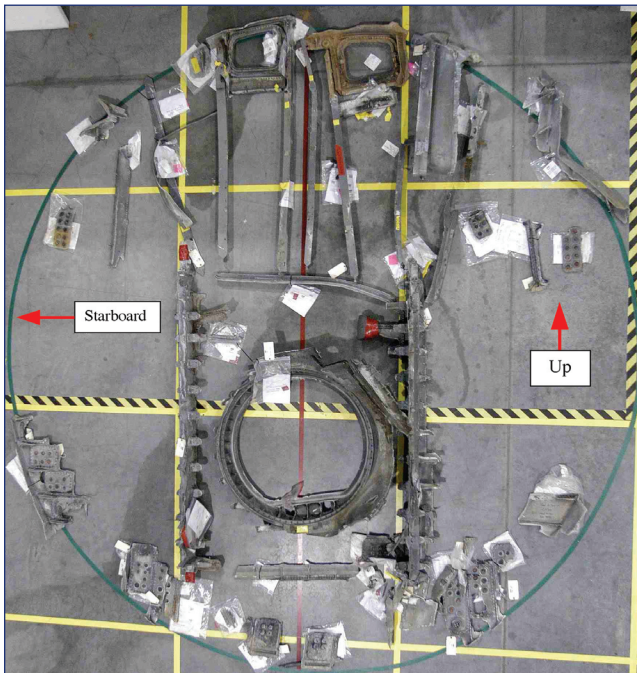
*Aft Bulkhead Debris (looking aft).*

The failure mode of the aft bulkhead structure has not been determined. Debris items recovered from the aft bulkhead show heating patterns initiating from multiple directions. All of the recovered stiffeners appear to have sheared along their attach points, consistent with a bulkhead bending failure. Some failure modes appear to have been affected by elevated temperatures.

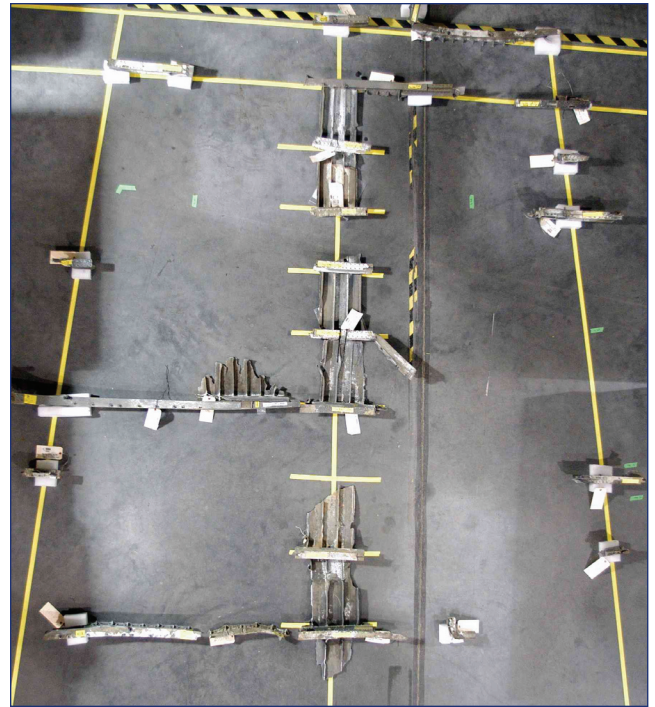
*Lower Crew Module Pressure Shell Debris.*

Barely ANY of the exterior pressure shell was recovered. Apparently, re-entry heating was sufficient to burn / melt away nearly all exposed thin sections (including bulkhead areas). In general, the only pieces of the pressure shell remaining were found attached to corresponding structure. Relatively speaking, more of the pressure shell was recovered from the lower crew module area than anywhere else .

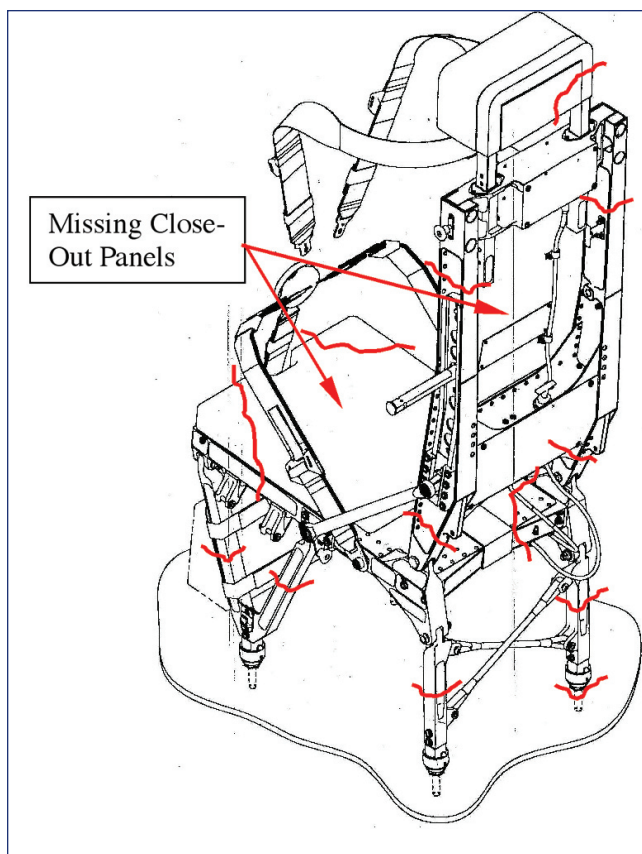
In nearly all cases, seat components generally fractured into relatively small pieces. It is noted that nearly all seat component fractures occurred at minimum thermal cross-sectional areas (minimum thermal mass), away from any large heat sink locations. It is also noted that nearly all thin-sheet aluminum materials (close-out panels on seat pan and seat back) are completely missing (i.e. overloaded / melted away). Common seat component fracture locations are shown below:

Common Seat Failure Locations (shown in red)  
(NOTE: Mission Specialist seat shown; Components below seat pan on Commander/Pilot seat are different in design).

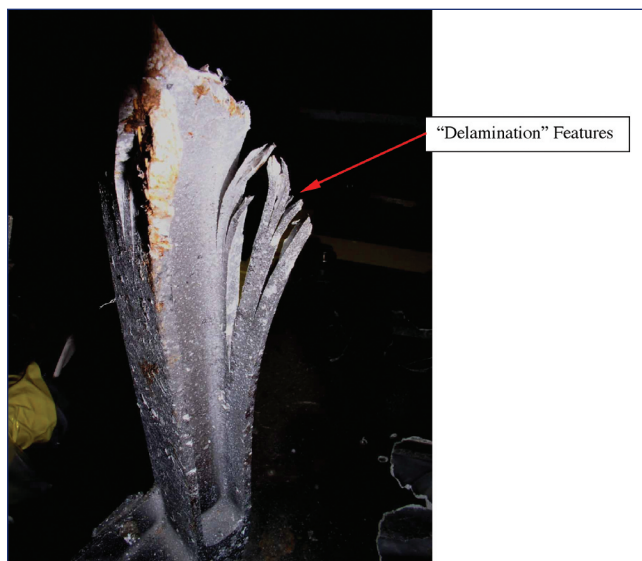
Upon inspection of fracture surfaces, a very unique “delamination” type fracture pattern was identified that is consistent throughout the seat component debris items. Several fractures almost appear as if the 7075 aluminum material is constructed of a laminate material (see below) when in ac-

Example of “Broom-Straw” Fracture.

tual fact the material is solid aluminum plate not a laminate structure. This phenomenon was termed as “broom-straw” fractures (see Example below).

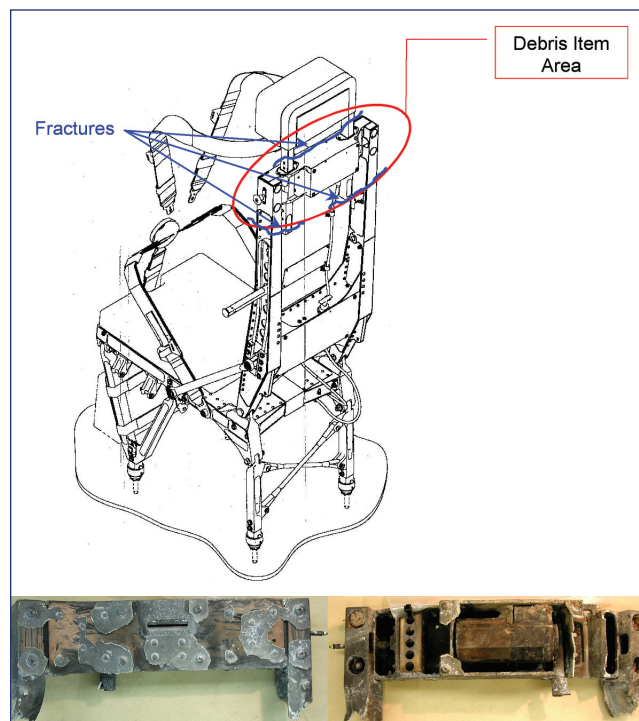
Six out of seven “Upper Seat Back” debris items were recovered (all but Seat 5). Each item was positively identified to a seat position. Each recovered upper seat back debris item contains the upper seat strap recoil mechanism and some amount of strap material, which had recoiled back into the mechanism subsequent to strap failure. A description of the debris location and an example of one recovered upper seat back debris item follows:

Schematic of “Upper Seat Back” Debris Location, and Example of Representative Debris Item (front and back shown).

In all cases, fractures at the upper seat back location occurred at the minimum thermal cross section, away from heat sinks on either side. These fractures are consistent with the general seat failure mechanism (thermal heating followed by mechanical overload).

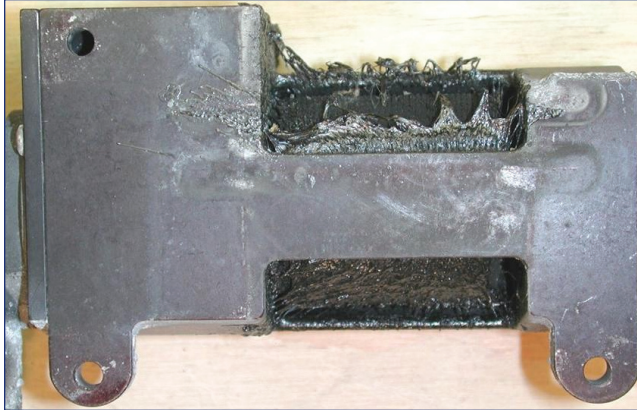
In all cases, a significant amount of melted / splattered strap material was discovered internal to the upper back seat cavity. Melting appears associated with air flow entering the upper seat back strap entry point. Melt patterns suggest melting occurred AFTER the seat straps had been recoiled into the housing (i.e. post-failure). Thus, it can be concluded that crewmembers were removed prior to completion of thermal heating event.

*Example of Strap Melt Patterns Surrounding Recoil Mechanism.*

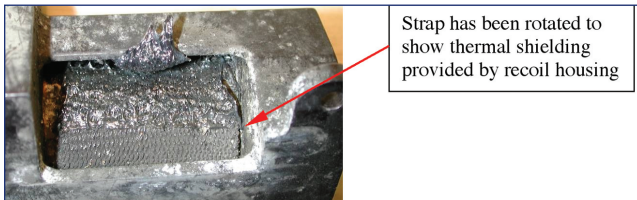
*Close-Up of Strap Melt Patterns.*

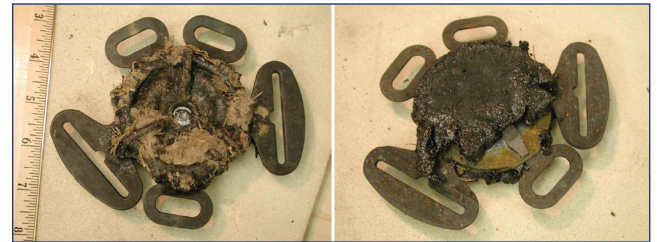
Only one of seven 5-point seat belt buckles was recovered. Positive identification was not possible. The one recovered buckle experienced significant re-entry heating. This resulted in substantial melting of the outer plastic housing. The structure however remained intact, with all five clasps still in place.

*Recovered 5-Point Seat Belt Buckle (front and back shown).*

Surprisingly, the two upper strap attach clasps were bent *outward* (away from the crewmember). All other clasps appeared nominal. The buckle assembly was disassembled in an attempt to locate "witness marks" which may have been caused by mechanical loading. Nothing was found.
