COLUMBIA

ACCIDENT INVESTIGATION BOARD

Report Volume V
Appendix G.13
October 2003

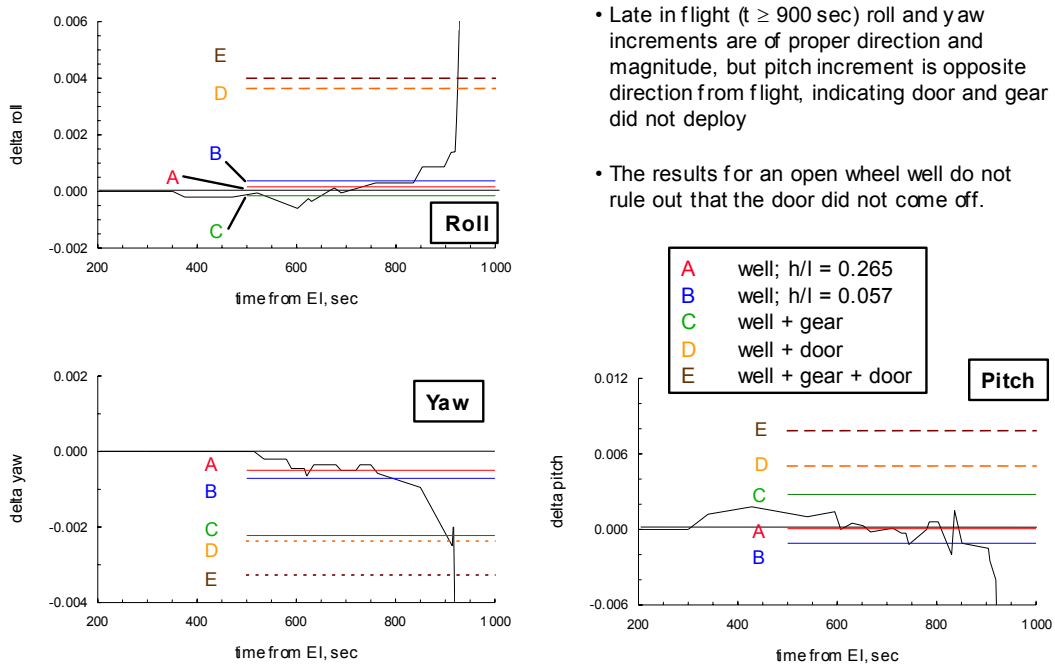
Bertin, J.J. (1975), Graumann, B.W. and Goodrich, W.D., “High Velocity and Real Gas Effects on Weak Two-Dimensional Shock Interaction Patterns,” Journal of Spacecraft, Vol. 12, No. 3, pp 155-161.

- Late in flight (t ≥ 900 sec) roll and yaw increments are of proper direction and magnitude, but pitch increment is opposite direction from flight, indicating door and gear did not deploy
- The results for an open wheel well do not rule out that the door did not come off.

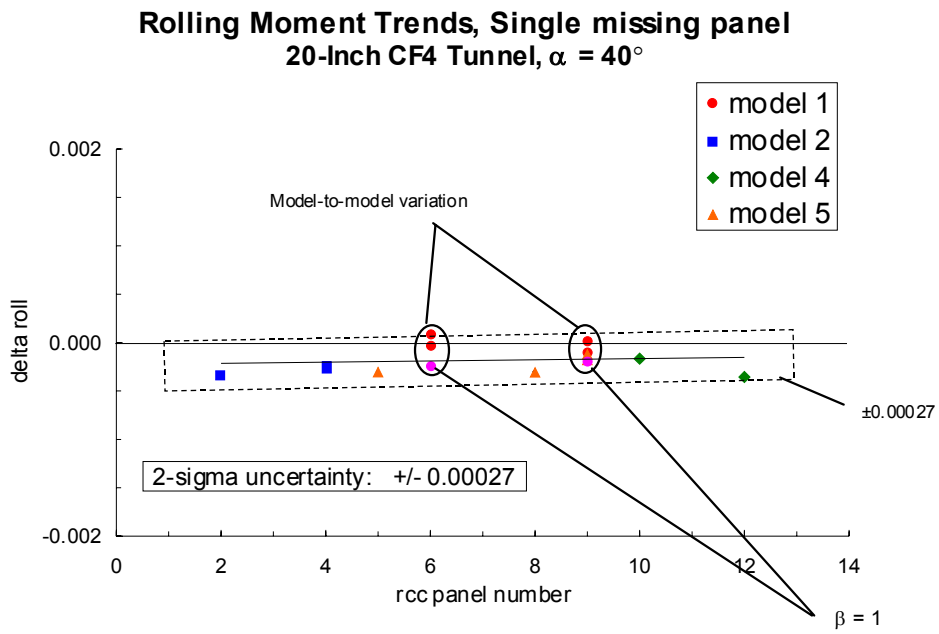
Figure 4.3-7 Aerodynamic Increment (delta Roll) – Missing Full RCC Panel by Location

• Roll increment is relatively constant for a given missing panel

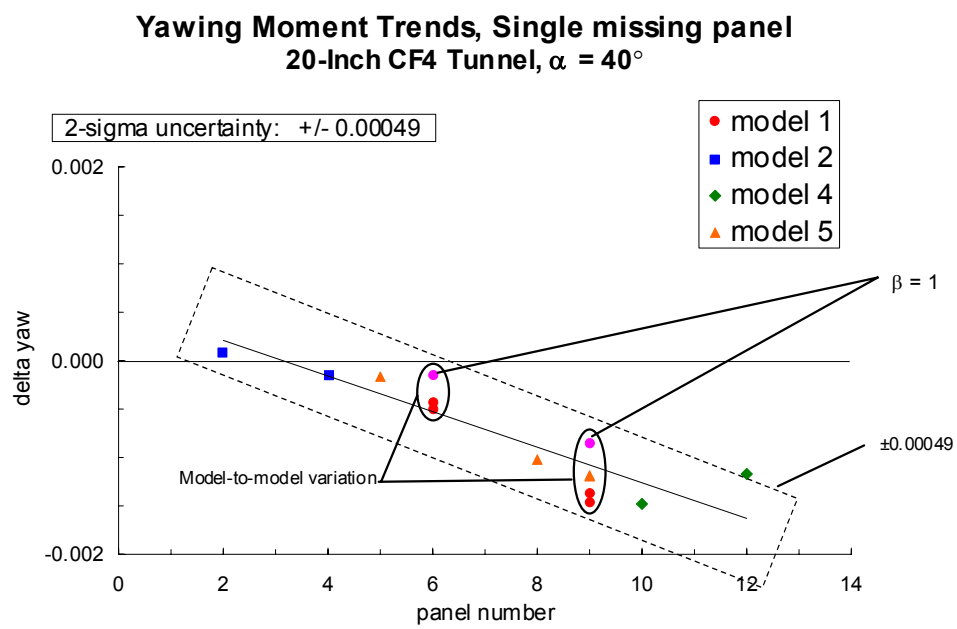
Figure 4.3-8 Aerodynamic Increment (delta Yaw) – Missing Full RCC Panel by Location

• Yaw increment is highly dependent on panel outboard location

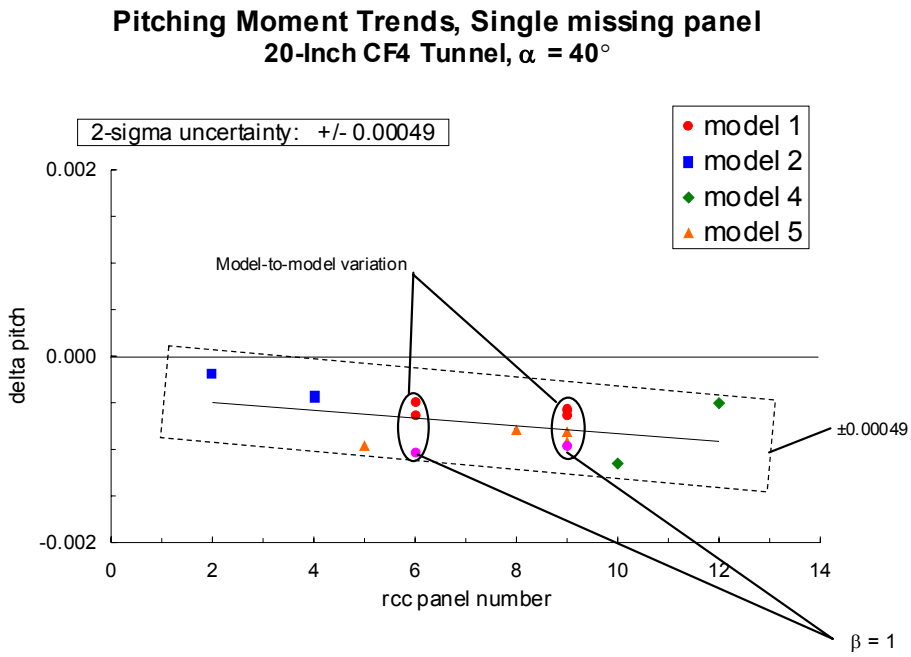
Figure 4.3-9 Aerodynamic Increment (delta Pitch) – Missing Full RCC Panel by Location

• Pitch increment is moderately dependent on panel location

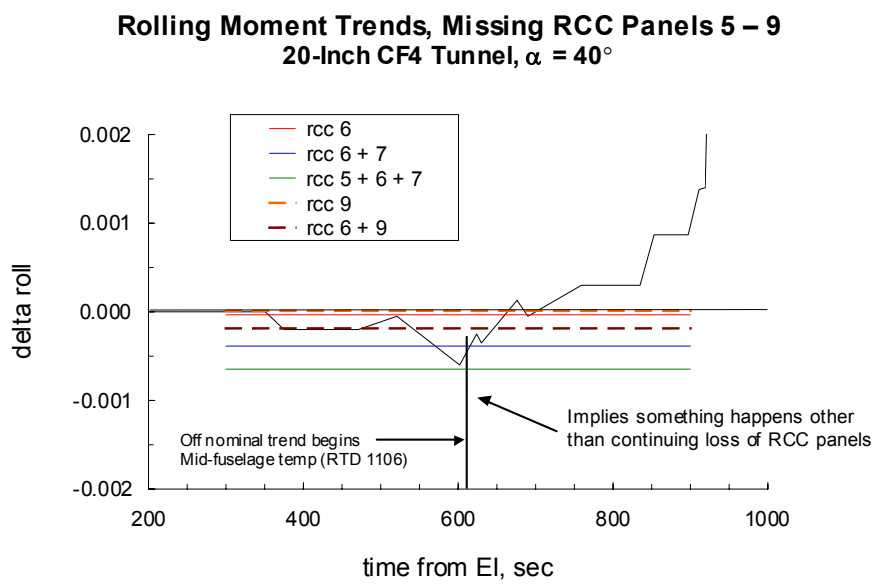
Figure 4.3-10 Rolling Moment Increment Trends - Missing RCC Panels 5-9

• Roll increment increases with increasing number of panels missing
• Two adjacent panels have larger increment than two separated panels
• Roll trend reverses at 615 sec; opposite effect from losing more leading edge panels

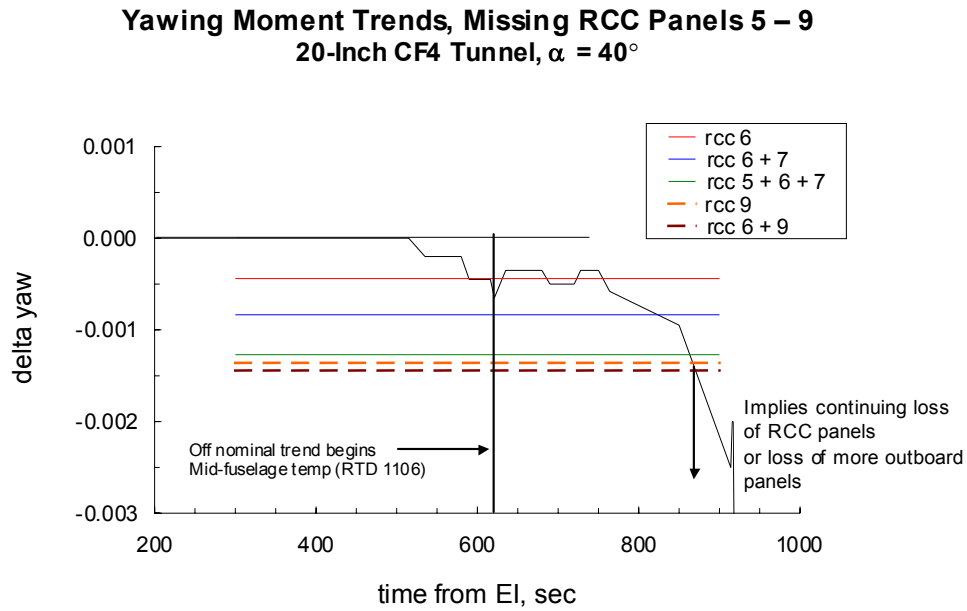
Figure 4.3-11 Yawing Moment Increment Trends - Missing RCC Panels 5-9

- Yaw increment increases for more outboard panels
- Yaw increment increases with increasing number of panels missing

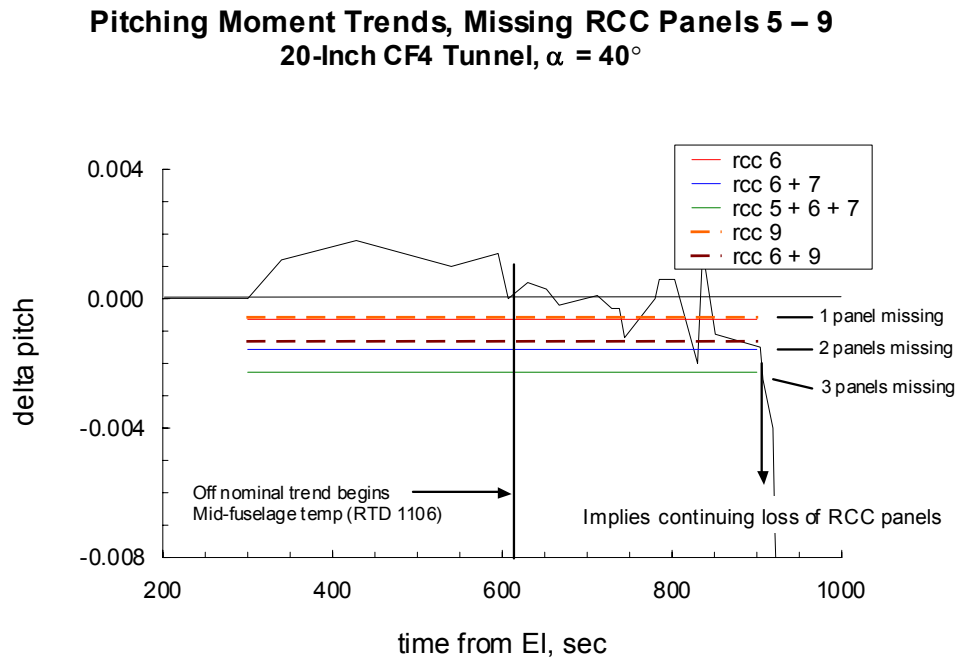
Figure 4.3-12 Pitching Moment Increment Trends - Missing RCC Panels 5-9

- Pitch increment nearly independent of panel outboard position
- Pitch increment increases nose-down with increasing number of panels missing

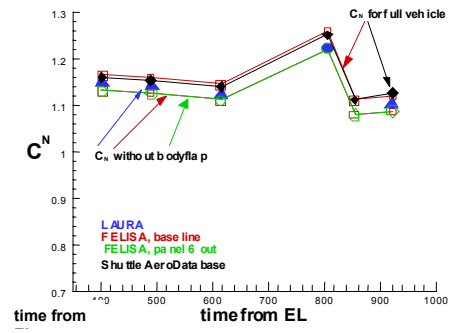
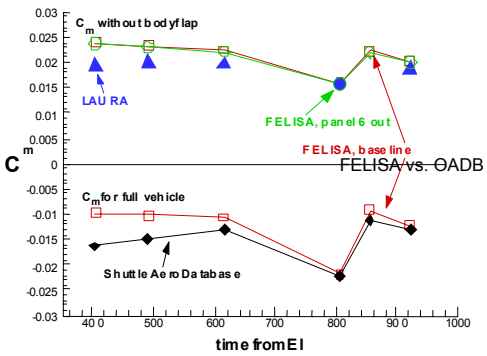
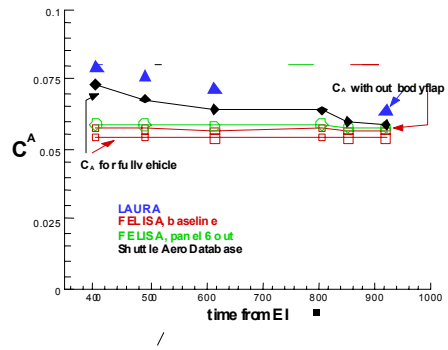
Figure 4.3-30 Baseline Aerodynamic Comparisons (Orbiter OADB vs. CFD Prediction)

The total normal and axial forces, and pitching moments for the solutions at CFD conditions 1 through 6 are plotted against time from EI of the STS-107 trajectory in Figure 4.3-30 (Note: side force, rolling and yawing moments are all zero for the symmetric baseline). The force and moments for the FELISA solutions are computed with and without the body flap, to serve as a bridge between the Orbiter OADB data and the LAURA computations. For pitching moment, the FELISA data is in better agreement with both the Orbiter OADB data and LAURA computations later in the flight, suggesting that the inviscid equilibrium chemistry model is not as appropriate for the higher Mach number range (M > 21). The trend in the LAURA predictions against FELISA without the body flap is similar to the trend of the Orbiter OADB data against the full FELISA solution, suggesting that the LAURA data is in good agreement with the flight database. The FELISA missing panel 6 result is also included in Figure 4.3-30 to illustrate how relatively small the delta aerodynamics due to damage are with respect to the absolute aerodynamics. A detailed discussion of this topic is included in the Aerodynamic Appendices Section 4.7.4.2.

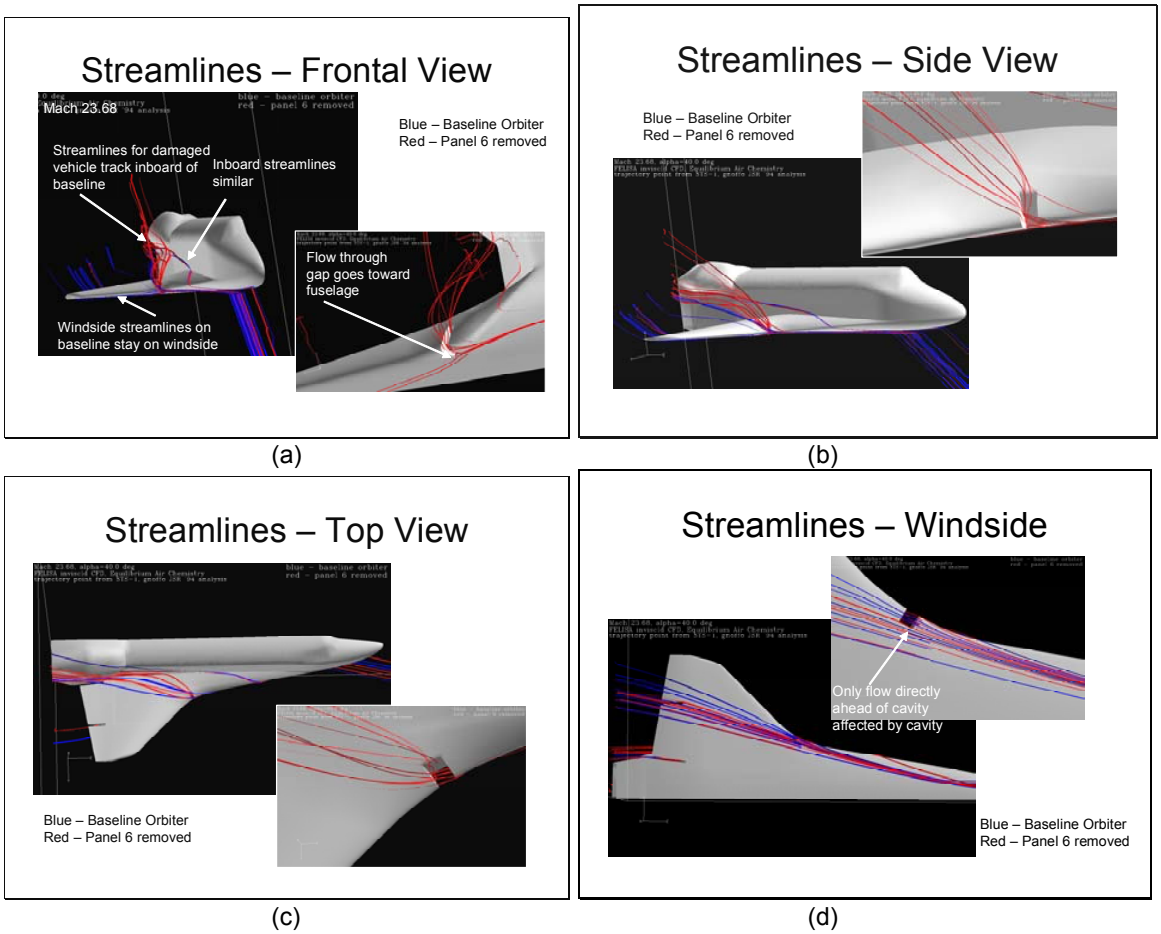
Figure 4.3-32 Nominal & Missing RCC Panel 6, Streamlines

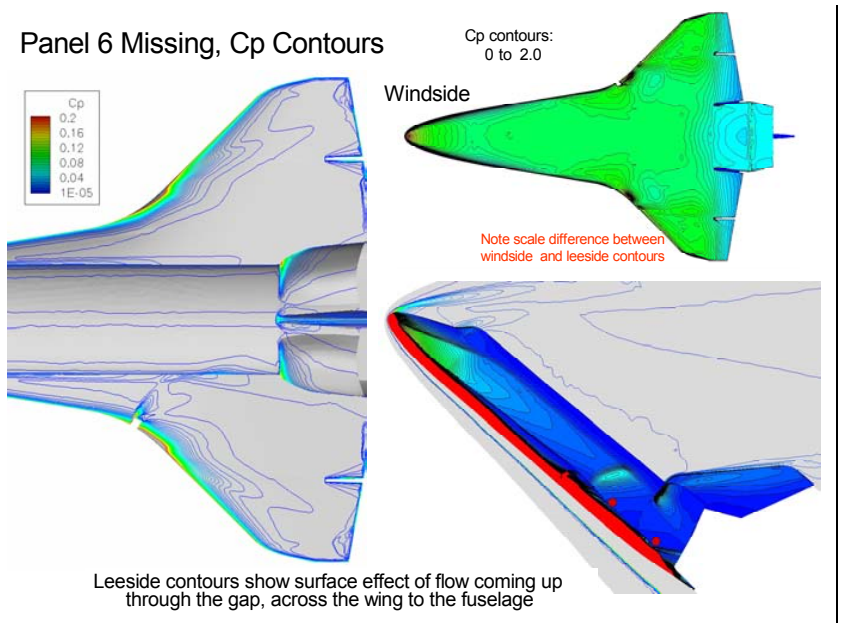
Figure 4.3-33 Panel 6 Missing – Surface Pressure Distribution

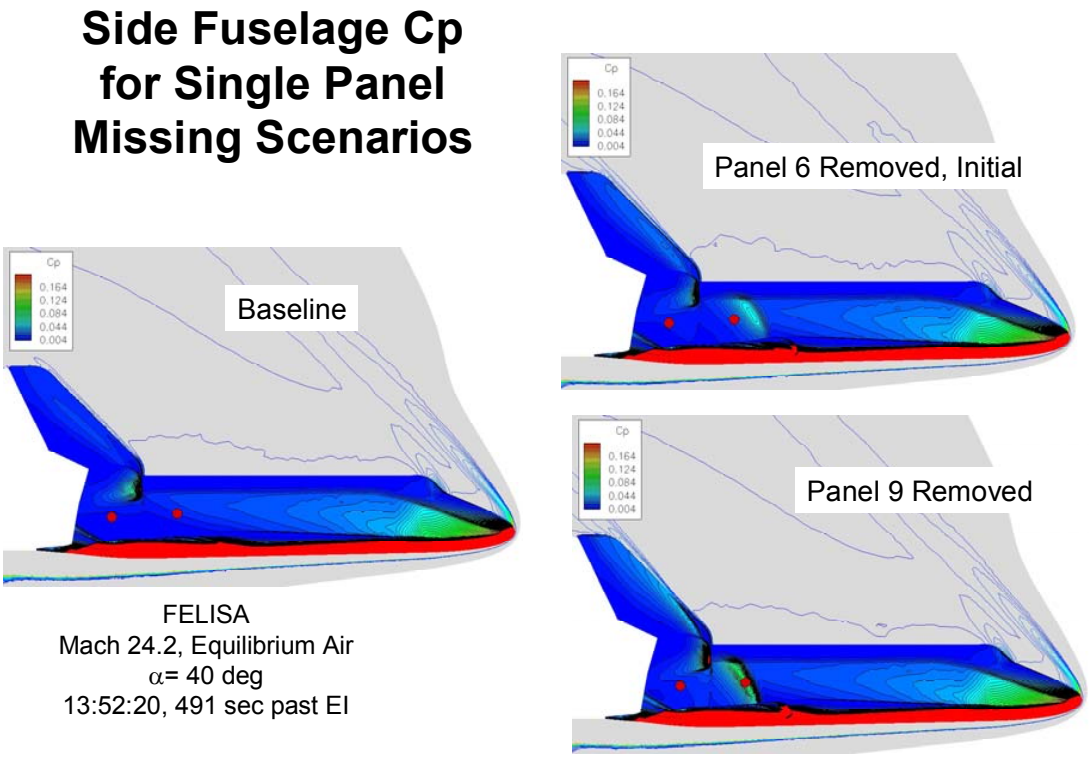
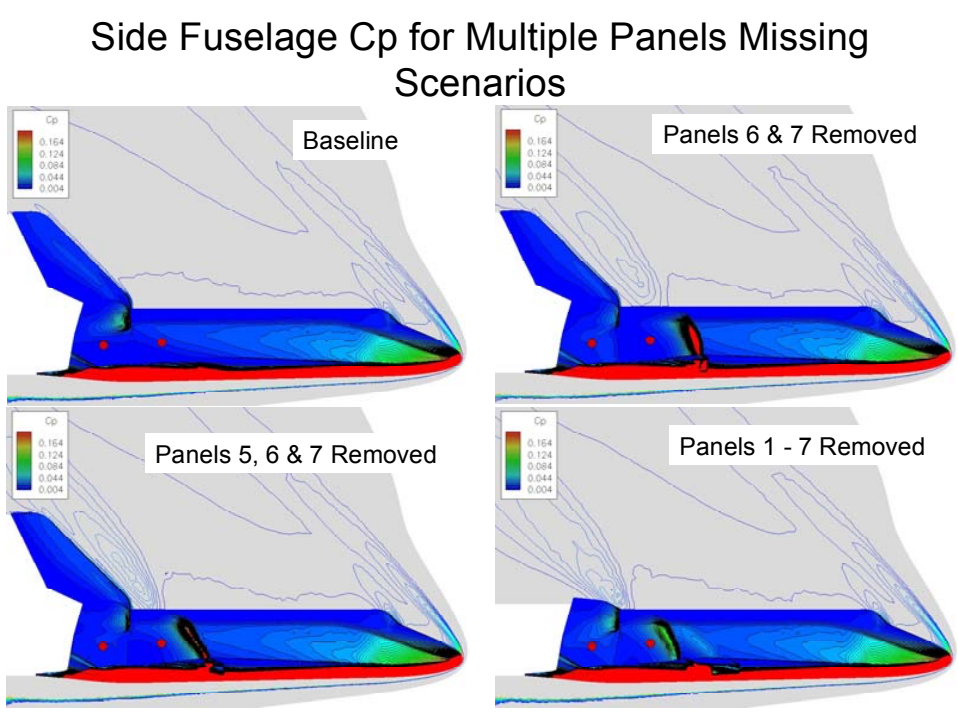
A damage scenario considered early in the investigation was that an entire RCC panel or perhaps several panels had been lost. This scenario was reinforced by an early FELISA computation (and subsequent wind tunnel testing) that showed windward flow passing through a notch in the WLE created by a simulated missing RCC panel. The notch was modeled with solid side surfaces and the open channel

behind the RCC panels was not represented. The flow was compressed as it passed through the notch, sending a jet over the leeward surface of the wing where it impinged on the side of the fuselage. This was this first evidence of a source for the augmented heating recorded by Columbia's fuselage and OMS pod surface temperature measurements. Consequently, a large portion of the computational effort in the investigation was spent looking at missing RCC panel configurations to gain an understanding of the effect of location and size of WLE damage on the aerodynamics and aerodynamic heating characteristics of the vehicle. The bulk of the computations were performed utilizing FELISA at both CF4 tunnel and flight conditions to establish a link between the wind tunnel results and the STS-107 flight data. A limited number of CART3D and OVERFLOW solutions were exercised at Mach 6 air and at flight Mach numbers with perfect gas (see Aerodynamic Appendices sections 4.7.5 (OVERFLOW) and 4.7.6 (CART3D) for more details), to provide additional insight into the trends shown with the wind tunnel and with FELISA. Additionally fully reacting Navier-Stokes calculations, primarily in support of the aerothermodynamic evaluation, were completed using LAURA, GASP and USA codes for several specific WLE damage cases. (see Aerodynamic Appendices Section 4.7.7 (USA) and Aerothermodynamics Section 5.2.4.5 (LAURA & GASP) for more details). Even though the debris recovery and subsequent analysis led to a more complex picture of the damage progression, the insight into the delta aerodynamics and the corresponding flow field characteristics gained by systematically looking at missing RCC damage proved invaluable to the investigation.

Figure 4.3-35 Missing Panels, FELISA Cp Contours, side view

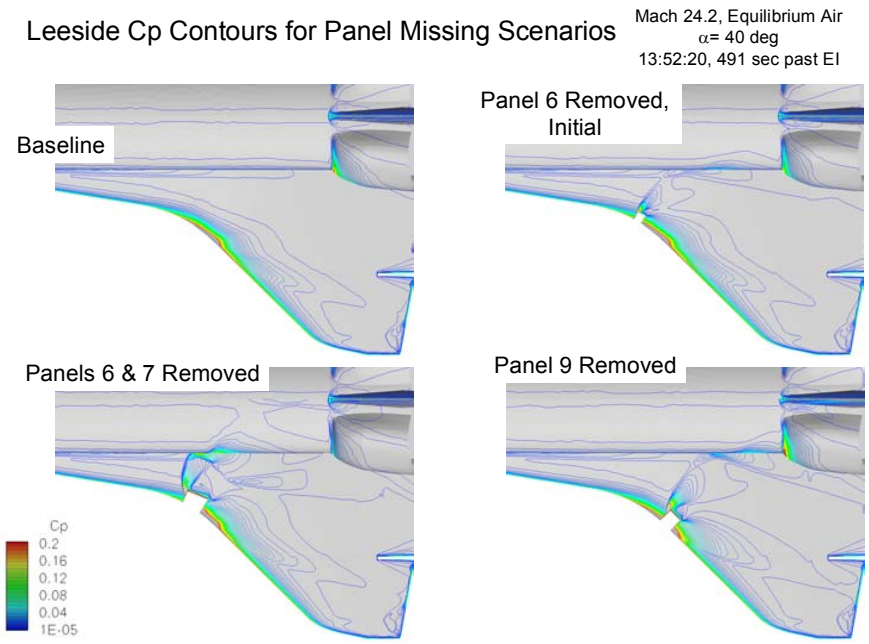
Figure 4.3-36 Missing Panels, FELISA Cp Contours, Leeside View

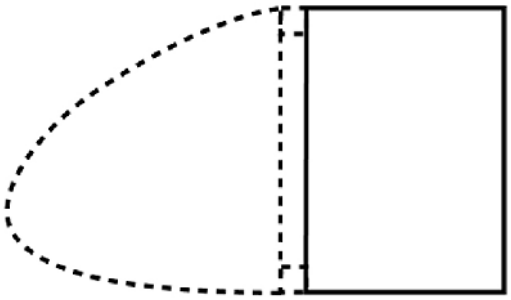
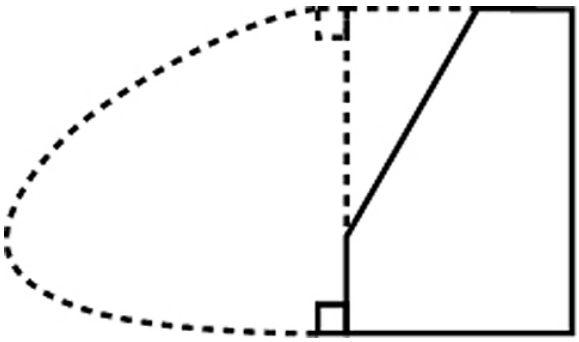
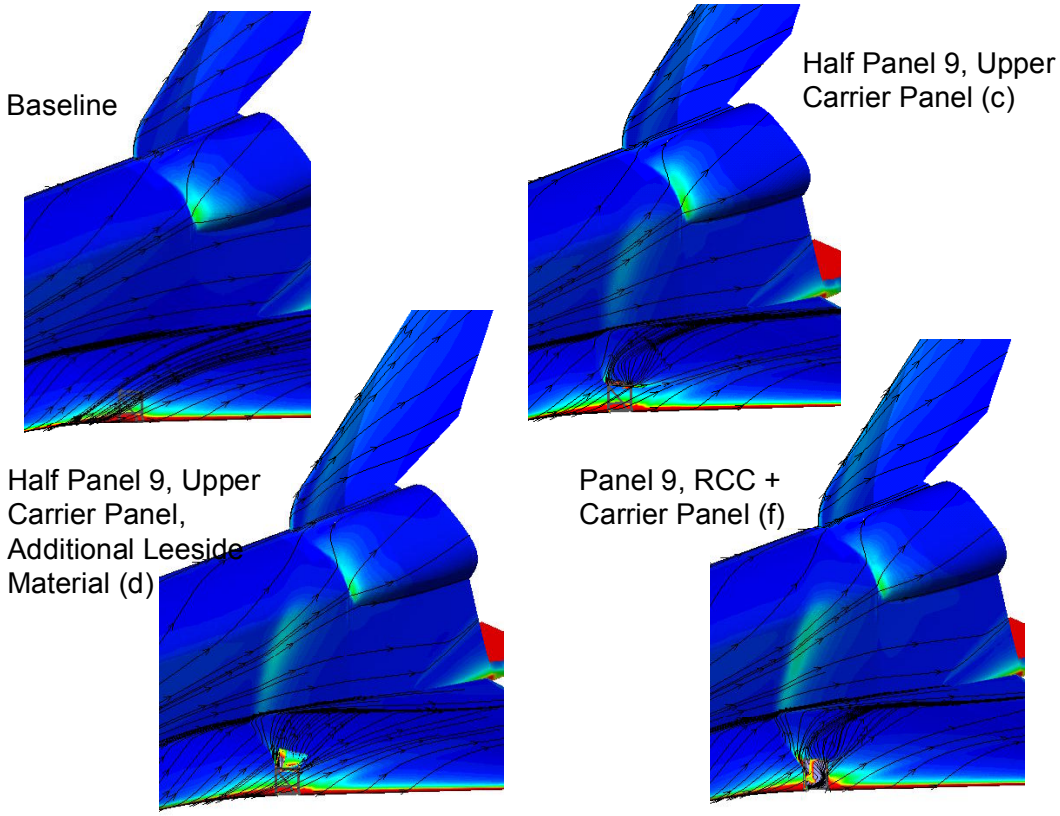
Figure 4.3-43 RCC Panel 9 Progressive Damage Configurations

(e) RCC 9 Removed

(f) Panel 9 Removed, RCC + Carrier Panel

(g) RCC Panel 9, Upper Carrier Panel 9, and Leeside Material Removed

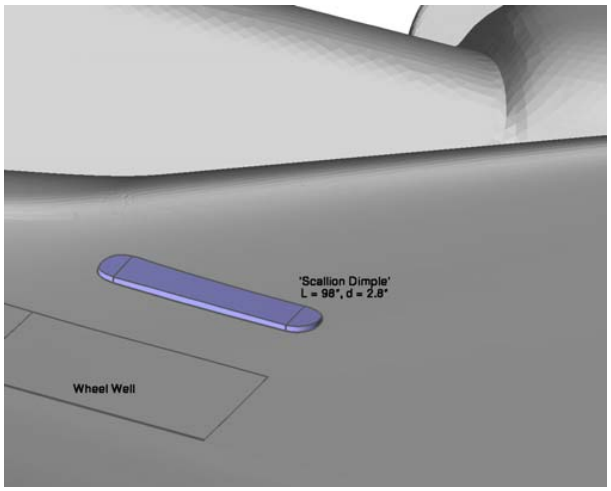
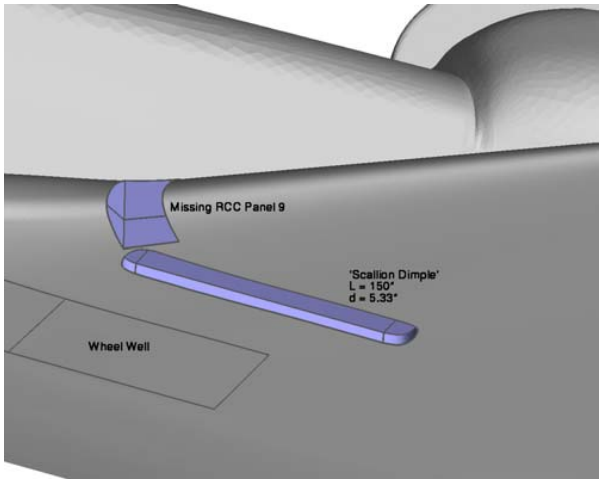
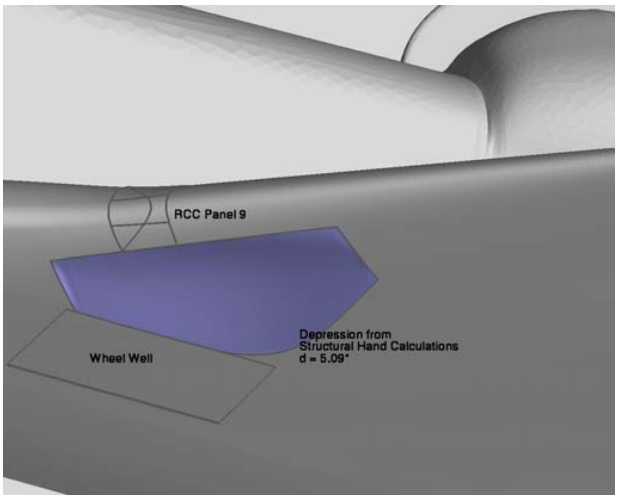
Figure 4.3-48: Windward Surface Damage Configurations

(a) Intermediate Length Windward Surface Depression

(b) Long Windward Surface Depression with RCC Panel 9 Removed

(c) Depression from Structural Calculations, d = 5.03”

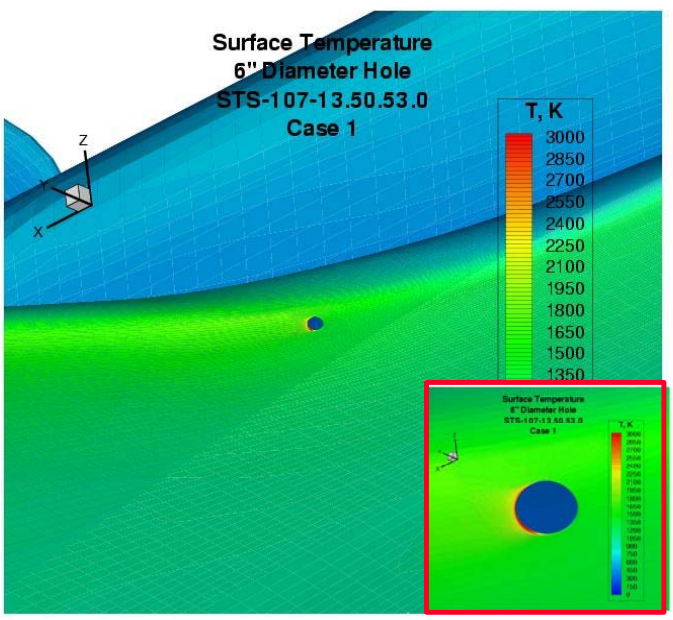
An analysis, to define internal heating to the WLE spar, was completed for a circular hole in RCC panel 6 using the LaRC Navier-Stokes LAURA code. Hole sizes of 2, 4 and 6 inch diameter were analyzed at STS-107 flight condition 1 (Mach 24.7, AOA =40.2, h=243,000 ft). As shown in Figure 4.4-1, there is little if any change (even locally) to the computed external surface temperature distribution. As expected the aerodynamic normal and axial force increments extracted for this case are negligible (less than 0.3% of the total). In the wind tunnel this level of damage and its potential disruption of the flow field was evaluated by placing boundary layer trips along the wing leading edge. In Figure 4.4-2, the measured surface heating distribution shows that a relatively small area of the lower wing surface is affected for a single trip located at RCC panel 6. It should be noted that on STS-107 starting around EI + 370 sec, an external surface thermocouple, (V07T9666A) downstream of RCC panel 9 indicates a small increase in heating, similar to what this type of lower

Figure 4.4-1 Surface Temperature - LAURA CFD Analysis – 6" Hole in WLE RCC Panel 6

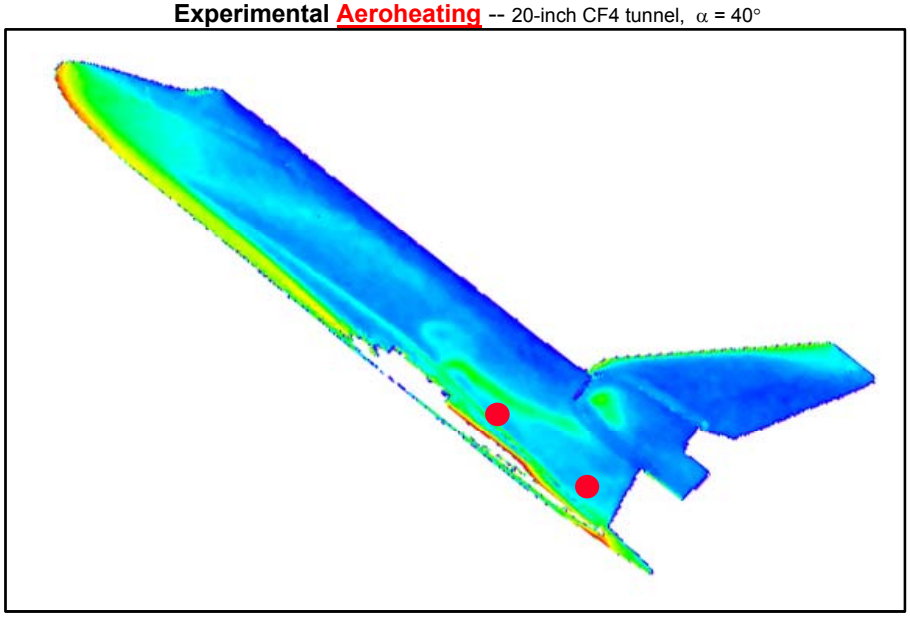
In testing and analysis the clearest way to affect the leeside flow field was to provide a path for the higher energy windward flow to pass through the wing. A missing RCC panel produces this flow path. Additionally, depending on panel location, it produced augmented heating to the side of the fuselage and OMS pod, consistent with the onboard measurements. In
Figure 4.4-4 WT test aerodynamic heating measurements and

Figure 4.4-4 Phosphor Thermography WT Test Surface Heating Distribution – RCC Panel 9 Missing

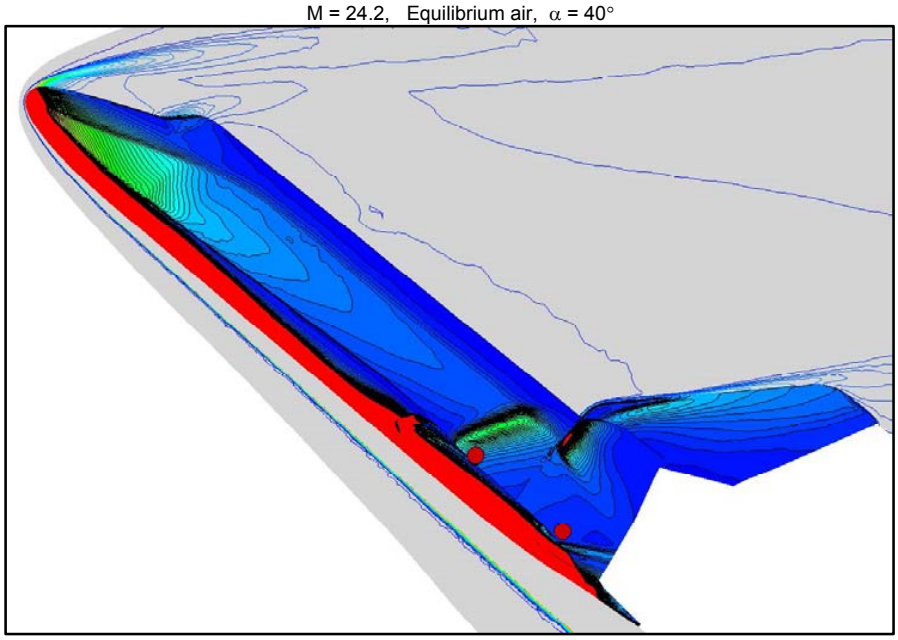
Figure 4.4-5 CFD analysis surface pressures the side fuselage effects due to the flow field interaction are clearly indicated. The aerodynamics for missing RCC panels are summarized in Figure 4.4-6 and presented along with the flight extracted aerodynamic increments for rolling and yawing moment. The shaded area represents the range of CF4 wind tunnel test data for all of the single panel testing. Several specific WT test and CFD analysis points are also included. The data shows that a missing RCC panel will produce the negative roll and yaw increments consistent with this time period (Yawing moment test data being slightly larger in magnitude than the flight data, rolling moment slightly lower). At the EI + 602 sec time point the data for a missing RCC Panel 9 is possibly the best match to the aerodynamic increments (as well as the side fuselage/OMS Pod heating augmentation pattern, see Aerothermodynamics Figure 5.2.3-16).

Figure 4.4-5 Surface Pressure Distribution – CFD Analysis - RCC Panel 9 Missing

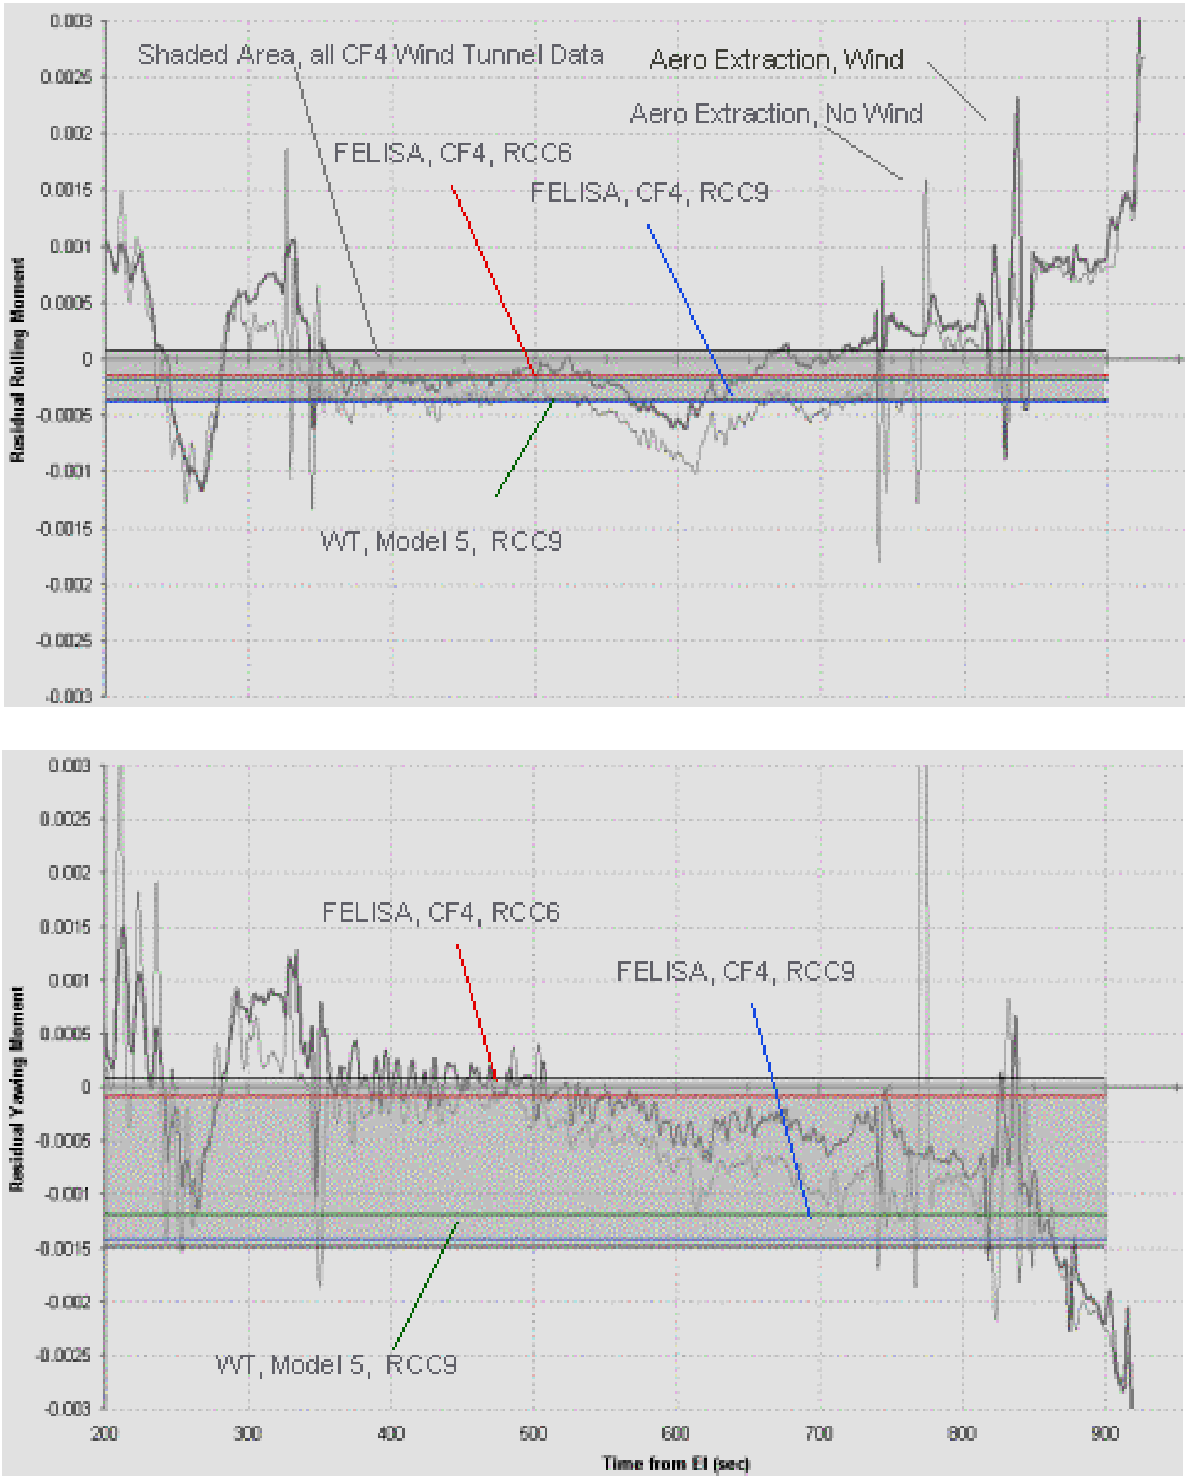
Figure 4.4-6 LaRC CF4 WT Test & FELISA (Inviscid) CFD Results – Single Panel Damage Predicted Delta Aerodynamics vs. Flight Extracted Increments

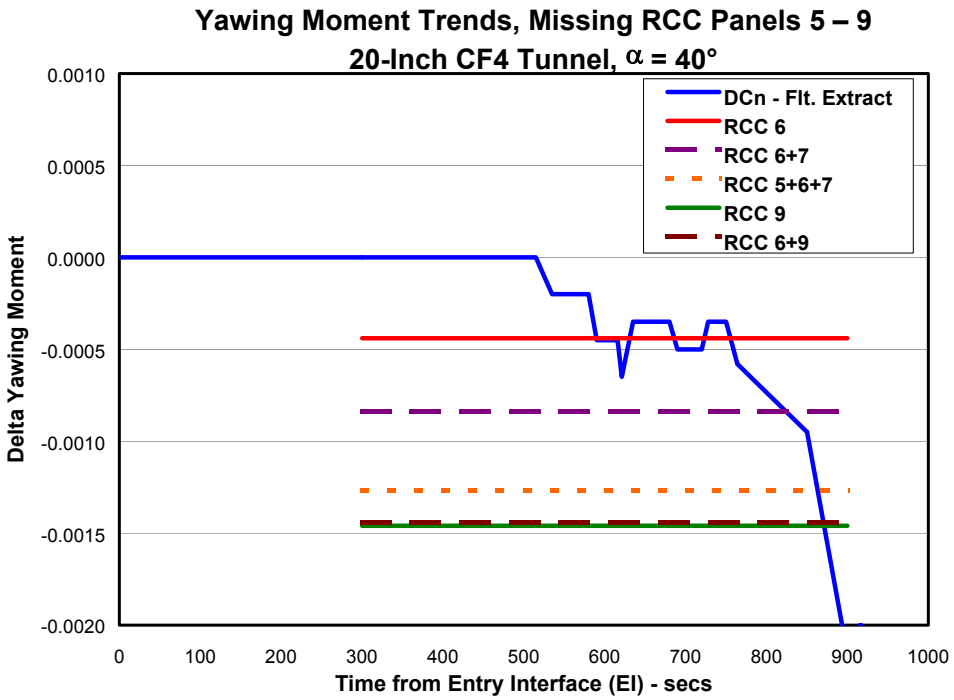
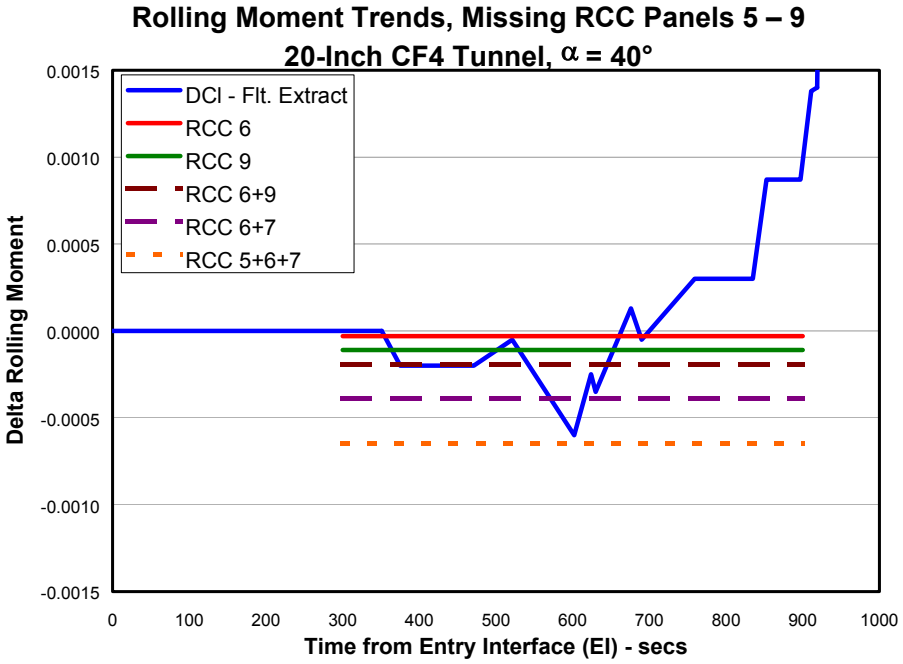
Another suggested damage progression involved multiple missing RCC panels. Test and analysis were conducted for this damage scenario in an attempt to match the flight extracted aerodynamics time history. Results, shown for yawing moment in Figure 4.4-7 and rolling moment in Figure 4.4-8, cover single then multiple missing panel combinations ranging over RCC panels 5 through 9. For rolling moment the continuing loss of WLE panels produces the maximum negative rolling moment observed at EI + 602 sec, while the yawing moment grows well beyond the levels observed during this time period. While this yawing moment trend is consistent with the time history beyond EI + 602 sec, the rolling moment trend is not. This implies that the damage progression must have involved something other than a continuing loss of RCC panels.

Figure 4.4-7 Aerodynamic Increment (delta Yaw) - Multiple RCC Panels Missing

Figure 4.4-8 Aerodynamic Increment (delta Roll) - Multiple RCC Panels Missing

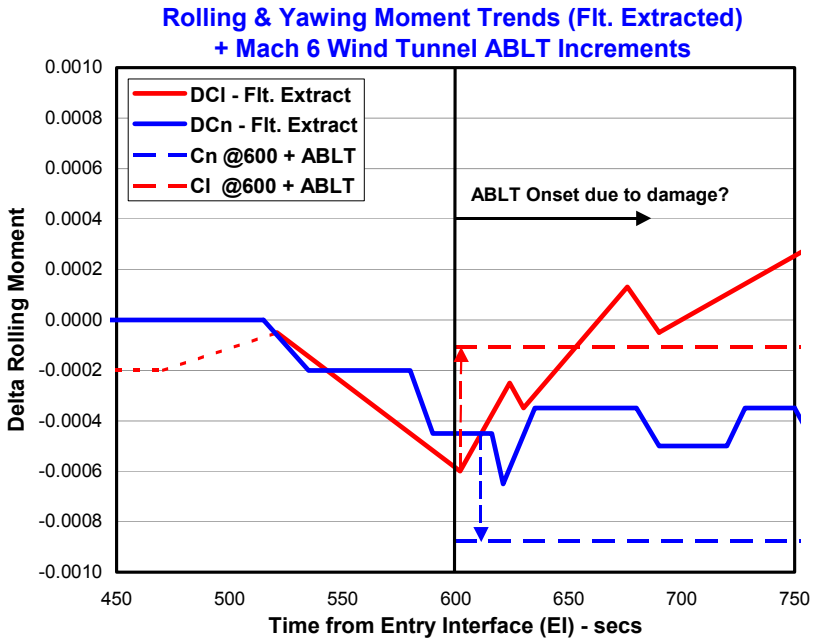
The onset of ABLT was first considered as a possible explanation for the observed trend. While no orbiter entry has previously experienced boundary layer transition prior to Mach 19, given the suggested extent of damage to the wing leading edge, the possibility of an early ABLT seemed plausible. While the change in rolling moment trend is consistent with a left wing ABLT, the fact that the delta yawing moment remains constant is not. To illustrate this, Figure 4.4-9, shows the flight extracted delta rolling and yawing moment with wind tunnel predicted ABLT increments applied at EI + 602 sec. The increments were established from a wind tunnel run forcing full ABLT over the left hand side of the orbiter (full ABLT as shown in Figure 4.3-2 through Figure 4.3-4). These results clearly illustrates that early ABLT is not consistent with the yawing moment and therefore cannot be the source of the delta rolling moment trend reversal.

Figure 4.4-9 Delta Rolling Moment Trend Change - Early ABLT Onset?

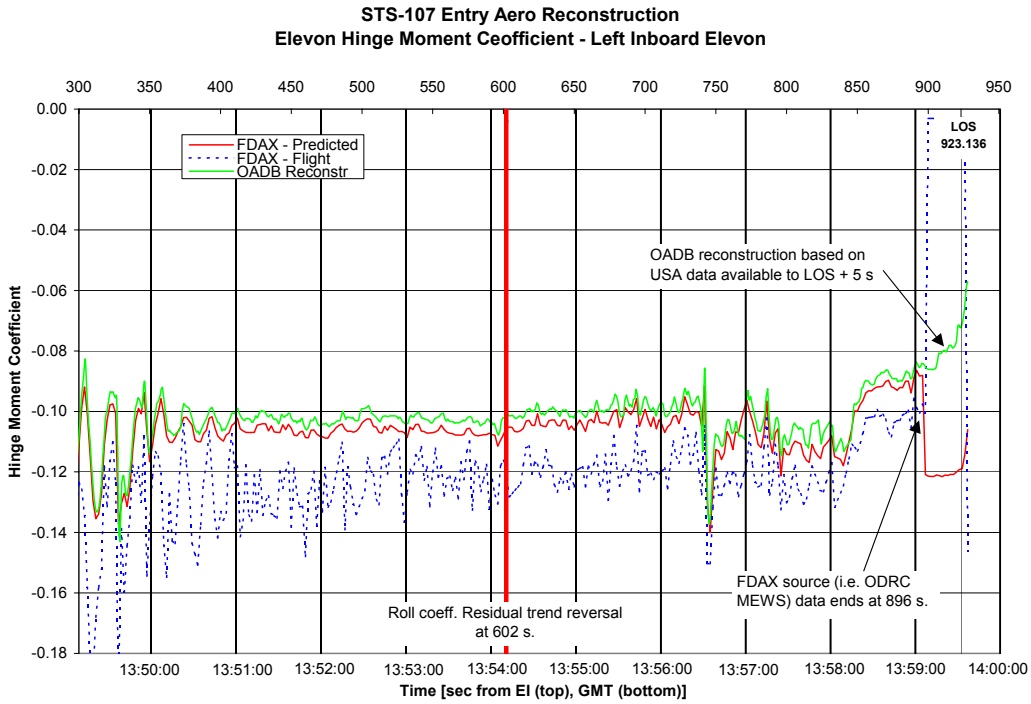
Another plausible explanation considered involved the potential for disturbed flow over the inboard elevon surface thereby altering the control surface effectiveness yielding the change in the rolling moment increment trend. This theory was bolstered by the recovered left hand inboard (LHIB) elevon actuator (debris item 7327) which incurred significant damage including a casing burn through suggesting the possibility of high energy flow through the wing and onto the actuator. However, the wing box primary vent is through the mid-fuselage and there is no design vent through the aft spar, (however there is some leakage). Also, the flipper door vents are intended to vent the elevon cove area only and not the wing. Therefore, no clear design flow path exists. Also the inboard elevon hinge moment data, Figure 4.4-10, shows no indication of off-nominal behavior during this time period and particularly nothing is evident at EI + 602 sec. Additionally, LHIB Elevon temperature sensors remained operational with nominal data throughout the time period. Based on the data available and these observations, there is no indication of flow exiting from aft spar and disturbing elevon flow field during this time period so as to contribute to the change in the rolling moment increment trend

Figure 4.4-10 Delta Rolling Moment Trend Change – Disturbed flow over LHIB Elevon?

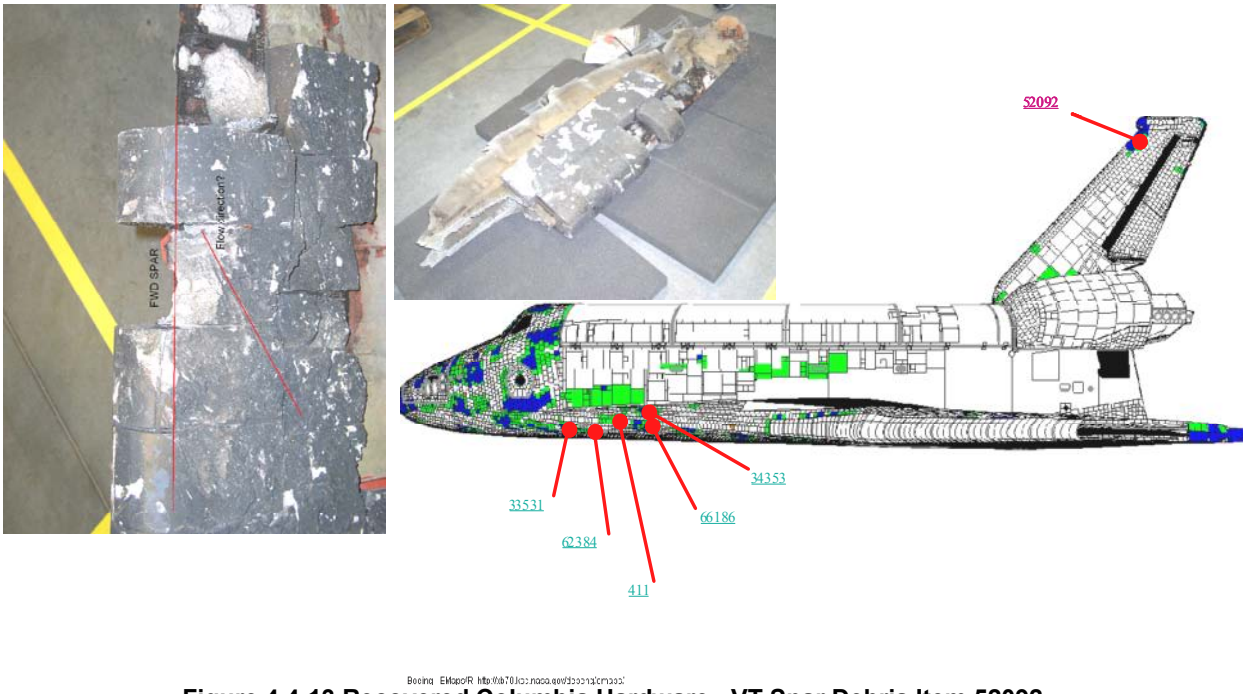
Figure 4.4-13 Recovered Columbia Hardware - VT Spar Debris Item 52092

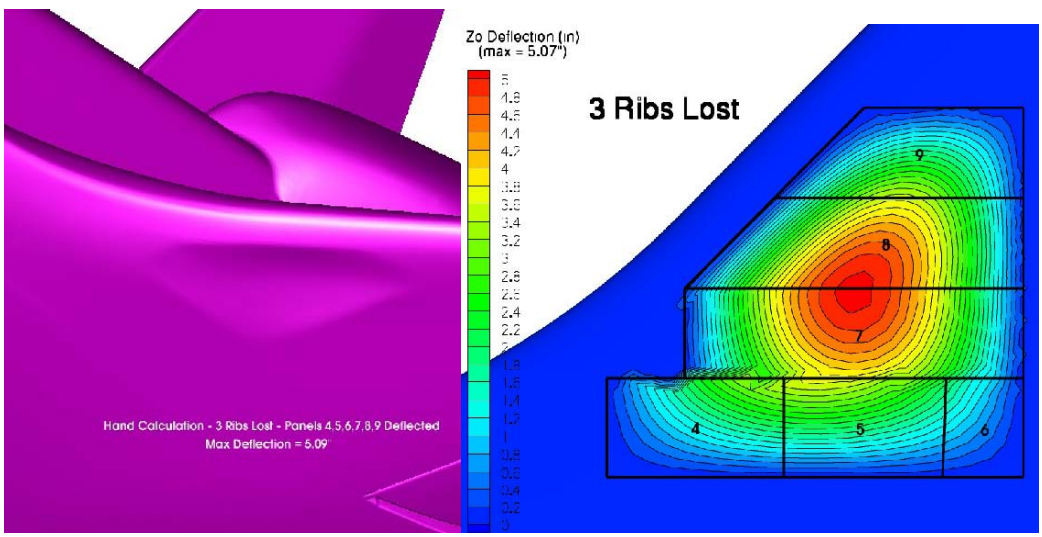
Figure 4.4-19 Orbiter Wing Surface (Skin) Deflection (z) – With Damage – 3 Ribs lost

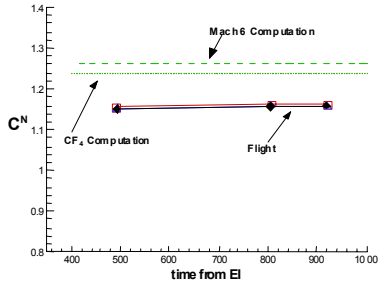
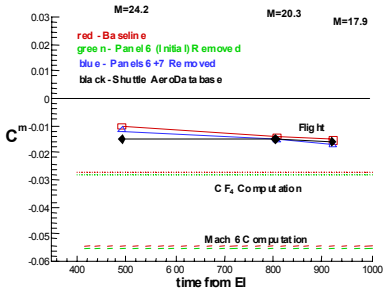
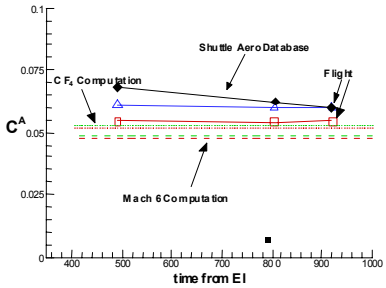
Figure 4.7-6 Comparison of Total Aerodynamics for Flight, CF4, & Mach 6 WT Conditions

- At this scale, effect of missing panel small except in axial direction at
- Flight cases are for panels removed, CF_4 and Mach 6 are for panel 6 only.
- CF_4 doesn't match flight, but is closer than Mach

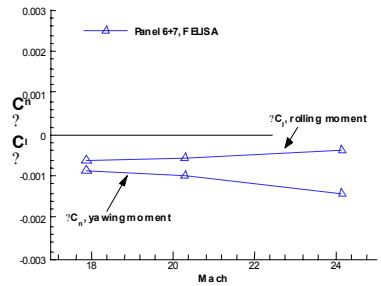
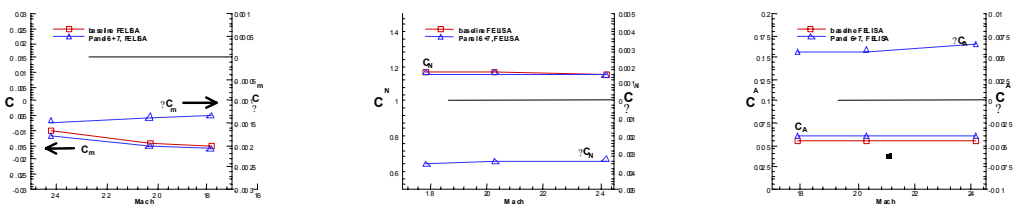
Figure 4.7-8 Effect of Mach Number on Delta Aerodynamics

The delta aerodynamics presented in Figure 4.3-42 show the missing RCC panel aerodynamics for a range of flight conditions, which have varying Mach and angle of attack. Several computations were run to isolate the Mach number and the angle of attack effect in the delta aerodynamics, for the missing RCC panels 6+7 configuration. Figure 4.7-8 shows the delta aerodynamics plotted against Mach number (which is opposite in trend from time from EI) for an angle of attack of 40° Only the delta yawing moment showed a strong trend, decreasing with increasing Mach number. The delta

- Pitch shows an increase with Mach, normal force a slight decrease
- Delta pitch flat, delta rolls shows slight increase, yaw shows significant decrease. Helps explain discrepancies between CF4 and flight computations.

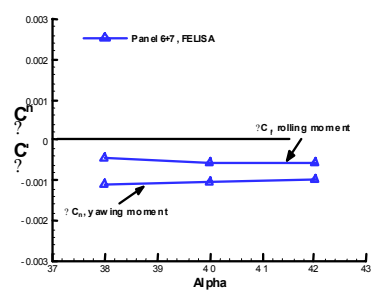
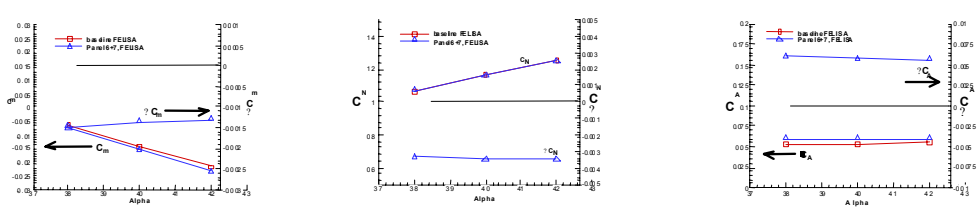
Figure 4.7-9 Effect of Angle of Attack on Delta Aerodynamics

rolling and pitching moments showed a very shallow trend toward positive with increasing Mach number. Figure 4.7-9 shows the aerodynamics and delta aerodynamics plotted against angle of attack, for a constant Mach number of 20.2 (CFD condition 4). While the typical trends with angle of attack are observed in the symmetric aerodynamics (normal force in particular), the delta aerodynamics show are not affected by angle of attack,

- Forces and moments show typical trends with alpha
- Deltas have no significant trends for symmetric or asymmetric loads

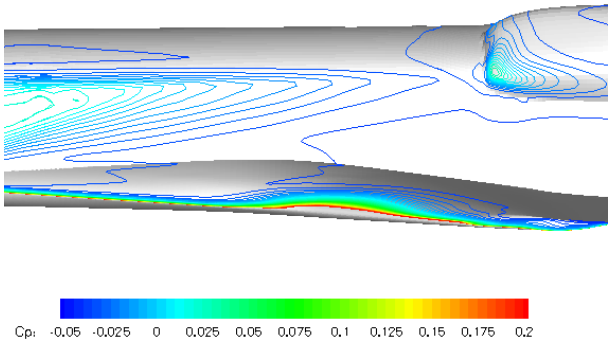
Figure 4.7-11 Surface Pressure (Cp) Baseline (no damage) Configuration.

Figure 4.7-11 shows the surface Cp for the baseline configuration. Figure 4.7-12 and Figure 4.7-13 show the surface Cp for the panels 6 and 9 removed, respectively. The black dots on the figures represent several of the flight temperature measurement gage locations.
