COLUMBIA

ACCIDENT INVESTIGATION BOARD

Report Volume V
Appendix G.13
October 2003

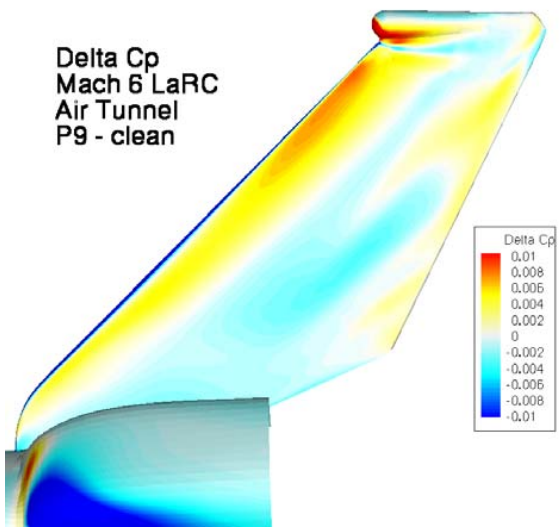
Figure 4.7-14 Delta Pressure (Cp) – Vertical Tail Surface (P9 – Baseline)

To further investigate the leeside interaction, the surface pressures on the vertical tail were analyzed to provide more information on tail pressure increments. Figure 4.7-14 shows the delta pressure coefficient (Cp panel 9 missing – nominal configuration) on the tail. It is evident from this figure the flow field on the tail is disturbed, but the maximum delta Cp values are on the order of 0.01, representing a very small change.

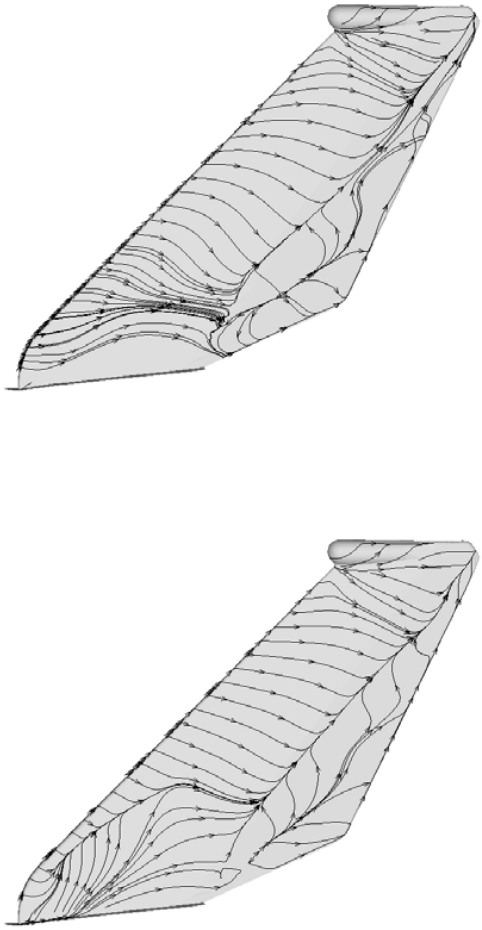
Figure 4.7-15 Surface Streamlines – Baseline and Panel 9 Configurations

Figure 4.7-15 shows surface streamlines (k = 3 surface) for both the baseline configuration and the panel 9 missing. The largest difference between the 2 configurations is the flow on the lower part of the tail. The direction of the flow in this region changed directions.

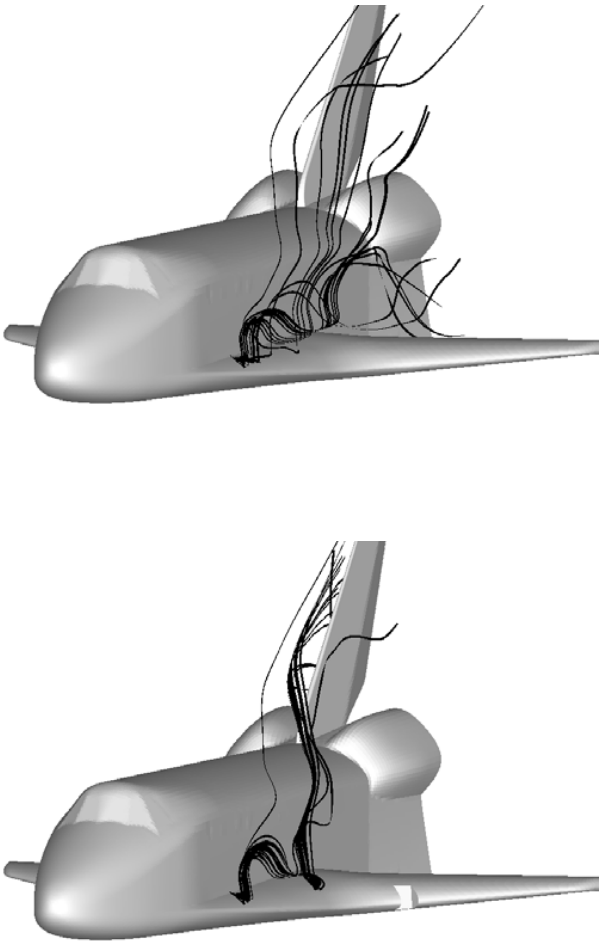
Figure 4.7-16 Volume Ribbons Emanating From the Strake - Baseline & RCC Panel 9 Missing

The flow field on the leeside of the vehicle is directly affected by the vortex that emanates from the intersection of the wing and the fuselage (strake). Figure 4.7-16 represents this vortex by using volume ribbons. The vortex starting from the left strake never crosses the centerline of the vehicle for the baseline configuration. This is not the case for the missing panel 9 configuration. The vortex is disturbed towards the leading edge of the wing and is then pushed across the pitch plane in front of the tail. This dramatically affects the flow field on the leeside.

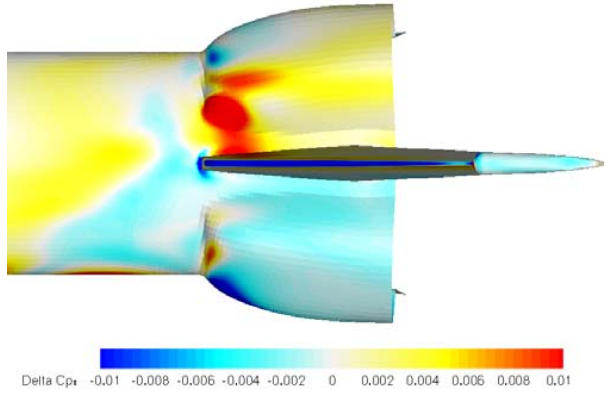
Figure 4.7-17 Delta Pressure (Cp) On the Vertical Tail Surface (P9 – Baseline).

Based on the volume ribbon patterns, a delta pressure (Cp) plot (similar to Figure 4.7-14) was made showing the leeside of the vehicle, including the tail. Figure 4.7-17 shows this delta Cp plot. The figure shows that the flow on the port and starboard side of the tail is disturbed.

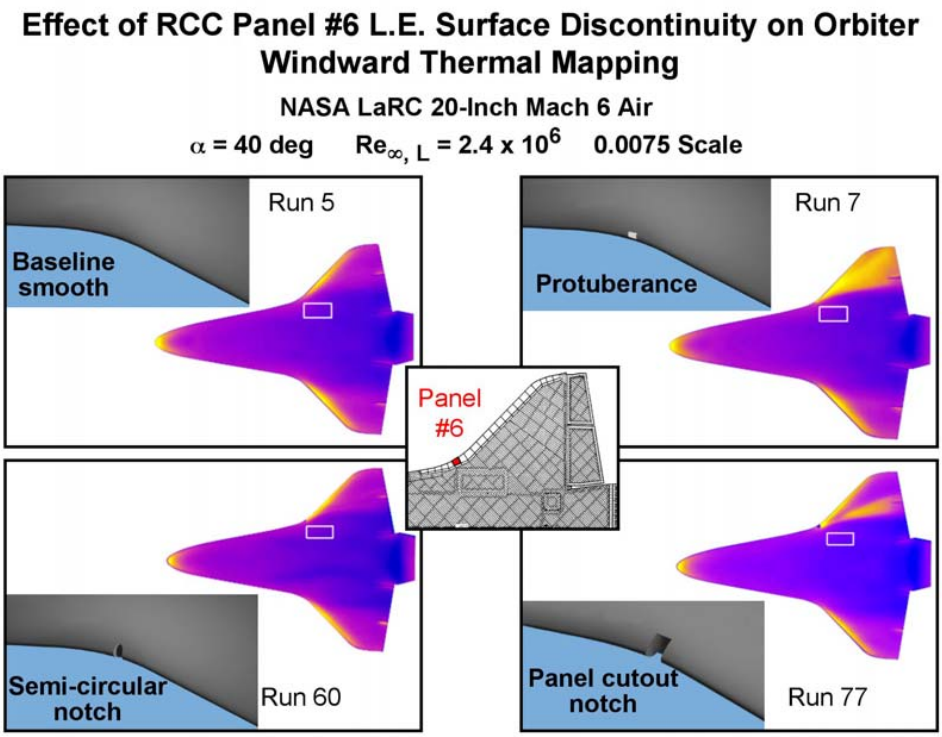
Figure 5.2.3-6 Effect of RCC Panel 6 surface discontinuity, windward view

The sensitivity of global aeroheating distributions on the windward and side fuselage surfaces to several forms of simulated RCC panel 6 damage is summarized in Figure 5.2.3-6 and Figure 5.2.3-7, respectively. These results, obtained using IR thermography, all correspond to the same model residence time in the flow and indicate local areas of increased surface temperature relative to the nominal configuration. The typical surface protuberances placed along the wing leading edge would correspond to a 13-inch x 13-inch full scale surface raised 0.5-inch above the nominal outer mold line. While shown to be effective at promoting boundary layer transition on the windward surface, the raised disturbances along the leading edge did not produce temperature augmentations on the side fuselage at these Mach 6 air conditions. The temperature image corresponding to run 47 in Figure 5.2.3-7 was the first direct experimental evidence that simulated RCC panel damage in the form of a “notch” could produce a localized heating anomaly on the Orbiter side fuselage.

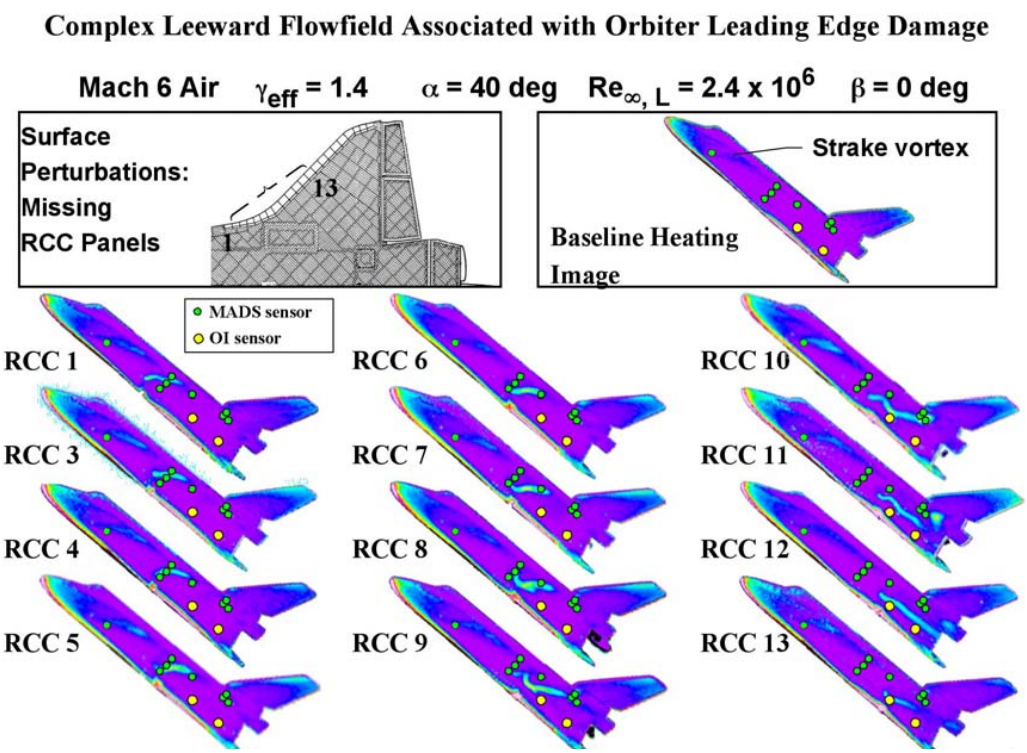
Figure 5.2.3-8 Mach 6 Air results of full RCC panel removed

The sensitivity of Orbiter side fuselage surface heating to simulated RCC panel damage for completely missing individual panels is summarized in Figure 5.2.3-8. At the time of testing, the body of recovered debris did not refute the possibility of entire RCC panels missing and it was felt that this form of damage would be easier to model computationally. Higher fidelity, parametric removal of individual leading edge RCC panels 1-13 was undertaken to characterize the location and magnitude of the heating disturbance on the side fuselage. The results were obtained using phosphor thermography and indicate local areas of increased surface heating relative to the nominal wing leading edge. Global heating distributions are presented in terms of the ratio of enthalpy-based heat-transfer coefficients h/h_{REF}, where h_{REF} corresponds to the Fay and Riddell (1958) predicted sphere stagnation-point heating with a 1-ft radius at flight scale (i.e., radius equal to 0.09-inches at wind tunnel scale). Unless noted otherwise, a constant maximum color value of 0.25 was selected for data presentation to maintain consistency when viewing or comparing images. On the contour scale, the colors tending towards red indicate areas of higher heating (temperatures) while the colors towards blue represent areas of lower heating.

A localized heating disturbance on the side fuselage (Figure 5.2.3-8) was evident for all panel locations RCC (1-13). Although the heating magnitudes associated with the disturbance were generally insensitive to the location of the missing panel, the inclination of the heating pattern on the side fuselage was

dependent on the span-wise location of the RCC damage. The nearly vertical side fuselage heating footprint associated with missing RCC panel 1 approached a nearly horizontal orientation (parallel to the Orbiter reference waterline) as the systematic removal of individual RCC panels progressed outboard to missing RCC panel 12. A missing RCC panel at the location of the Mach 6 air wing/bow shock interaction (RCC panel 12) did not result in abrupt changes to the side fuselage heating footprint in terms of location or magnitude. In addition, no large location or magnitude changes to the surface heating associated with missing RCC panel 12 were observed for small changes in angle-of-attack (Figure 5.2.3-9), sideslip (Figure 5.2.3-10), or a factor of 4 increase in Reynolds number (Figure 5.2.3-11). Heating images taken from above the model (Figure 5.2.3-12) indicated that disturbances created from wing leading edge damage could produce leeward flow field perturbations strong enough to reduce the OMS pod heating for missing RCC inboard of panel 9. In contrast, local heating augmentations to the forward face of the OMS pod were measured for missing $9 \leq$ RCC panel ≤ 11. Comparison of Schlieren images revealed the local shock structure complexity associated with missing RCC panel 8 (Figure 5.2.3-13) relative to a baseline undamaged wing leading edge (Figure 5.2.3-14).

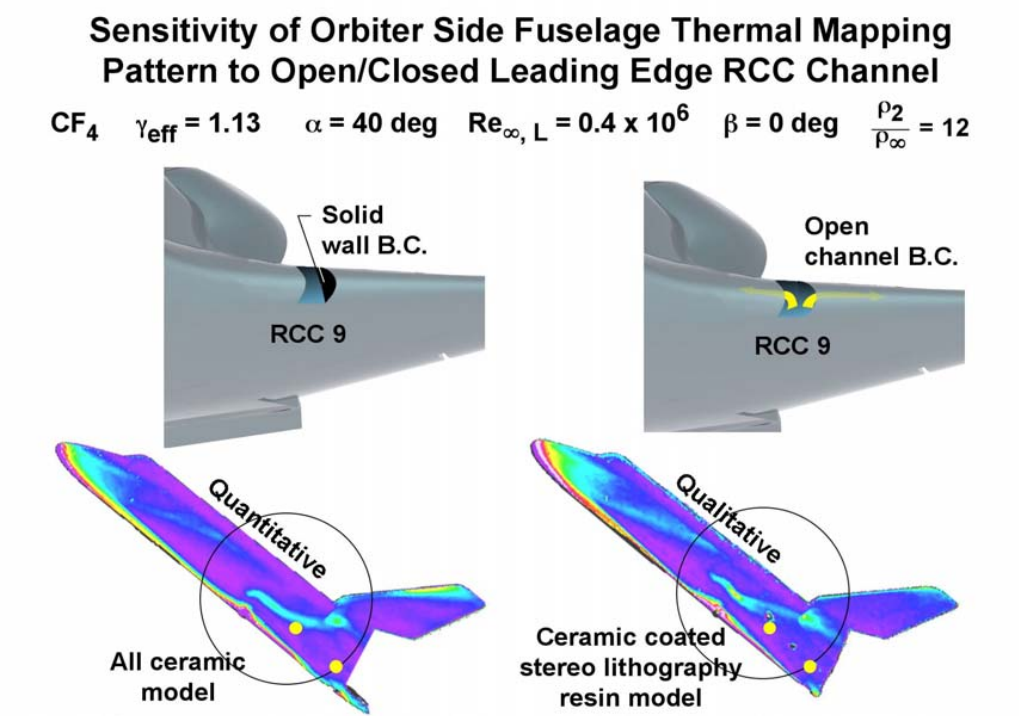
Figure 5.2.3-16 Mach 6 CF4 results for full RCC panels removed

Side fuselage heating augmentations associated with missing RCC panels were found to range from 2 to 12. In Mach 6 air, no changes to the surface heating associated with missing RCC panel 12 were observed for small changes in angle-of-attack (Figure 5.2.3-9), sideslip (Figure 5.2.3-10), or a factor of 4 increase in Reynolds number (Figure 5.2.3-11). Similar to the Mach 6 air trends, side fuselage heating peak magnitudes associated with missing RCC panels in Mach 6 CF_4 were generally insensitive to the location of the missing panel as shown Figure 5.2.3-16.

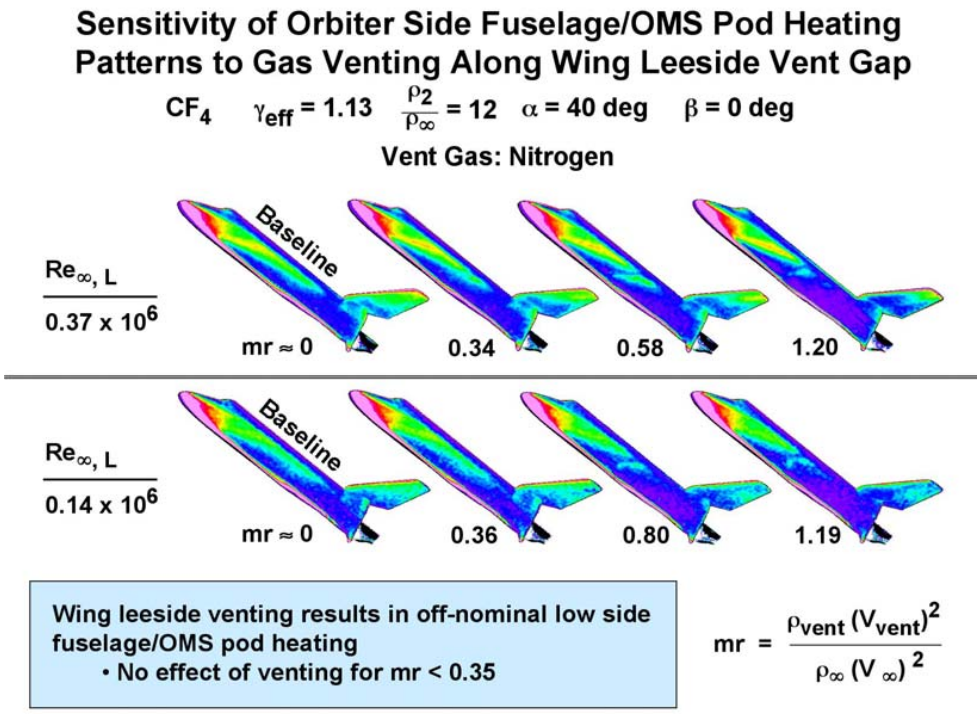
Figure 5.2.3-22 Effect of venting from a WLE cavity with leeside vents; gas supply was from a pitot probe in the flow field

The heating data presented in Figure 5.2.3-22 through Figure 5.2.3-24 suggest that in the absence of major leading edge damage (that tends to dominate the leeward flow field and results in *both* off-nominal high and low heating), mass addition via a degraded upper surface vent slot along the RCC 1-22/carrier panel interface can produce off-nominal low heating on both the side fuselage and OMS pod. As the heating data measurements were made on resin models, they are considered qualitative. However, it was determined that the side fuselage areas indicated in Figure 5.2.3-22 showed heating reductions of approximately 65% to 75% of the nominal surface heating. In terms of momentum ratio, a threshold for leeside venting effects was experimentally determined and should be correlated against flow field predictions involving both leading edge damage and leeside venting. However, the experimental data do suggest that a momentum ratio of at least approximately 0.3 is required to provide changes in leeside heating on the Orbiter.

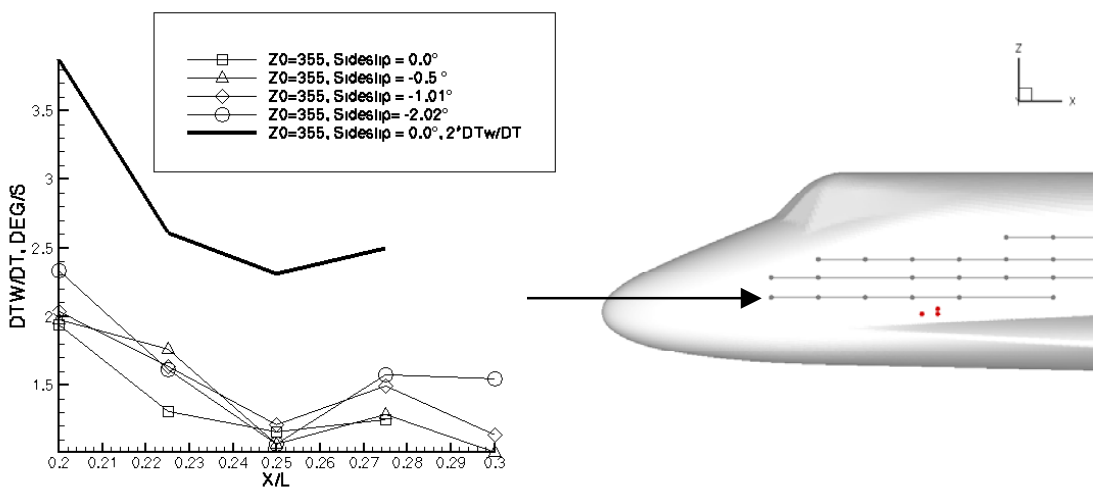
phenomena that occurs in flight, the general data trend should be captured. Thus, the theory that the underlying cause of increased temperature rise rate is a sideslip effect is not supported by the available wind tunnel data. Even at an order of magnitude larger sideslip angle than the slip angle observed in flight, the increase in temperature rise rate from the wind tunnel data is only 20% of the flight observed increase.

Figure 5.2.4-55 Wind Tunnel Measured Temperature Rise Rate

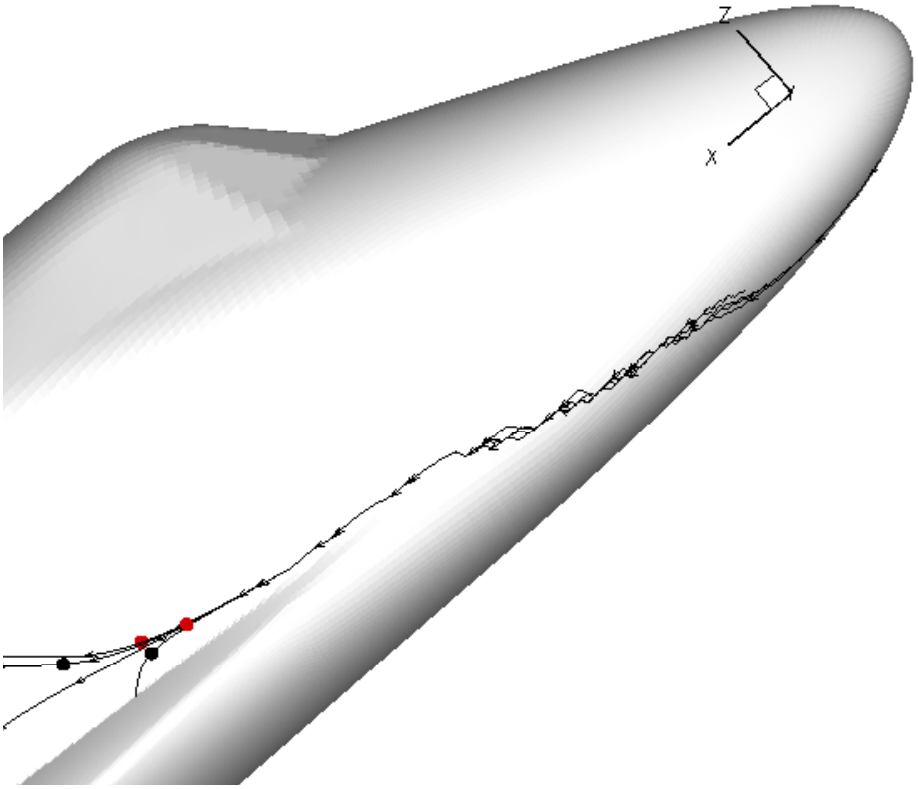
located near its center, the waste dump nozzle is located below it, and the water dump nozzle and thermocouple are located above it. Figure 5.2.4-59 shows surface streamlines passing through the measurement locations for the vent/waste dump nozzle temperature instruments. The streamlines are tightly packed together until they reach the vacuum vent nozzle, where they begin diverging from one another. On the left of Figure 5.2.4-60 is an image of the front view, and on the right side is a close up of the nozzle. The front view shows that a disturbance in the chin panel region could propagate back to the nozzle locations. The close up of the nozzle locations shows that a disturbance could affect each nozzle differently, but with three streamlines passing the measurement locations, a clear case cannot be made. The simulation results do support the theory that a chin panel disturbance could have been the cause of the temperature rise rate. However, these results do not provide enough evidence to draw any conclusions. Since the temperature rise-rate returned to its nominal behavior after about 15 seconds of abnormality, it is very difficult to make any firm conclusions without additional data.

Figure 5.2.4-59 Nozzles and thermocouple streamlines at flight conditions

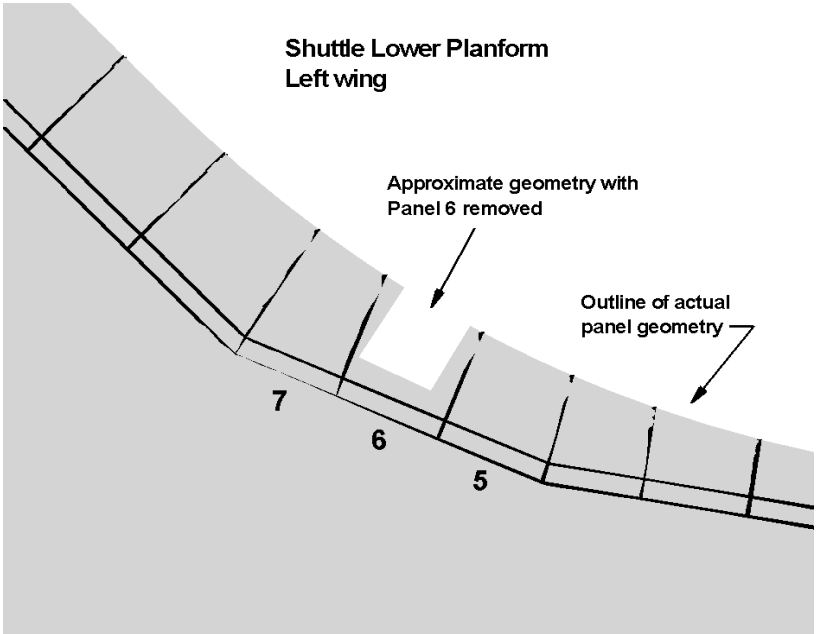
For expediency in assessing the effects of leading edge damage, a grid approximating a missing RCC panel 6 was generated early in the investigation for the first damage scenario CFD case at flight conditions. Coordinates defining RCC panel 6 were estimated from existing literature since this work occurred prior to acceptance and distribution of a common CAD geometry within the investigation team. Subsequent comparison of the estimated panel 6 coordinates with the actual size and location revealed that the approximated missing panel was centered about the correct location but was roughly only 2/3 of the full panel. Figure 5.2.4-61 shows a planform view of the missing panel modeled in this work compared with the size and location of the actual RCC panels. The exterior grid for this “notched” panel 6 out case was developed at LaRC very early in the investigation before the common grid development had taken place. Details of the grid are presented in section 5.2.4.2. The grid uses an O-H topology to define the interiorof the missing RCC panel 6 cavity. This topology allows grid cells to be clustered against the solid side and back surfaces to capture viscous boundary-layer behavior. This current cavity grid can be thought of as a hybrid between two cavity grid alternatives described in section 5.2.4.2. The grid has an H topology in the spanwise direction and an O topology in the streamwise direction. The interior cavity grid was composed of 5 matching blocks, one in the center and four surrounding it with their outward faces forming the backplane and the matching faces to the RCC panel 6 OML. Each of the two spanwise faces of thesefive cavity blocks meets the side walls of the cavity. To construct the missing panel geometry, solid vertical surfaces were used to slice the nominal Orbiter geometry along the sidewalls and backplane, thereby forming the leading edge cavity. In reality, the sidewalls of a cavity formed by a missing RCC panel are hollow. This would allow flow into the channel on either side, but such venting was not modeled in the present computation. The backplane of the cavity is a rough approximation of the main wing spar in this simulation; however, no other internal geometry components (e.g., spanner bars, carrier panels, earmuffs) were modeled. The solution was obtained with LAURA using thin-layer Navier-Stokes equations on a grid that had been coarsened to one-half the available grid density in directions parallel to the surface, with full resolution normal to the Orbiter surface. This coarsened grid totaled approximately 8.5 million points, 2.5 million of them located within the missing RCC panel cavity.

Figure 5.2.4-61 Planform view of missing panel 6 "notch"

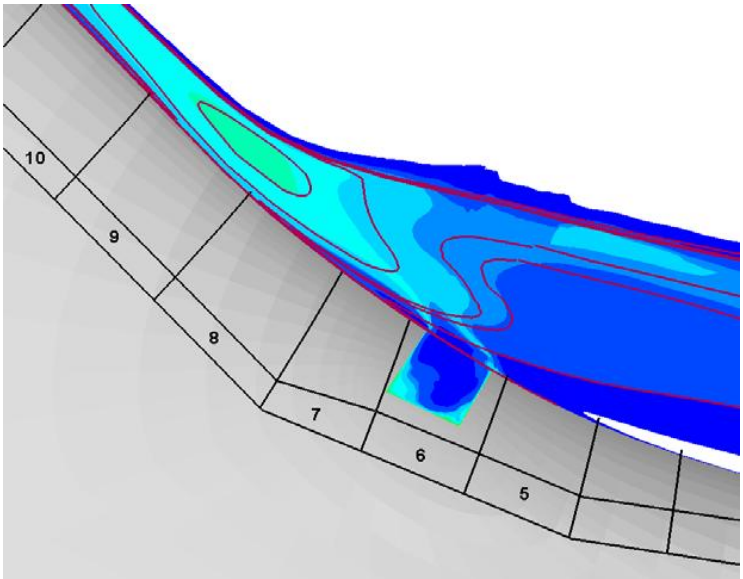
Figure 5.2.4-62 Planform view of flow field density contours for nominal geometry (contour lines) and for missing RCC panel 6 (flooded contours)

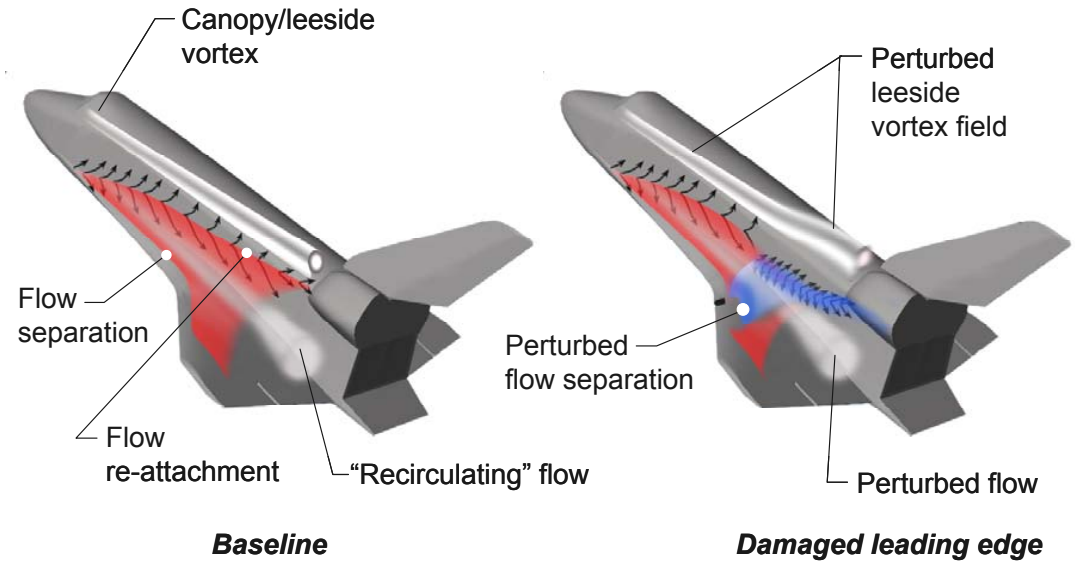
The decreased and increased temperature response on the side fuselage and OMS pod can be explained by the working scenario involving damage to the WLE, RCC panels 5 through 9. In Section 5.2.3, sufficient empirical evidence has been obtained to indicate that reduced heating exhibited early in flight (< EI + 480 sec) on the side fuselage and OMS pod sensors was due to changes in the leeside vortex field of the Orbiter, Figure 5.2.5-1, possibly coupled with the dynamics of flow emanating from the WLE damage which perturbs the WLE separation zone. For this reduced heating segment of the flight the most consistent result that matched the flight data was obtained by a case where there was flow through degraded RCC WLE cavity vents, Figure 5.2.3-22 through Figure 5.2.3-24. During this period of the flight, changes in the vortex field were likely caused by additional gas entering the leeside flow field through the vents designed into the upper RCC panel and T-seals, and in possible combination with small local upper carrier panel damage. The correlation of the vented flow to the lee side with flight data necessitates that there was a windside breach along the WLE in order to have the pressure necessary to drive the flow to the leeside with sufficient momentum. The momentum scaling, typically used for flows injected into a cross flow, was used to verify that a proper simulation of the flight environment was being performed and checked against various WLE breach CFD simulations, Figure 5.2.3-23. However, the slot in the wind tunnel model was an order of magnitude larger (1” width full scale, as opposed to 0.1” width full scale) than for the nominal Obiter WLE vent configuration. Therefore, local small damage to the vent area, which could easily occure where the RCC and upper carrier panels meet, has to be present to yield these leeside heating effects. The need for additional vent area was also confirmed using a coupled venting and thermal math model of the wing, Section 5.3.5, for a 10” diameter hole in the windward side of RCC panel 8. For this analysis, the hole existed at EI and the simulation was terminated at the estimated latest point of spar breach, Figure 5.2.5-2. Although mass flow rate is presented, the trend would be similar for momentum. The momentum scaling ratio is on the order of 0.6 from the coupled venting and thermal model. Venting of the RCC WLE cavity with a breach begins to increase significantly at the time the decreased temperature response is recorded on the Orbiter leeside instrumentation. However, the momentum ratio scaling parameter and the information from the wind tunnel tests and venting analyses allow the conclusion to be made, that the mass flow rates, and thus the momentum rates, out of the nominal 66 square inch leeside vent area would be too small to result in the initial side fuselage and OMS pod disturbance. Thus, before either the spar is breached or additional significant damage to the upper carrier panel occurs, the flow entering the WLE from the windward side was exiting through the leeside vents with locally damaged upper carrier panel(s), Figure 5.2.3-24.

Figure 5.2.5-1 Postulated Orbiter Leeside Flowfield Associated With Wing Leading Edge Damage. Wing leading edge damage perturbs leeward flow separation and re-attachment locations as well as leeward embedded shocks (not shown).

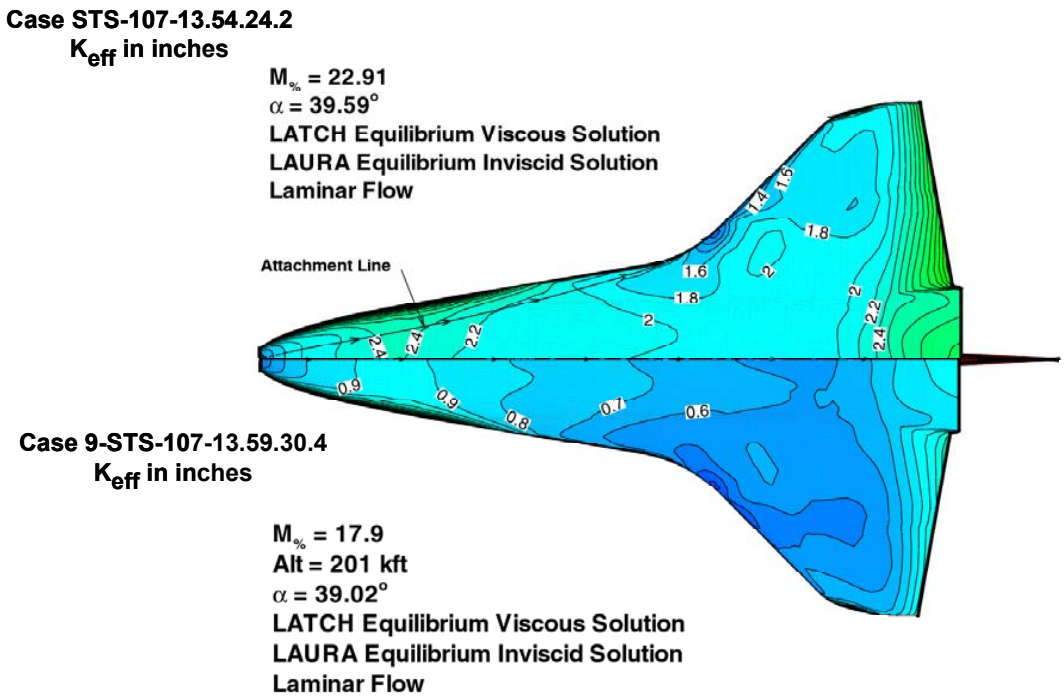
For the first possibility, a boundary layer transition analysis of the Orbiter near this point of the flight was performed. Figure 5.2.5-5 indicates that it would require a trip height of between 1.2" and 1.4" to result in an effective transition trip (see Appendix 5.6 for more information on effective trip calculation). At EI+370, the free stream Reynolds number for the Orbiter, presented in Figure 5.2.5-3, is approximately 5.0×10^5. Given a large enough damage site, a boundary layer disturbance could propagate downstream. No correlation is presented between the effectiveness of a protuberance versus that of a cavity, but a cavity would be more representative of a damaged WLE. However, protuberances are typically more effective at promoting boundary layer transition. For example, Figure 5.2.5-4 shows the limited downstream effect of a 6" diameter hole on the windward side of RCC panel 6. However, it will be shown that the damage necessary to cause the Columbia accident has been narrowed down to either a significant portion of a T-Seal, or RCC acreage damage on the order of 30 to 80 square inches. Moreover, this size of damage would be large enough to result in a locally disturbed flow extending from the damage site to this region of the wing given a high enough Reynolds number. Figure 5.2.5-6 presents a surface streamline plot of the Orbiter WLE region showing how the flow passes over the vehicle at EI+404 seconds. Since the working scenario addresses damage to the WLE in the area of RCC panels 5 through 9, this damage zone propagates streamwise effects which would pass over this gauge.

Figure 5.2.5-5 Effective Roughness Height for Transition

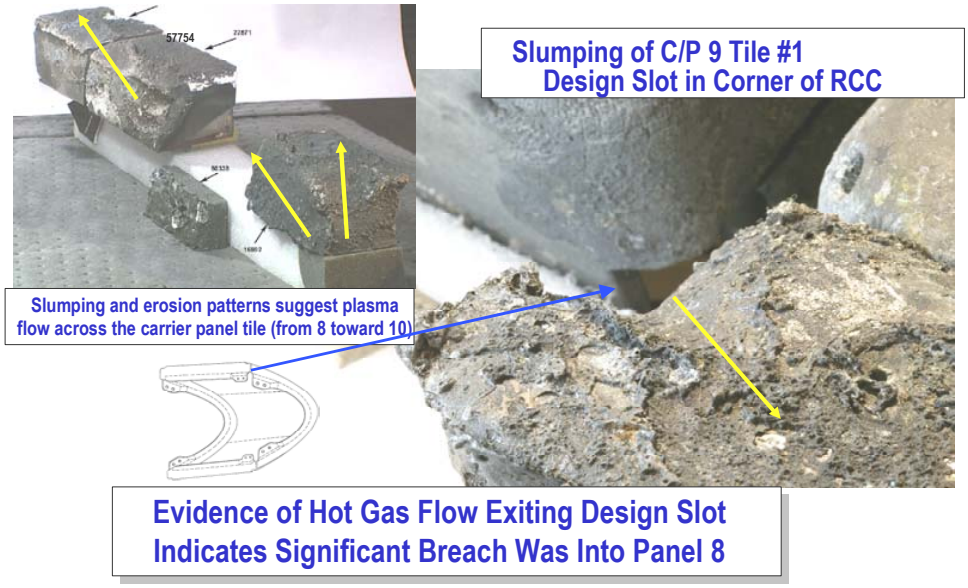
However, the debris evidence indicates that most of the RCC panels were recovered with the exception of a majority of panel 9 and a large segment of panel 10. In addition, all the recovered RCC panel debris was found in Texas. It is believed that having substantial portions of the RCC missing as early as EI+510 seconds is not consistent with the vehicle flying all the way to Texas airspace. It is noted that the debris contains only a single interior tile for upper carrier panel 8 and that neither of upper carrier panels 9 and 10 was recovered. This lack of debris along with the above discussion on the reduced heating provides a consistent explanation for the initial cause of increased heating on the side fuselage and OMS pod. The explanation is that damage to the upper carrier panels became severe enough to allow substantial flow through the WLE vents, with at least a compromised vent path geometry. In order to demonstrate this, a half RCC panel 9 removed model configuration was modified to include the upper carrier panel missing. This geometry allows WLE damage to provide gas flow through the WLE and out the leeside venting location. The results of that wind tunnel test, shown in Section 4.3.1, indicated similar heating trends as the full panel out case.

Figure 5.2.5-7 Hardware Forensics Team reassembly of RCC Panel 8 with RCC Panel 9 Lower Carrier Panel Tiles. April 28, 2003 presentation to the OVEWG.

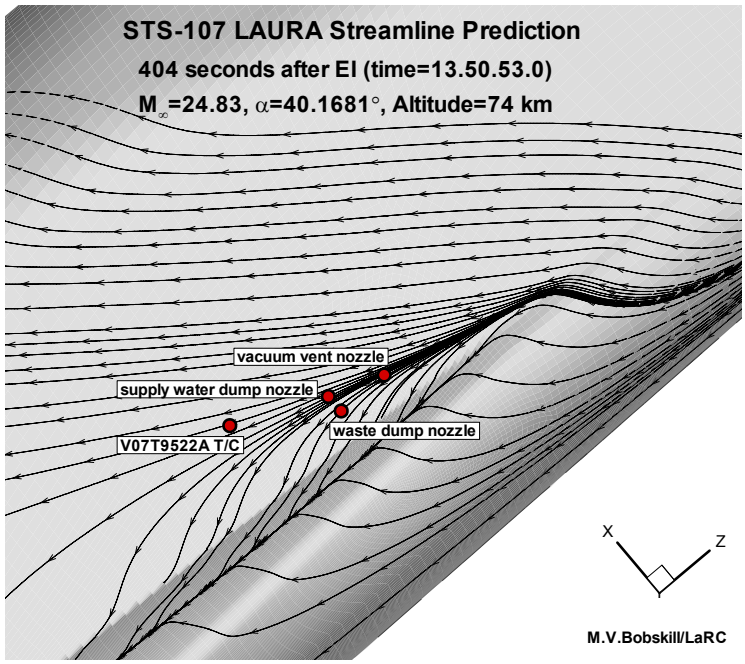
From a local flow disturbance perspective, as can be seen in
Figure 5.2.5-9, the flow crossing both the vacuum vent nozzle and the water supply dump nozzle would also cross V07T9522, a surface T/C. Any disturbance strong enough to cause a change in the heating of the nozzle should have also disturbed the heating to this surface T/C. As was indicated previously, the only anomaly seen on this gauge is a sharp drop in temperature for one cycle during this time; otherwise, the response was determined to be nominal. Thus, again, from an aerothermodynamics perspective, the responses of the vent nozzle and water supply dump nozzle cannot be readily explained. Therefore, both the off-nominal events related to the chin panel and these nozzles should be listed as unexplained anomalies (UA).

Figure 5.2.5-9 Orbiter surface streamlines in vent nozzle region. CFD solution is of right side when angle of sideslip equals 0. Nozzles are in the correct relative position.

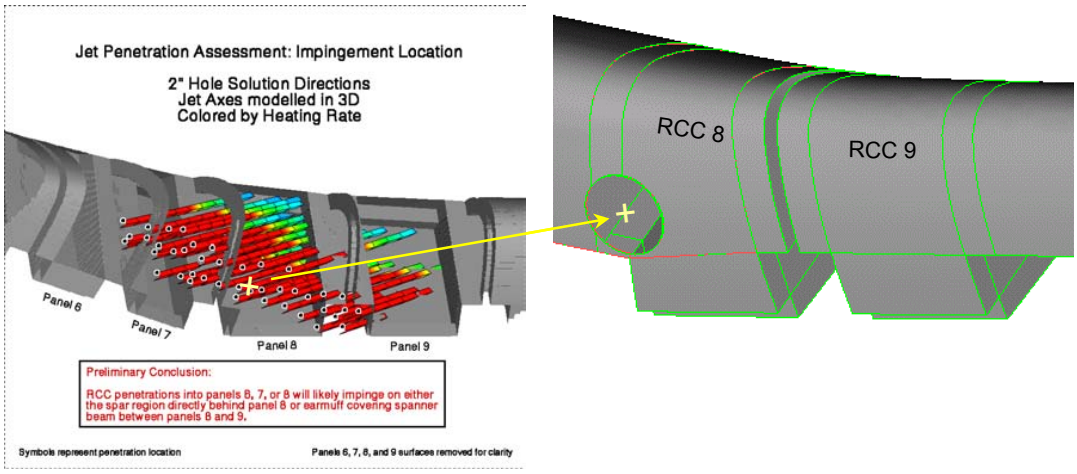
Figure 5.3.6-43 - 10 inch Hole Location Compared to Jet Penetration Analysis

A 10 inch diameter hole was located at coordinates X=1066.00, Y=-214.75, Z=234.6 as shown in Figure 5.3.6-43. Also shown is a jet penetration analysis by NASA JSC based on a NASA LaRC LAURA external flow solution. This indicates that impingement will occur on the inboard side of the RCC 8/9 spanner beam insulators (earmuffs) given a hole at this location. These results were used as a guide for grid clustering in this analysis.

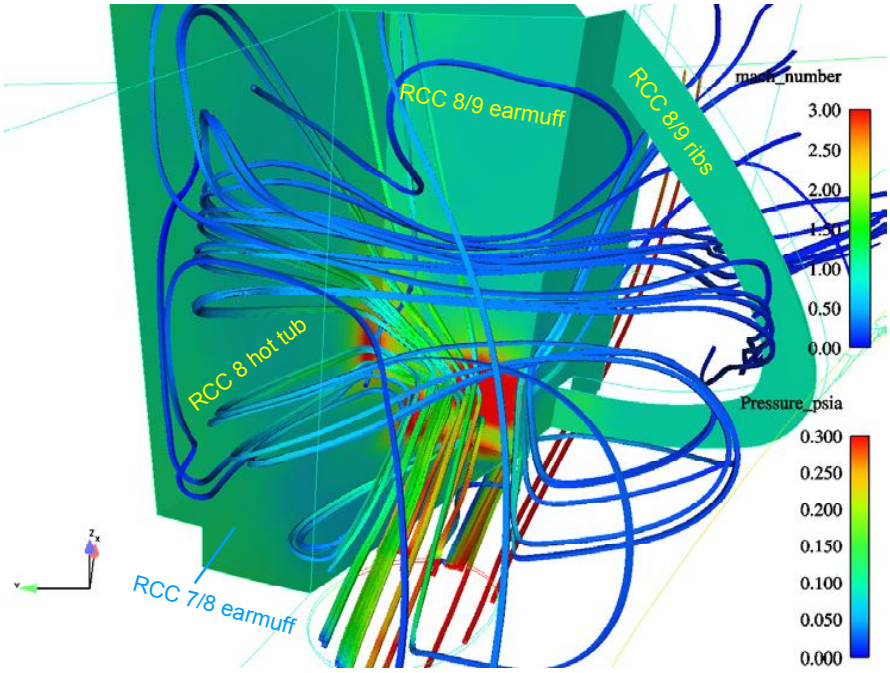
Figure 5.3.6-46 – Mach-colored Streamtubes and Wall Static Pressure Viewed from in Front of Leading Edge

Figure 5.3.6-46 shows the flow inside the LESS cavity. The walls are colored by static pressure and the streamtubes are colored by Mach number. The primary jet issuing from the hole impinges on the inboard side of the RCC 8/9 earmuff. The jet makes a near constant-pressure turn (as observed by the small change in Mach number) and splits into two supersonic tails. This behavior was consistently observed in the T-Seal 2-D solutions (Section 5.3.6.2.2). The weaker tail (#2) impinges in upper corner of hot tub, while the stronger tail (#1) impinges in lower corner of hot tub. The latter impingement creates a transonic "re-tail" that impingements on RCC 7/8 earmuff outboard surface then shocks down to subsonic conditions. Entrainment of a subsonic vortex by the primary jet creates small supersonic impingement on RCC 8 rib. These features account for all of the supersonic flow inside the LESS cavity, and hence all of the high pressure and heat flux areas. Once subsonic, the flow twists into complex vortical patterns and makes its way to the outflow boundaries.

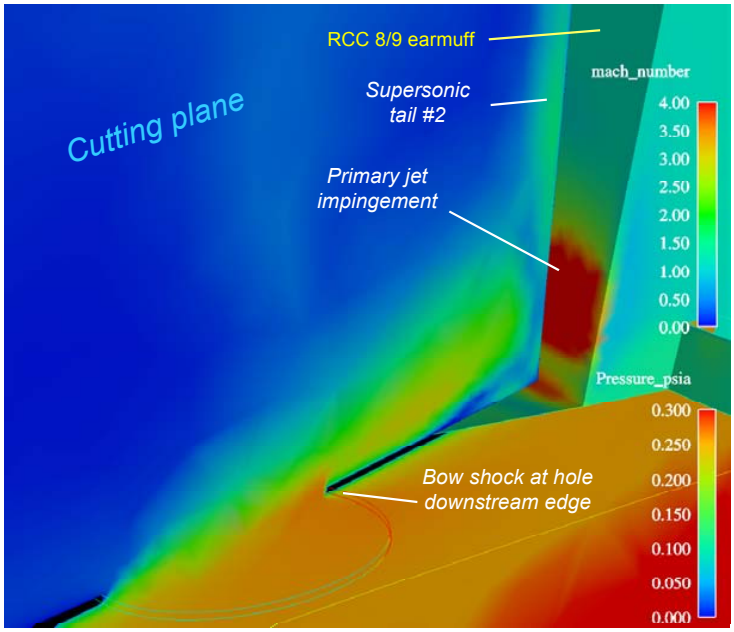
Figure 5.3.6-47 - Mach-colored Cutting Plane and Wall Static Pressure Detail View From in Front of Leading Edge

Figure 5.3.6-47 shows static pressure on the walls and Mach number on a cutting plane. The cutting plane includes the internal and external flow fields. The external flow captured by the hole includes all of the wing boundary layer and some of the local freestream. Recall that the local freestream has been processed through the vehicle shock envelope that is oblique in this area. The captured flow expands through a 10° turn into the hole and forms the primary jet. The jet expansion is small internally since the pressure ratio due to the turn is only about 1.9. The primary jet then encounters a near-normal (80°) impingement onto the RCC 8/9 earmuff. The resulting stagnation pressure exceeds freestream-normal shock pressure due to recompression by oblique vehicle shock. Supersonic tail #2 is observed moving vertically along the earmuff.

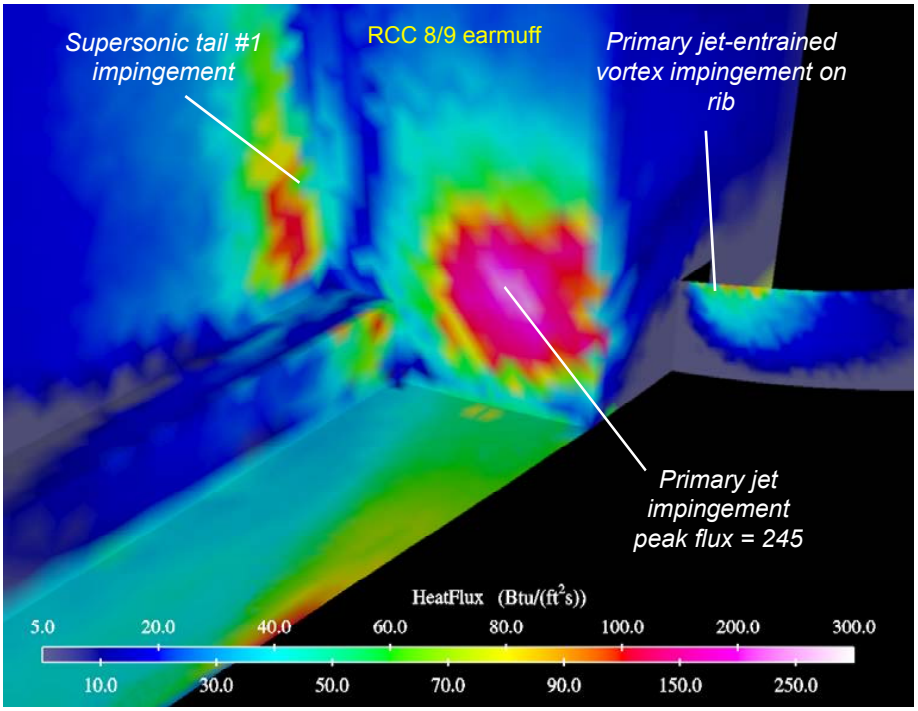
Figure 5.3.6-48 – Surface Heat Flux Detail View From in Front of Leading Edge – Medium Grid Solution

Figure 5.3.6-48 shows surface heat flux for the medium grid solution in the region where the RCC 8/9 earmuff and the RCC 8 hot tub intersect. This is the area of highest heating, as would be expected based on the pressure and Mach fields observed. The primary jet impingement produces the highest heating, while supersonic tail #1 produces the second highest. The tail flow has lost some total pressure due to shock waves encountered in the turning process that created it (Figure 5.3.6-48) so its stagnation pressure

and heat flux are lower. The RCC 8 rib encounters some heating do to the impingement of vortical flow that was reaccelerated to supersonic velocity via entrainment in the primary jet. Flow field animations were used to reveal this phenomenon as the source of that heating.

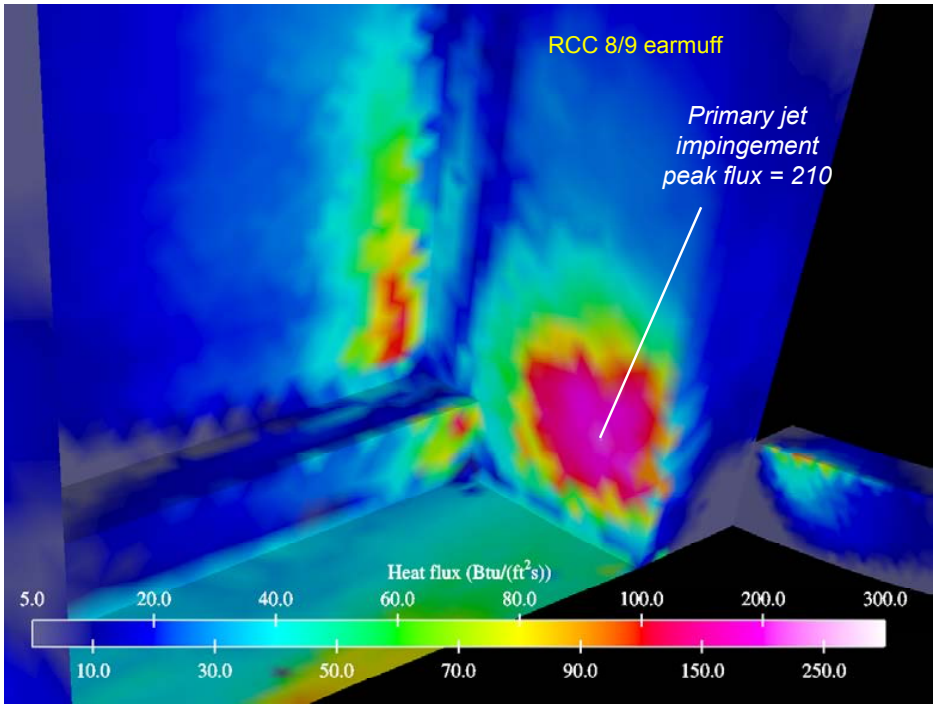
Figure 5.3.6-49 – Surface Heat Flux Detail View From in Front of Leading Edge – Fire Grid Solution

The fine grid solution is shown in Figure 5.3.6-49. The peak heat flux is 14% lower, however this occurs at a single surface cell. The integrated heat load in the regions of interest differs by only 2.3% with the fine grid solution having the lower value. Based on the proximity of these results, grid independence can be claimed. The medium grid solution was run a total of 30,000 time steps, while the fine grid solution was run a total of 32,000 time steps. Both were monitored periodically using flow visualization. No indication of unsteady flow was found, however there is still a possibility that this could occur. Many more time steps would be needed to be certain.

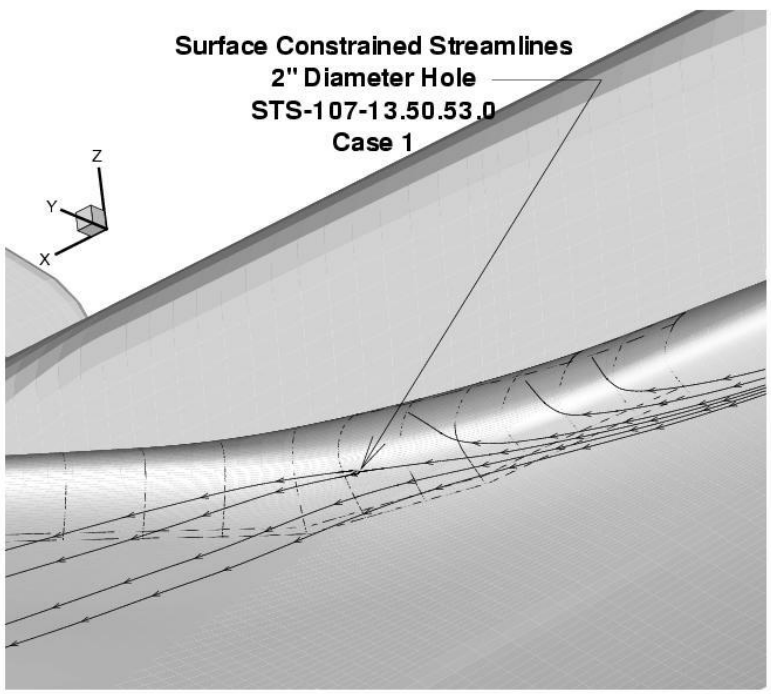
Initially, quarter inch deep holes with varying diameters were inserted into the baseline, external flow solution at Panel 6. (See Figure 5.3.6-51.) The boundary condition at the bottom of the hole used a zero-order extrapolation from interior points for density and velocity and a specified reservoir pressure equal to

Figure 5.3.6-51 Streamlines over RCC panels on the leading edge and the location of the circular breach through the wing in panel 6.

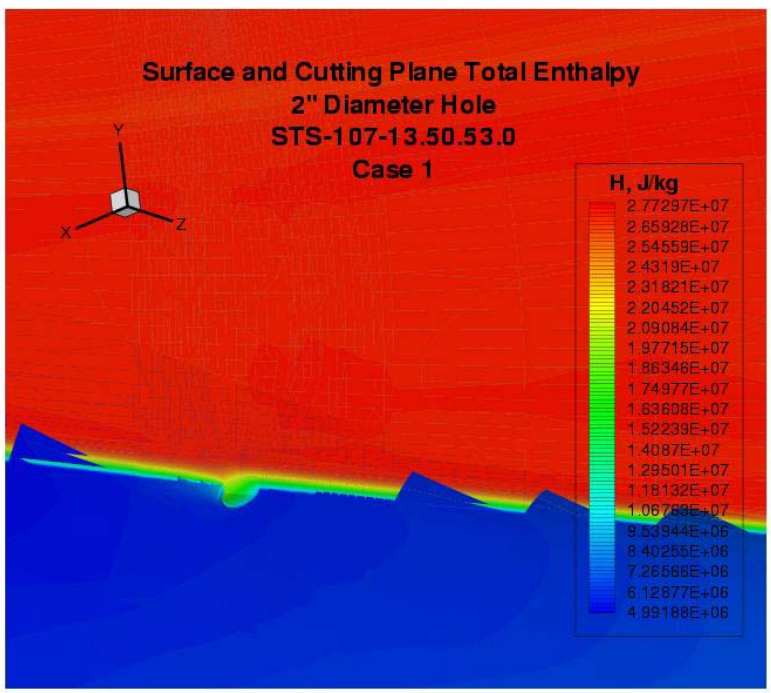
Figure 5.3.6-55: Total enthalpy in cut plane above hole showing partial ingestion of the boundary layer. (Blue jags are artifact of picture format conversion.)

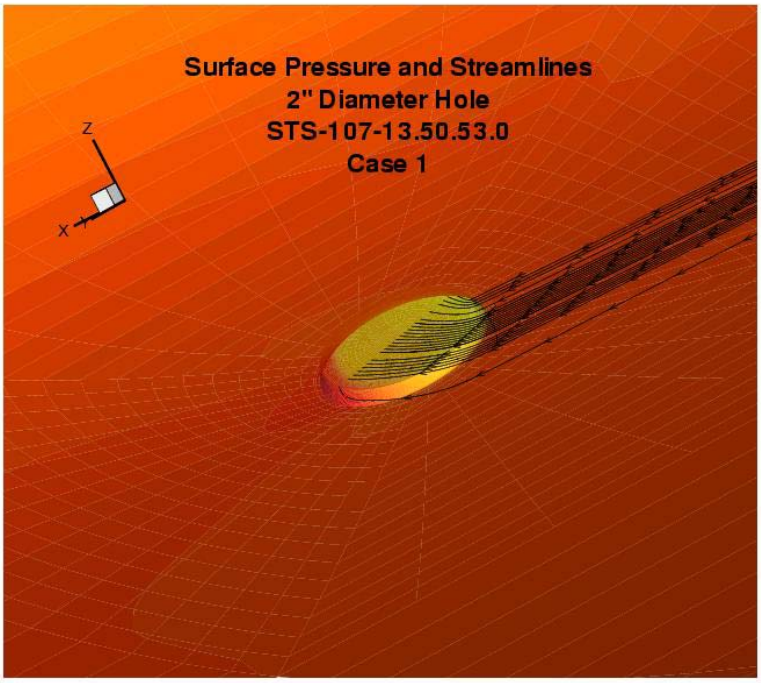
Figure 5.3.6-56: View of streamlines entering breach showing significant retention of external streamwise momentum.

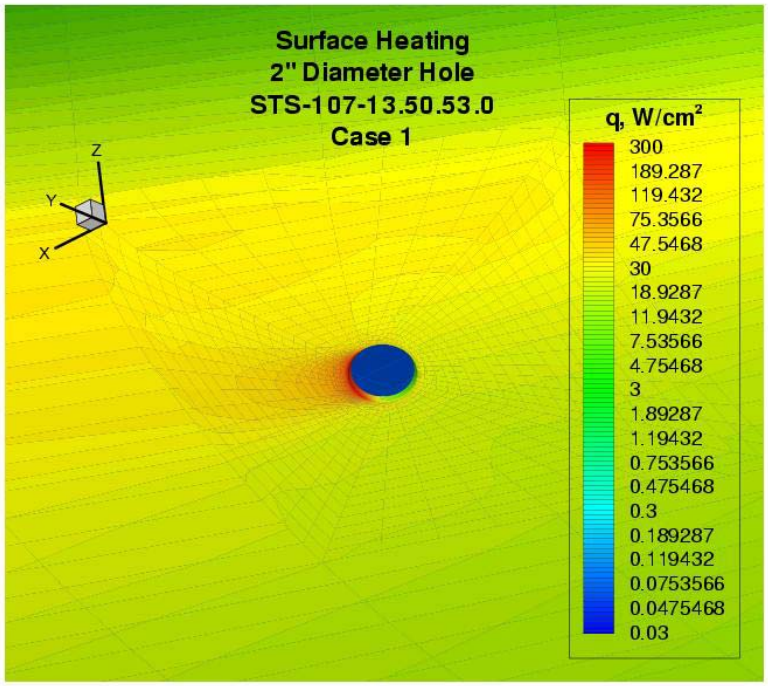
Figure 5.3.6-57: Surface-heating contours in the vicinity of the two-inch hole in Panel 6.

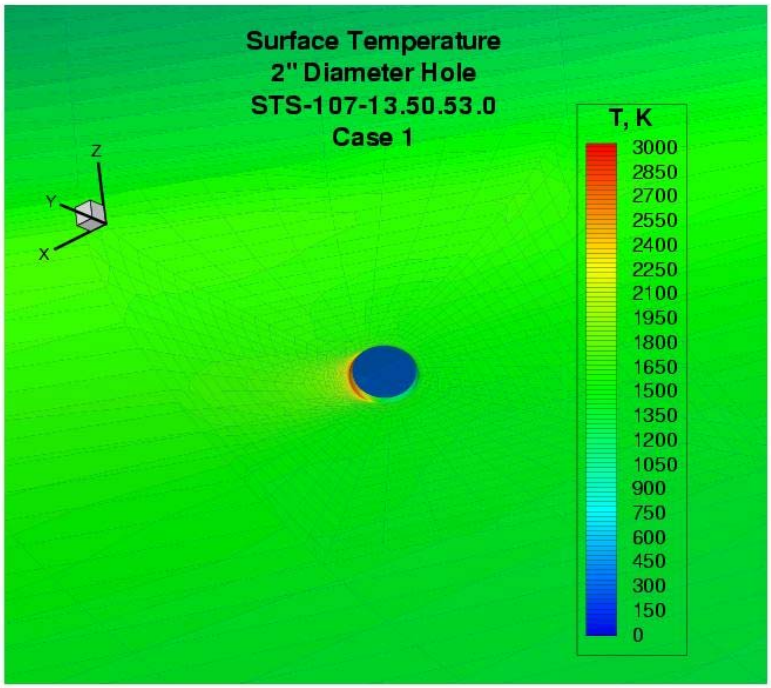
Figure 5.3.6-58: Surface temperature contours in vicinity of the two-inch hole in Panel 6.

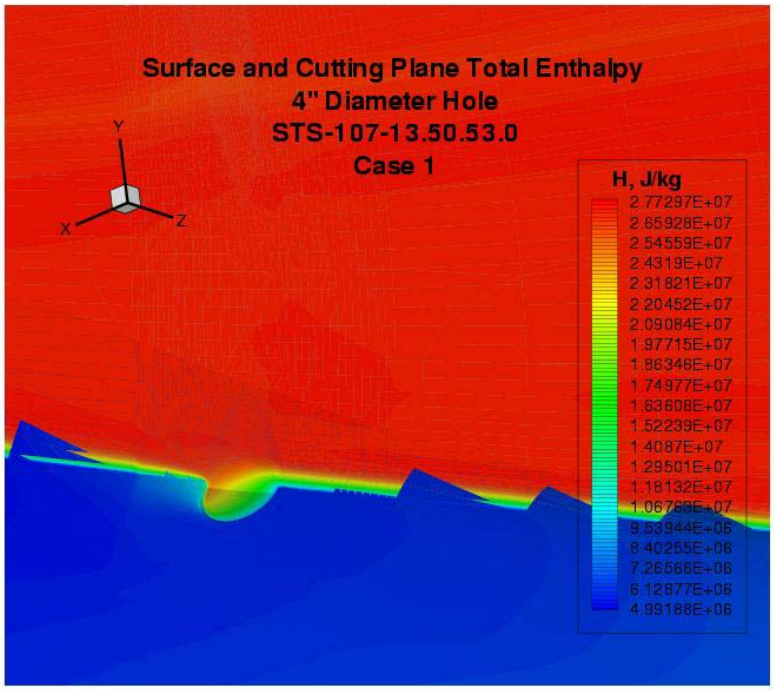
Figure 5.3.6-59: Total enthalpy in cut plane above four inch hole showing significant ingestion of the boundary layer. (Blue jags are artifact of picture format conversion.)
