COLUMBIA

ACCIDENT INVESTIGATION BOARD

Report Volume V
Appendix G.13
October 2003

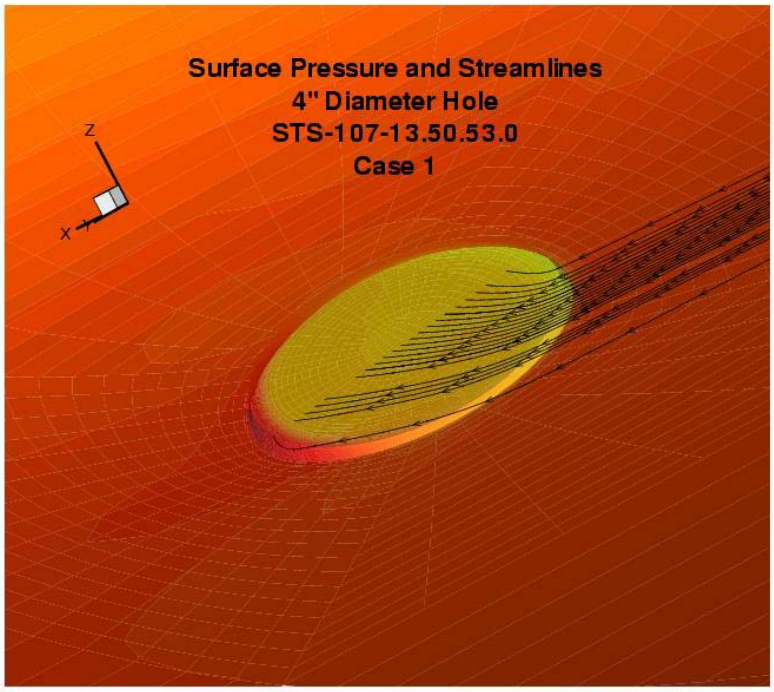
Figure 5.3.6-60: View of streamlines entering four-inch breach showing significant retention of external streamwise momentum.

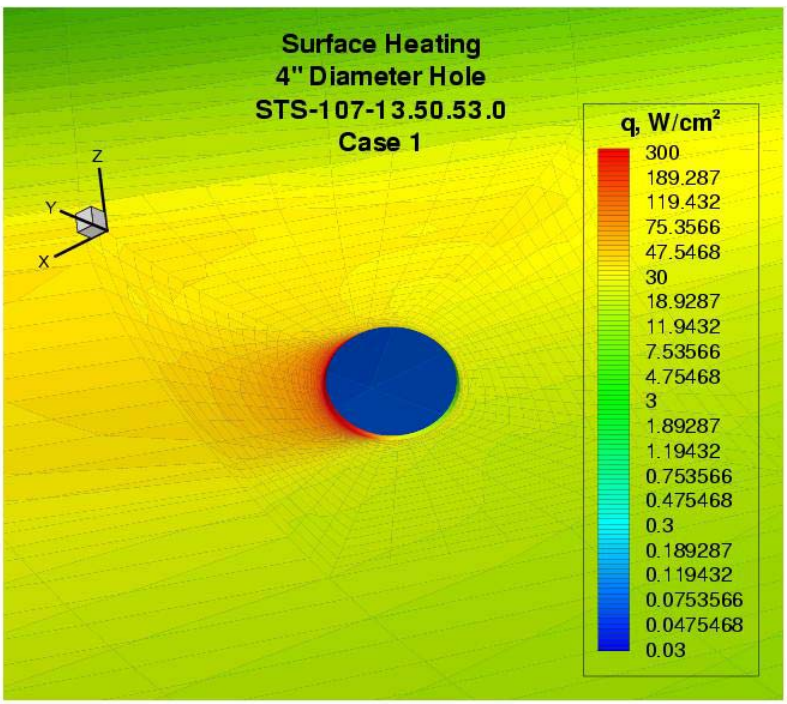
Figure 5.3.6-61: Surface-heating contours in the vicinity of the four-inch hole in Panel 6.

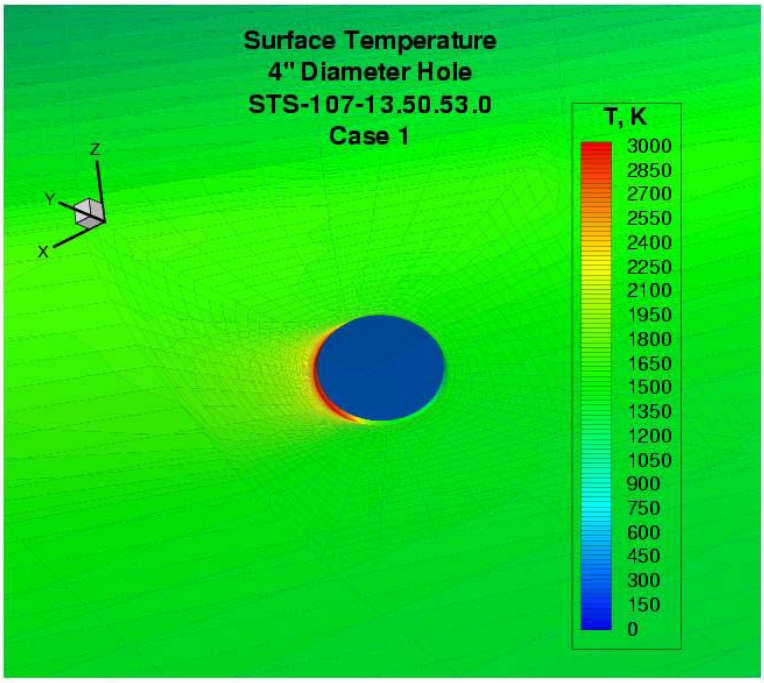
Figure 5.3.6-62: Surface temperature contours in vicinity of the four-inch hole in Panel 6.

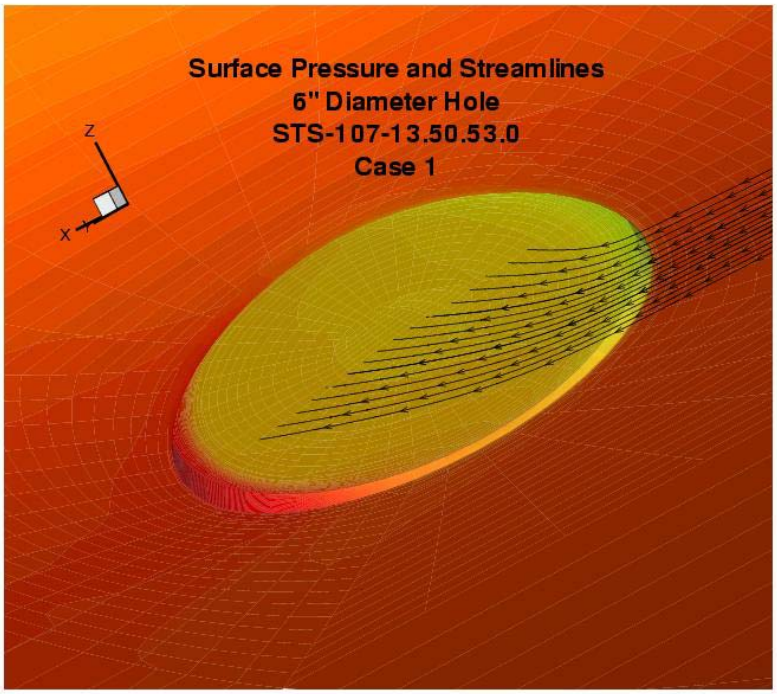
Figure 5.3.6-64: View of streamlines entering six-inch breach showing significant retention of external streamwise momentum.

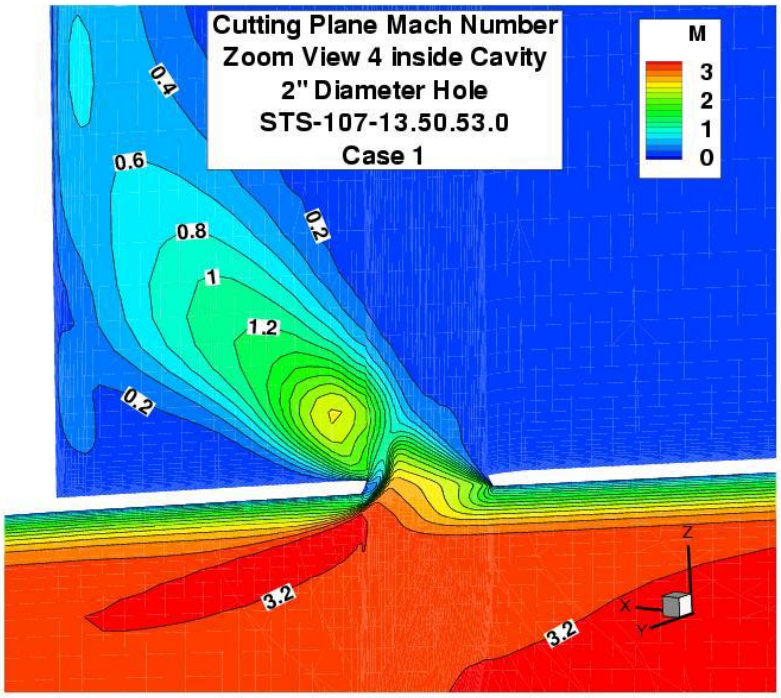
Figure 5.3.6-68: Mach number contours across the breach and in the jet entering the cavity. A sonic, choked condition sets up behind the lip shock over the downstream lip of the breach.

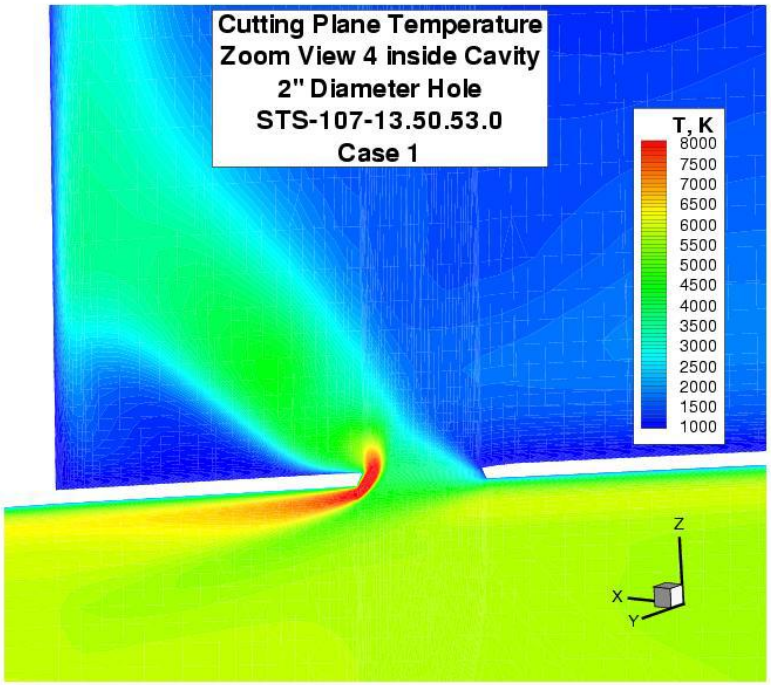
The temperature in the shock over the downstream lip approaches 14,400° R (8000 K) in Figure 5.3.6-70. The corresponding total enthalpy profile is shown in Figure 5.3.6-71 that corresponds to the earlier result in Figure 5.3.6-55 except now the cavity beneath the hole is included. Conditions just below the boundary layer edge impact the lip to drive the large surface heating rates and surface temperatures (Figure 5.3.6-72). The impingement heating on the edge will tend to cut a slot along the surface in the external streamline direction.

Figure 5.3.6-70: Temperature in vicinity of the breach.

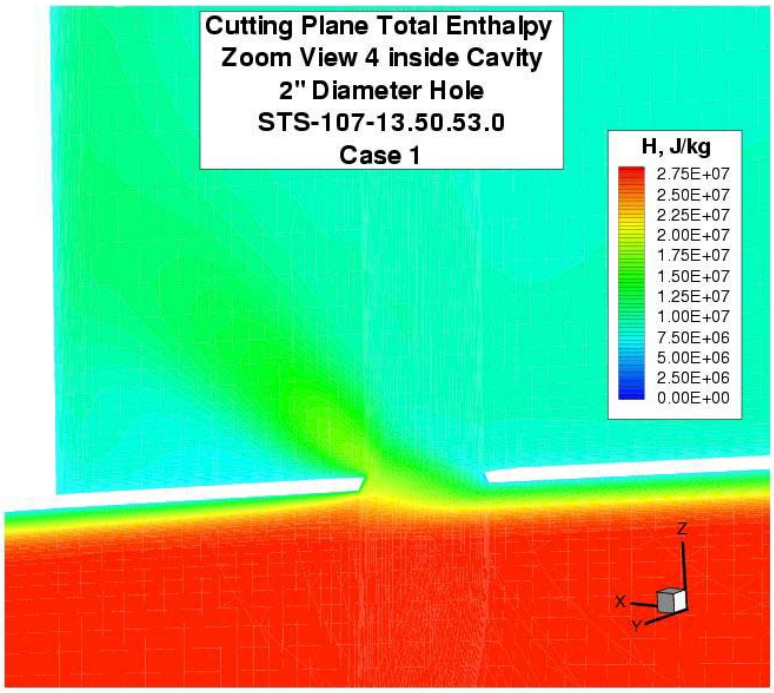
Figure 5.3.6-71: Total enthalpy in vicinity of breach indicating level of ingestion of the external boundary layer.

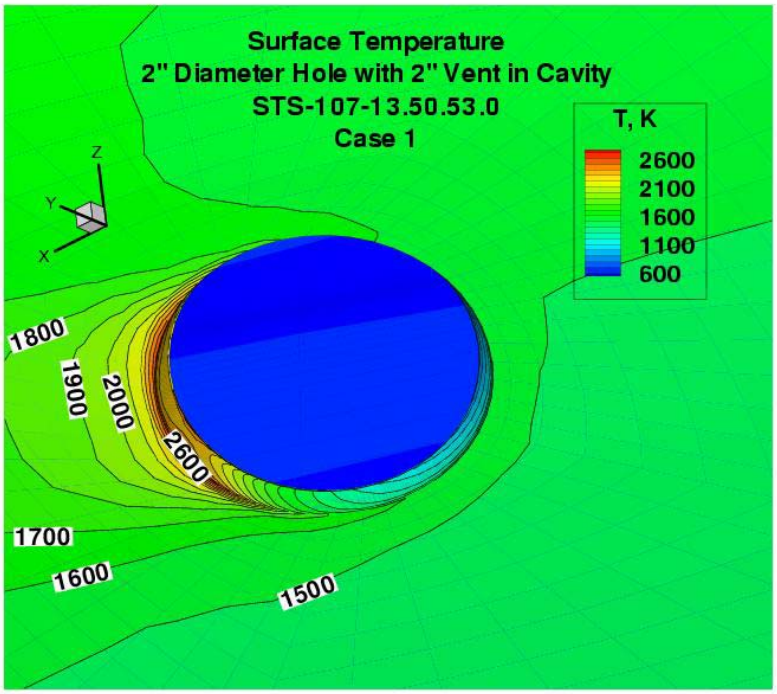
Figure 5.3.6-72: Surface temperatures in vicinity of downstream lip of two-inch hole over cavity.

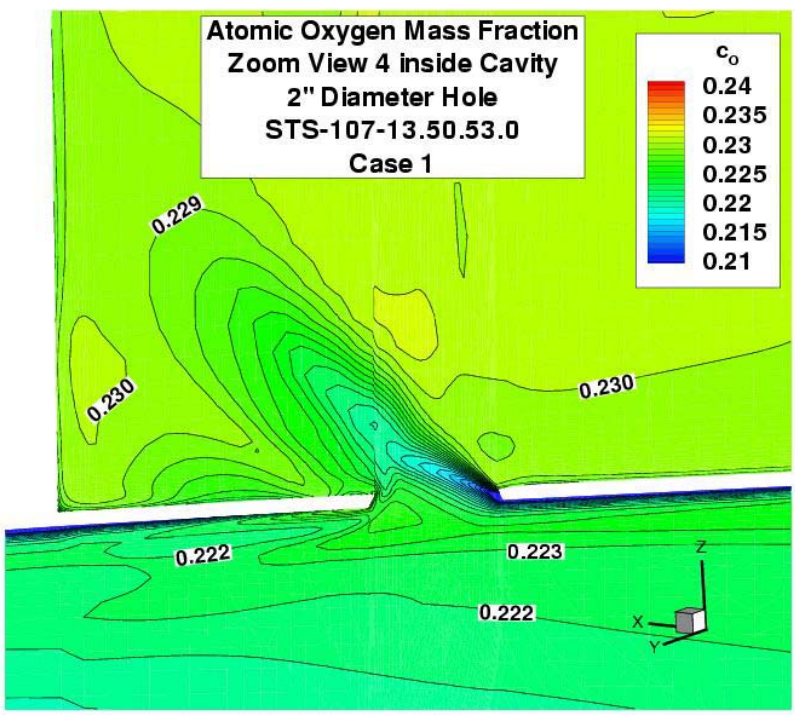
The oxygen content of ingested flow is almost fully dissociated as indicated in Figure 5.3.6-73. A strong catalytic heating effect would be expected on metallic cavity walls but the finite catalytic boundary condition on the external surfaces was continued into the cavity. Also, the radiative equilibrium wall boundary condition assumes cavity walls can radiate to free space whereas the actual closed environment would restrict radiative cooling. Conductive cooling through metallic walls is not considered. Given these conditions (expected to produce lower heating rates) the surface temperatures on the cavity walls (Figure 5.3.6-74) exceed the melting point of pure aluminum at the impingement zone. Note that the breach hole through the lower surface is not visible in this figure. The vent hole on the top surface still sees temperatures that would melt aluminum.

Figure 5.3.6-73: Atomic oxygen mass fraction ingested through breach.

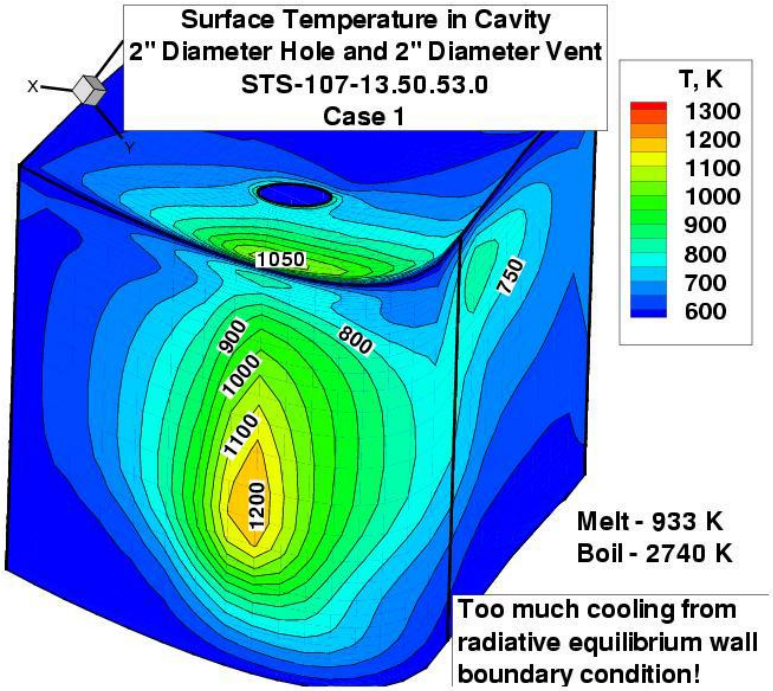
Figure 5.3.6-74: Surface temperature on cavity walls with identical cooling mechanisms as used for external flow.

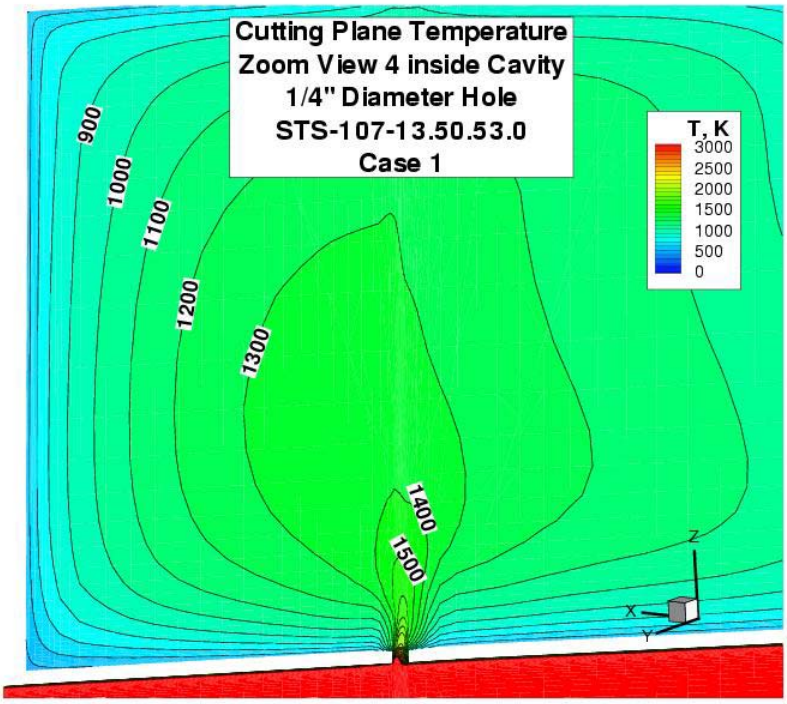
A quarter-inch diameter hole was simulated to provide reference conditions in which the hole diameter was not larger than the hole depth and all hole dimensions were smaller than the local boundary layer thickness. In this case, the jet develops in an orthogonal direction to the wall as seen in the Mach number contour of Figure 5.3.6-75. Impingement heating and temperatures on the downstream lip are much more benign (Figure 5.3.6-76) because the energy content and total pressure of the impinging streamlines emerging from deep within the boundary layer is significantly dissipated. Temperatures entering the cavity (Figure 5.3.6-77) exceed 1800° R (1000 K).

Figure 5.3.6-77: Jet temperatures in cavity bled from bottom of external boundary layer.

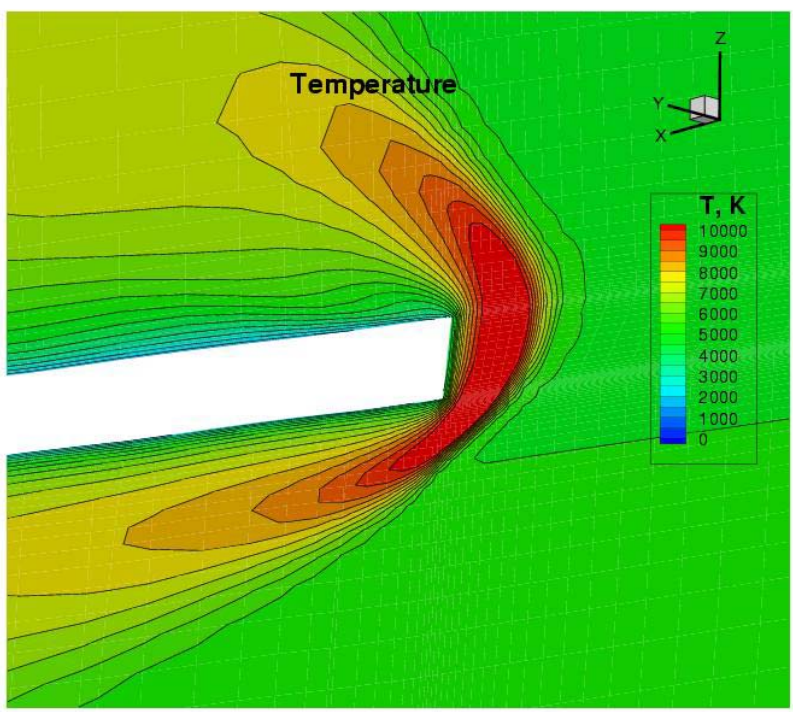
Figure 5.3.6-81: Details of temperature in shock layer over downstream lip with ten-inch breach through panel 8.

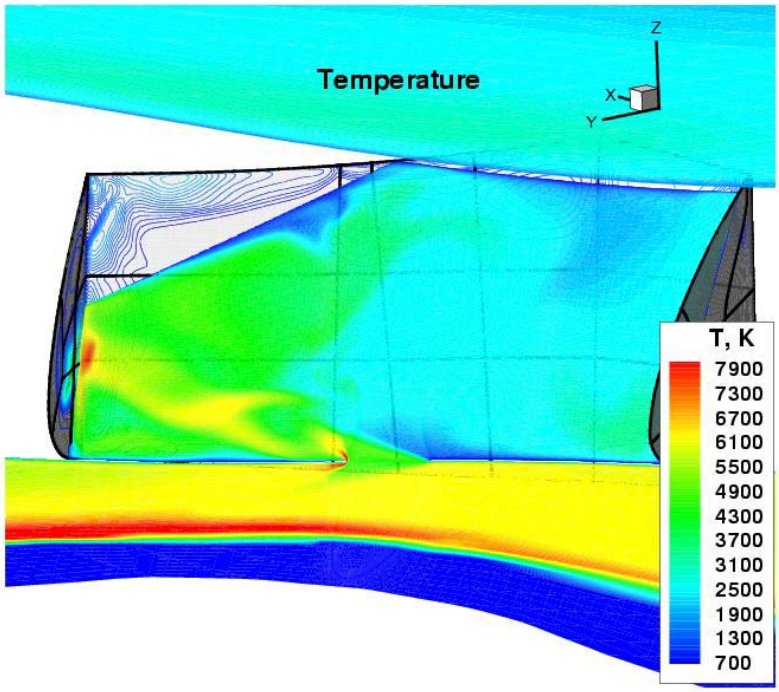
Figure 5.3.6-84: Temperatures in cutting plane through chunnel showing high temperatures at impingement of jet on the side wall.

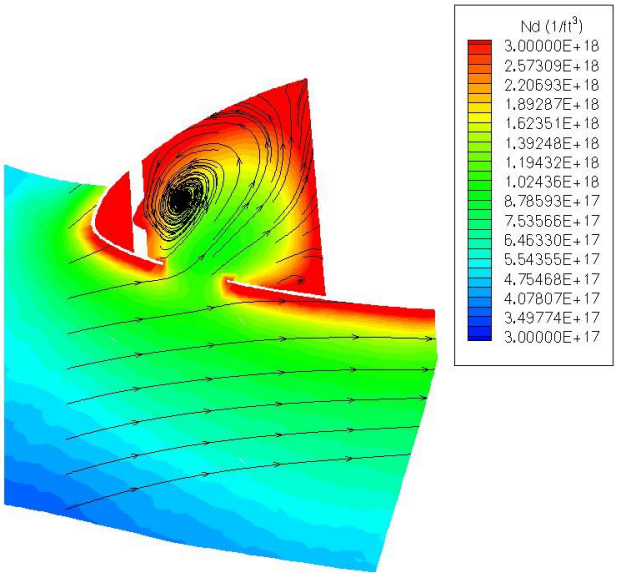
Figure 5.3.6-98 and Figure 5.3.6-99 display a Y-slice of the flow field number density for the 350kft and 300 kft cases respectively. Due to the fact that the SLICE code (the DAC post-processing code that extracts the flow field properties of a certain plane) only has the capability to extract properties in a constant x, y, or z plane, Figure 5.3.6-97 was included to display a visual picture of the Y-direction cutting plane chosen. In Figure 5.3.6-98 and Figure 5.3.6-99, the streamlines shown depict the movement of the flow as it enters the hole in panel 8 and begins re-circulating inside the cavity. Figure 5.3.6-100 through Figure 5.3.6-103 (front and back view for the 350 and 300 kft cases, respectively) show the heating distribution in the RCC cavity while and Figure 5.3.6-104 through Figure 5.3.6-107show the corresponding pressure distribution. For the 350 kft case both the heating and pressure values shown in the legends on the right side of the figures have been normalized by reference heating and pressure values chosen from a point near the hole in panel 8 on the upstream RCC external surface. For the 300 kft case the heating and pressure were normalized by the free stream values at 300 kft. From these figures, it is evident that the area of highest pressure and heating due to the breach is near the earmuff between panels 8 and 9. In Figure 5.3.6-100 through Figure 5.3.6-103, a splash effect is shown on the panel 8 spar surface. As the flow hits the corner of the earmuff, a shock is formed and the flow is seen to splash onto the spar. Elevated heating levels are also seen near the earmuff between panels 7 and 8.

Figure 5.3.6-98 350kft Case-Number Density in Flowfield with Streamlines (Slice in Y-Direction)

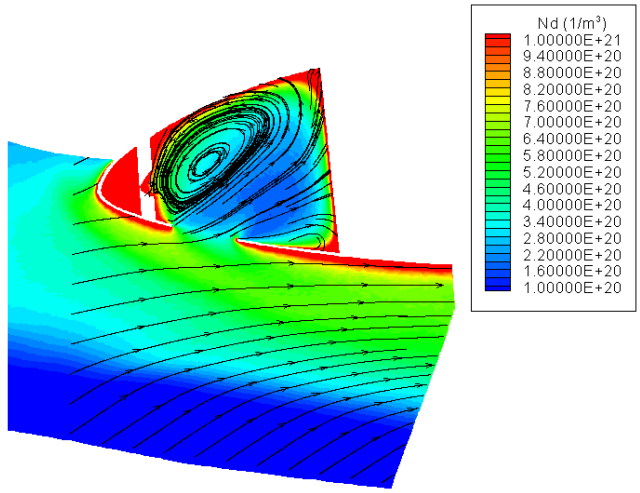
Figure 5.3.6-99 300kft Case-Number Density in Flowfield with Streamlines (Slice in Y-Direction)

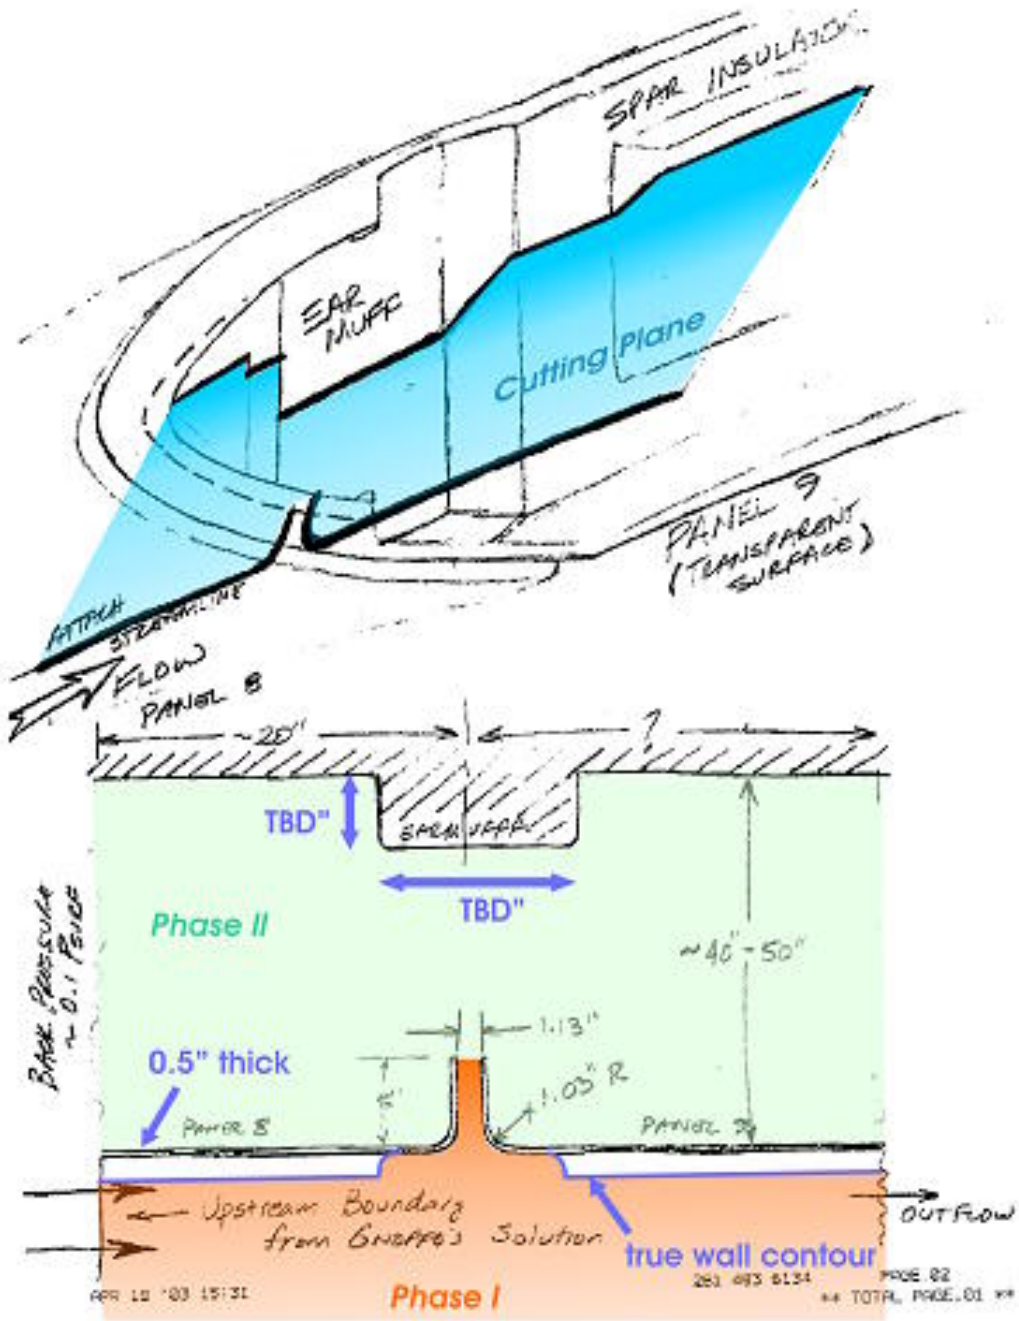
Figure 5.3.6-108 Representative T-seal geometry

Two-dimensional simulations were done with GASP to model the internal wing flow field around the earmuff with a T-seal missing. Figure 5.3.6-108 is a representation of this simplified geometry. The true wall contour on the windward surface was not modeled in the GASP simulations. Instead, the windward surface was just a straight wall (black line instead of blue line in Figure 5.3.6-108).

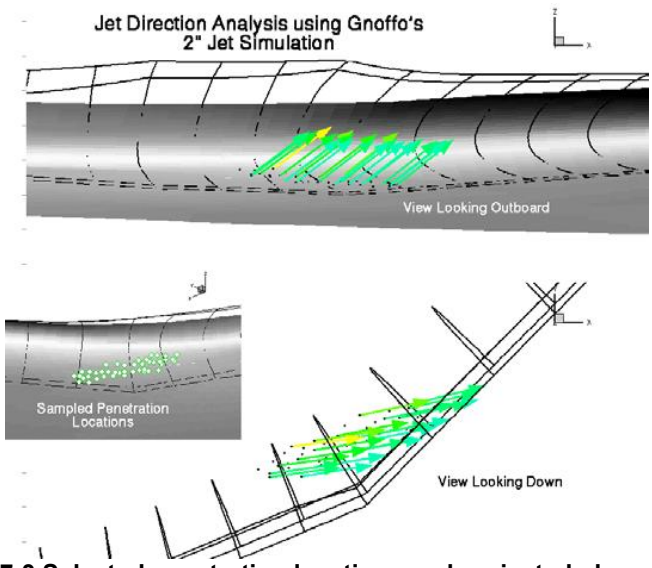
Figure 5.3.7-3 Selected penetration locations and projected plume directions

With this definition established, a series of points along the projected debris path were chosen as illustrated in Figure 5.3.7-3 with the symbols. The ***J*** vectors are represented in three dimensions in the accompanying views of Figure 5.3.7-3, with the view from inboard on top and the view looking down on the RCC outlines on the bottom. Due to the double delta shape of the Orbiter wing, and the projected impact path at the juncture, the vectors primarily point to the spar region behind panel 8.In Figure 5.3.7-4 a representation of the RCC insulation system has been added in investigating the impact points of the selected jet penetrations. Due to the vector alignment and insulation configuration the conclusion is that the most likely primary impingement location for an RCC penetration along the predicted foam path is the spar region behind panel 8 or the earmuff region between panels 8 and 9. Table 5.3.7.1-1 provides the selected penetrations and the associated jet direction unit vectors.

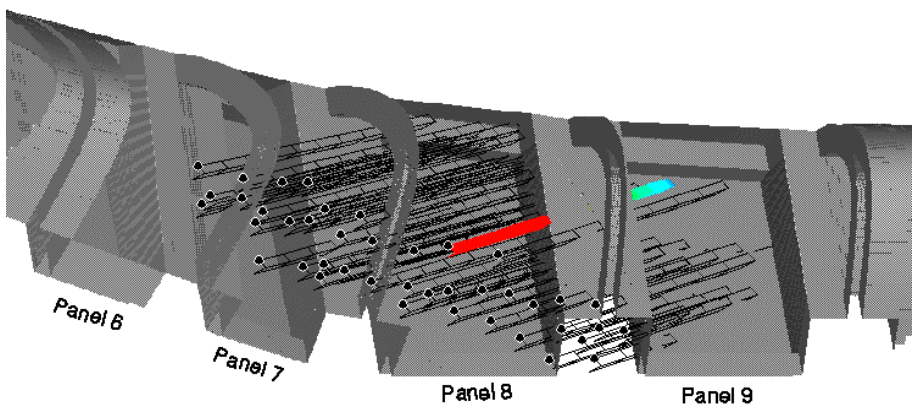
Figure 5.3.7-5 Panel 8 lower surface penetration location

The present working scenario includes penetration of RCC from panels 6-9 with subsequent spar breach at 488 seconds from entry interface. The team chose a single penetration location for complete analysis in order to ballpark the hole size required to match the flight data for the panel 9 spar and clevis temperature measurements and the spar breach time of 488 seconds from E.I. Given similar heating analysis completed early in the investigation using the basic MMOD plume model, 5.3.3.2, hole sizes of 4, 6, and 10 inches in diameter were chosen and anticipated to bound the data. Hole location was chosen to maximize the predicted primary impingement heating rate, based on the internal flow direction analysis of 5.3.7.1. Using the simple 1-D plume heating model, the plume vectors of Table 5.3.7.1-1 were assessed and vector # 18 chosen and colored red in Figure 5.3.7-5. The anticipated heating rates at the primary impingement point are increased both by the short distance to the earmuff and the small radius of curvature on the TPS edge. The coordinates of the assumed penetration are X=1065 in, y=-219 in, and z= 286.3 in.

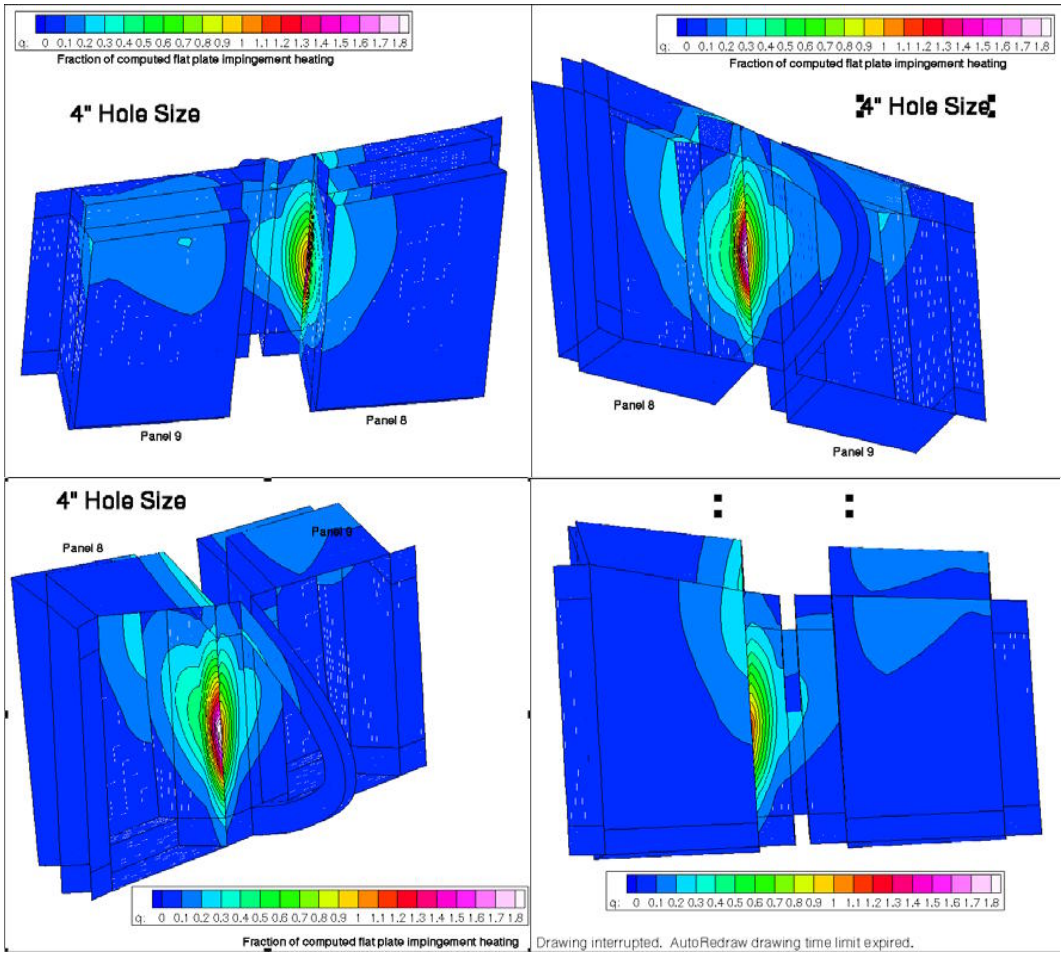
Figure 5.3.7-8 Heating factors for a 4" diameter hole in panel 8 lower surface

Engineering predicted heating distribution factors are presented in Figure 5.3.7-8 through Figure 5.3.7-10. All cases show a peak heating point on the earmuff between panels 8 and 9 at the edge of the TPS along the jet axis. By comparison, as the hole grows larger, so does the high heating region, with higher splash heating factors to secondary surfaces. Peak amplification factors do not change since the driving factor on the earmuff edge is local curvature, which is consistent between predictions. Keeping the previous equation and Table 5.3.7.2-1 in mind, however, shows that while the geometry amplification factors are the same, the 10" hole will experience significantly higher heating to the entire internal geometry.

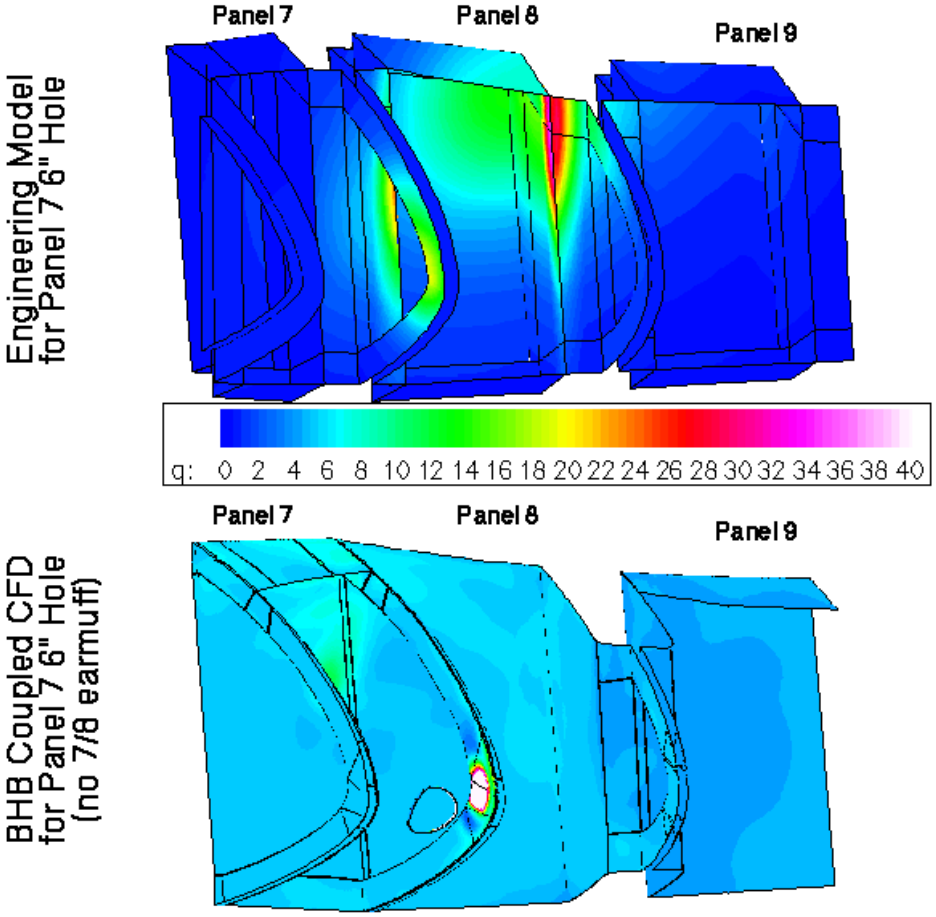
Figure 5.3.7-13 Comparison of STS107 methodology with panel 7 6" coupled CFD

Figure 5.3.7-13 points out the dramatic change in internal heating distribution due to the external flow coupling. Here the same hole location produces a very concentrated, high enthalpy flow impingement on the interior rib surface of panel 7 just downstream of the hole. Examination of the engineering methodology indicates that the jet would, indeed, impact the rib, there is no automatic correction applied to account for it. The flow that strikes the rib has all of its downstream momentum arrested and winds up producing only moderate heating to the spar behind panel 7 while the STS-107 methodology shows a panel 8 spar impingement with elevated heating rates. Figure 5.3.7-14 shows the impact of local geometry changes to the distribution once more, as the earmuff between panels 7/8 is added and greatly changes the result. Fortunately, the additional interaction of the rib splash flow with the earmuff geometry produces heating distributions and magnitudes in line with the engineering methodology. While this is clearly a case of two wrongs make a right, it lends support to the use of the engineering approach for thermal analysis and does not negate the resulting outcome the thermal analysis to the panel 8 and 9 spar surfaces. RCC rib heating is handled by a separate modeling approach; section 5.3.3.6.5.

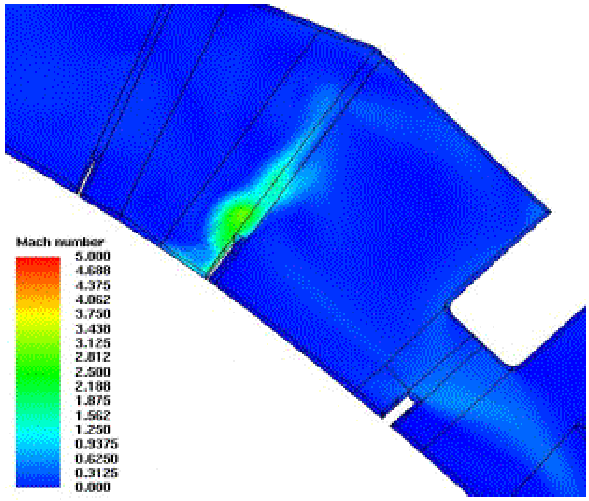
Figure 5.3.7-17 BHB Panel 7, 6" hole coupled internal flow field

BHB results of Figure 5.3.7-17 illustrate that even a relatively small geometric feature, in this case an RCC rib, can sufficiently absorb momentum to cause the jet to change direction completely. Any secondary burn-through of the spar in this case would clearly produce a normal jet through the breach.

In providing this assessment, however, the best that can be said is that **initially** the jet was certainly produced normal to the secondary breach surface. Given heating rates many times external values, eventually the primary impingement zone will be completely melted to the dimensions of the jet and there is then nothing to inhibit the free flow of the jet into the mid wing volume with full momentum. The time required to achieve such a state is entirely dependent on the initial damage and the TPS surface that is directly impinged.

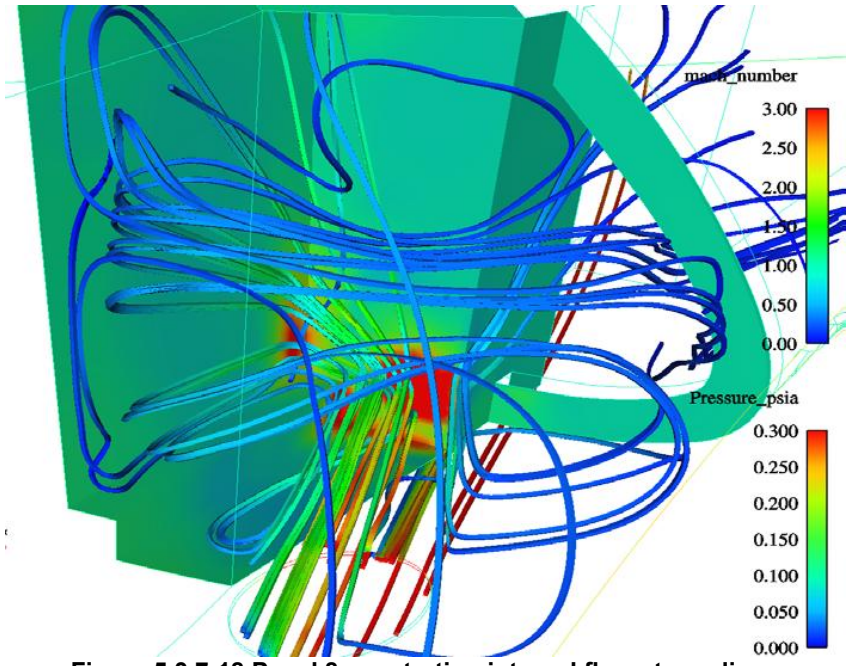
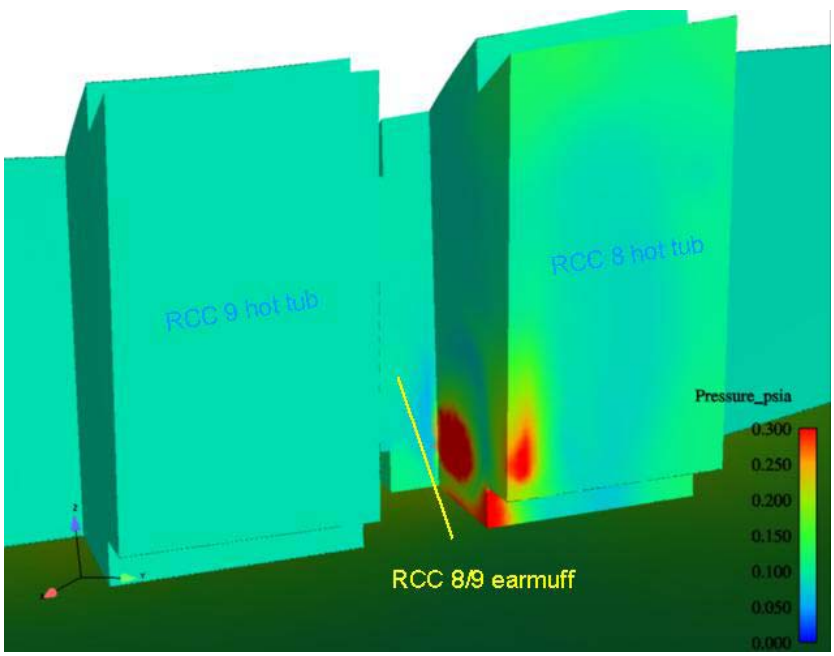
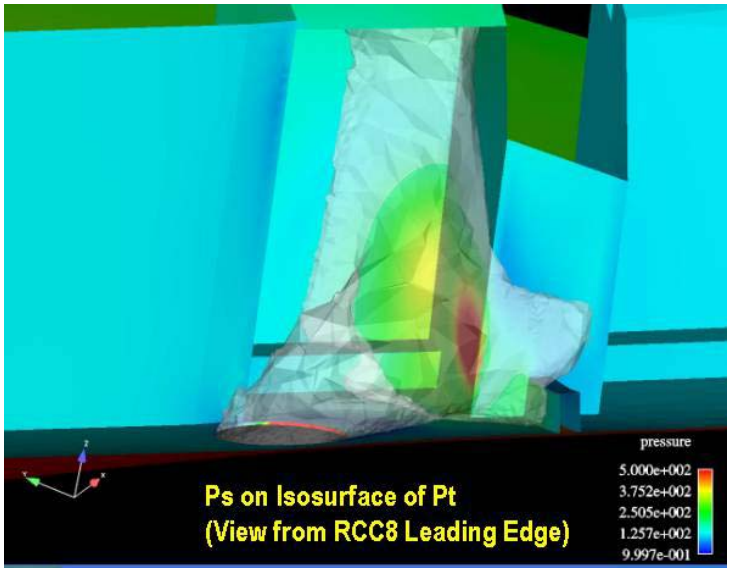
The BHB panel 7 CFD solution predicted heating rates over 200 Btu/ft^2-sec to the panel 7 interior rib surface in the primary jet impingement zone. BRPP results to the 8/9 earmuff are also over 200 Btu/ft^2-sec for the panel 8 penetration. Examination of Figure 5.3.7-18 shows how a slight adjustment of hole location would place the primary jet impingement heating region directly on the RCC rib. The directional aspect of the knife-edging observed in the debris can only be explained with a jet flowing internally from panel 8.

Preferential jet splash patterns off of the earmuff surface and up and into the panel 8 spar region focus high temperature gases directly into the RCC leeside vents at the upper carrier panel. With the poor

radiation relief of tile to RCC, enhanced heating will quickly elevate the tile surface above the slump temperature and open the vent even more. Debris forensic evidence contains a panel 8 upper carrier panel tile with deposit buildup consistent with the internal insulation materials over 0.4" thick. Examination of Figure 5.3.7-20 shows the jet shape as it comes off the earmuff clearly heading directly into the region where the tile would be located, carrying with it any melted/vaporized material for deposit to the relatively cooler surface of the tile.

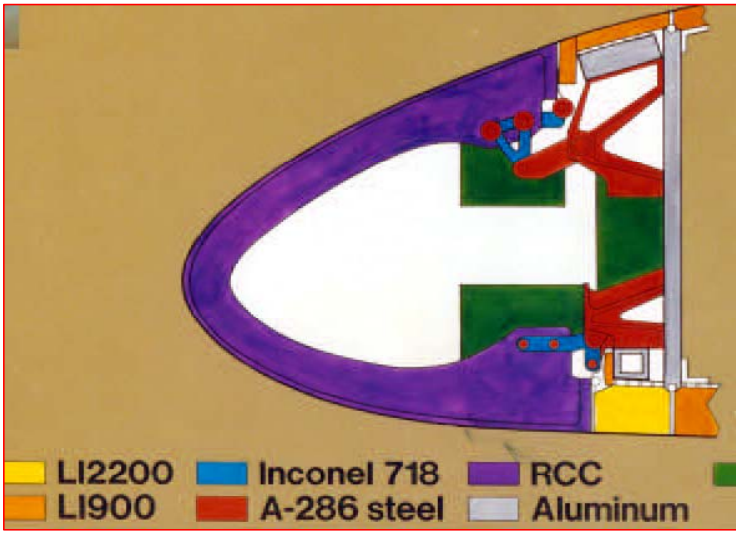
Figure 6-1 - Wing Leading Edge Cross-section

A thermal analysis was conducted to compare the flight data instrumentation of the spar (V09T9895) and clevis (V09T9910) to the predicted thermal response in a plume heating environment of each of these panel 9 locations. The wing leading edge (WLE) cavity is shown in Figure 6-1. Two independent thermal math models, one from JSC and the other from Boeing Huntington Beach (B-HB), were utilized to perform this analysis.

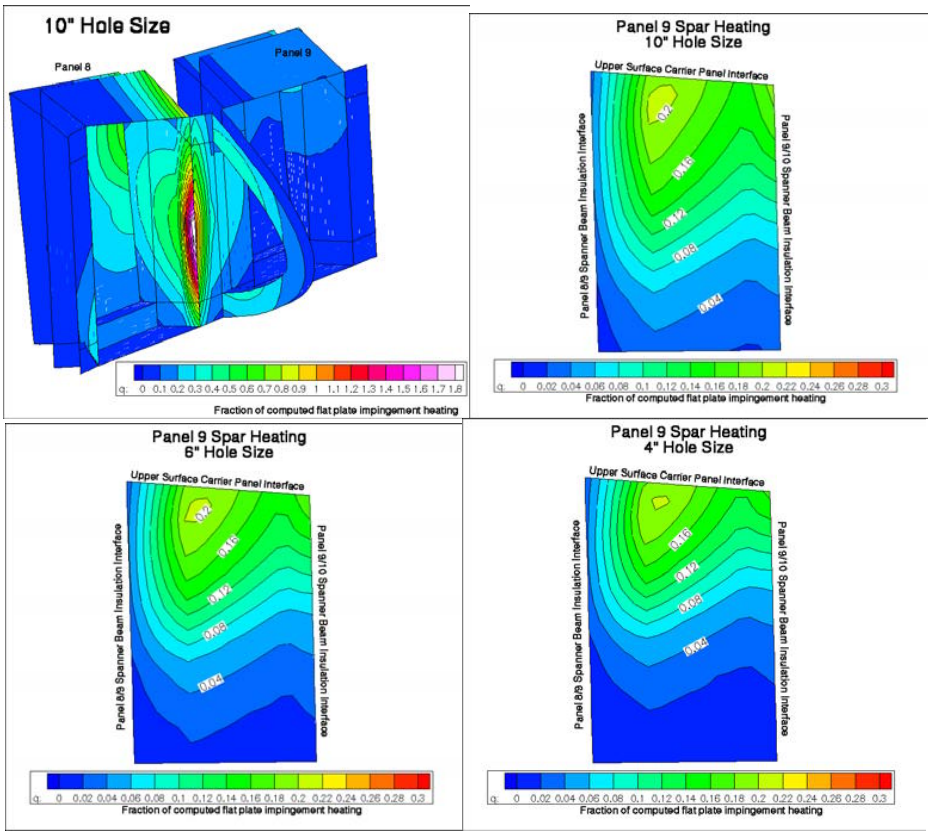
Figure 6-2 - Heating Distribution

Figure 6-2 shows how $\dot{q} \Big/ \dot{q}_{plate}(x,y,z,d_{hole})$ varies for a 10 inch hole. The average distribution factor of the stagnation heating value over panel 9 for a 4 inch, 6 inch, and 10 inch hole are .02, .08, and .12, respectively. Additional heating behind the spar insulation, directly on the aluminum near bottom clevis locations, is also considered as a fraction of the panel 9 heating.

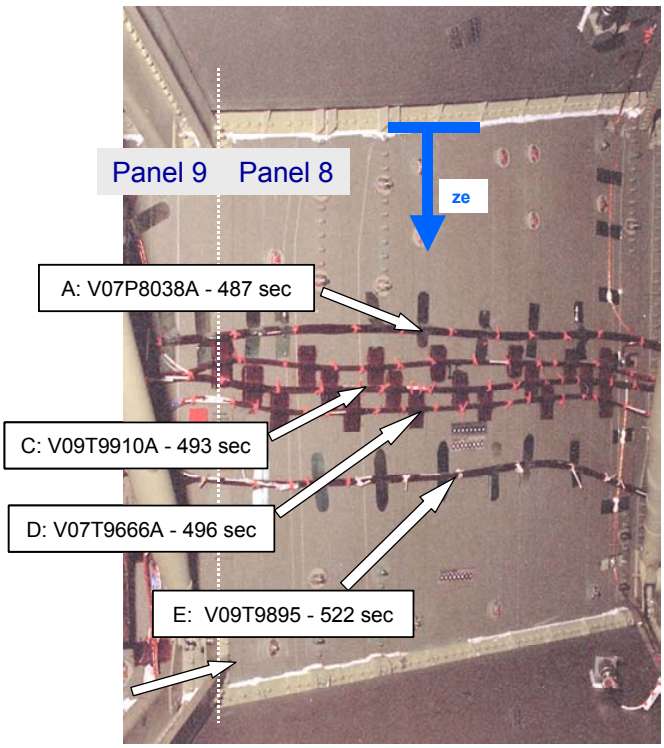
Figure 6-13 - Damaged Tee-seal - Clevis Transients

is invalid after about 500 seconds because hot gases know to be within the wheel well at this time were not simulated. Figure 6-13 shows the analytical clevis temperature compared to the flight data. Here it is seen that the analytical prediction rises slightly earlier than the flight data but is not totally out of proportion.

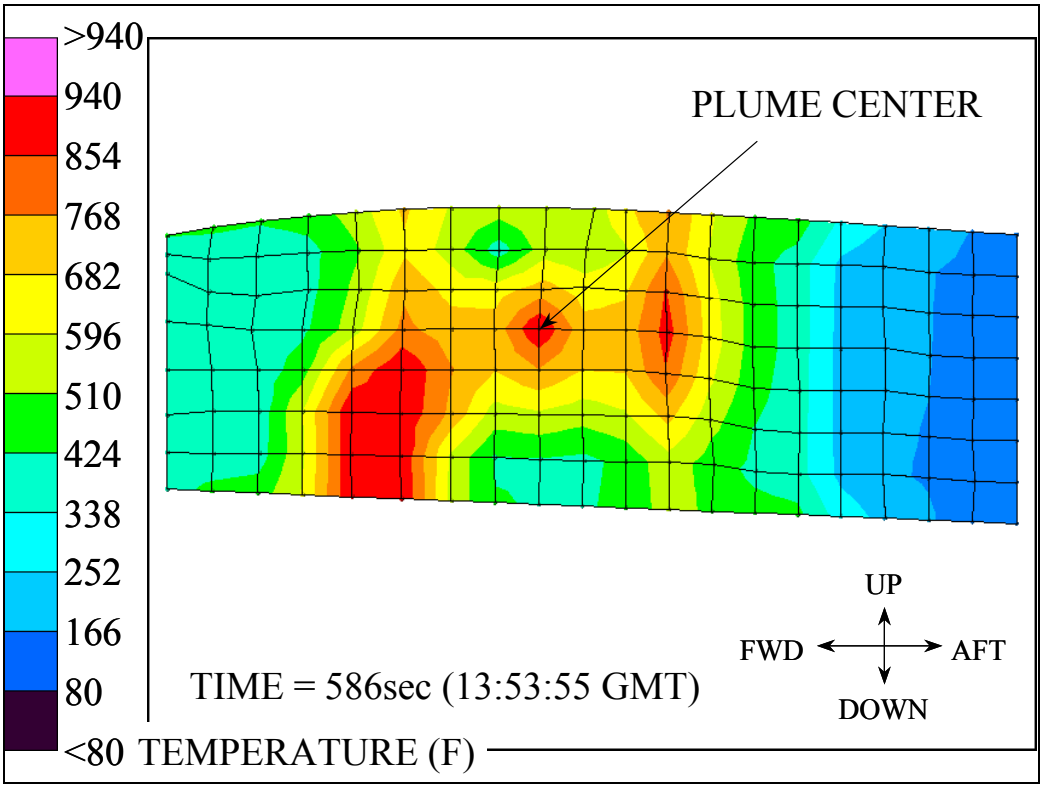
Figure 6-25 - Outboard wheel well wall temperature at 13:52:39 GMT

At first glance sensors V58T1700A and V58T1701 correlate very well with the flight data. However, past EI+510 sec (GMT 13:52:39) the low mass honeycomb access panel has reached its melting temperature in the analysis as shown in Figure 6-25. This would allow hot gases to enter the wheel well and deposit energy through convection directly on the MLG components. However, one could argue that this convective energy then replaces radiative energy but CFD would have to confirm this. After EI+586 sec (GMT 13:53:55) the wall at the center of the plume reached its melting temperature as shown in . At this point the area available for hot gases to enter the wheel well increases rapidly as more of the outboard wall melts. The assumption of holding the wheel well wall at its melting temperature (935°F) is no longer valid for this analysis and CFD is required to determine the hot gas flow inside the wheel well in order to account for the convective heating.

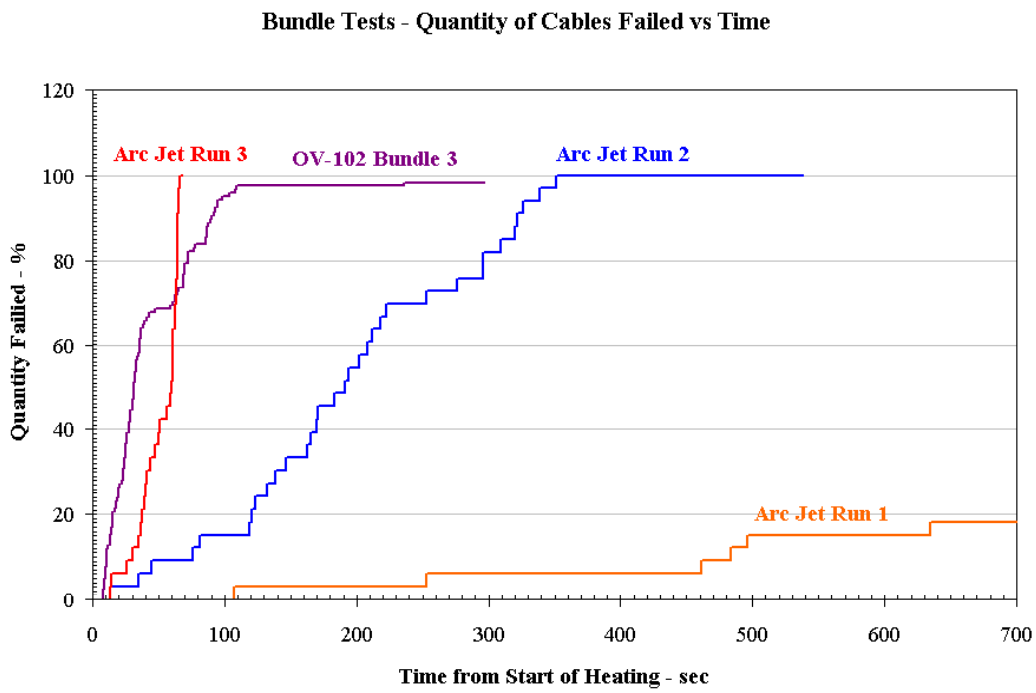
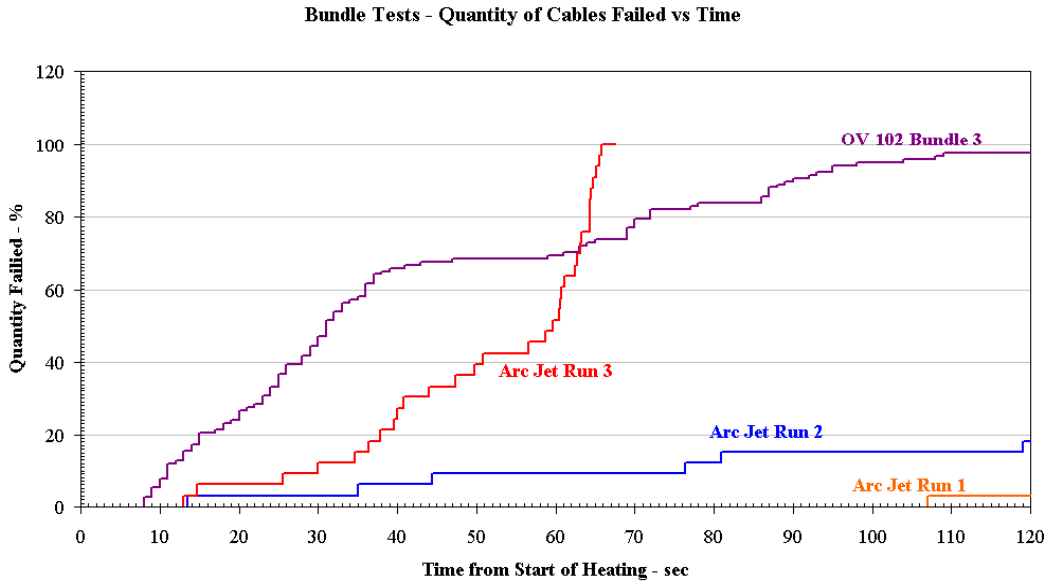
Figure 6-34 and Figure 6-35 shows a comparison of cable failure rates for this test series and that observed on the vehicle. Based on the various observed cable failure rates, heating rate for the vehicle cable bundle must have been between those of Run 2 and Run 3.

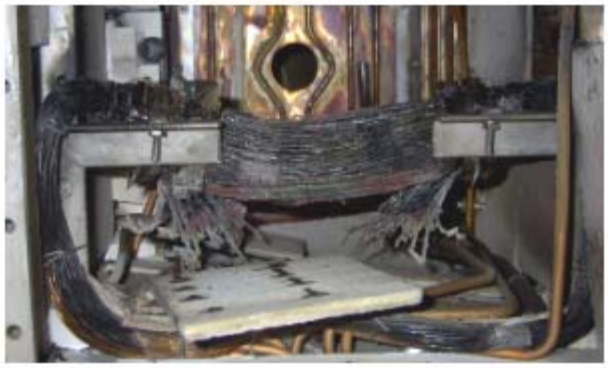
Figure 6-37 – Cable Bundle Post-Test Run #2

Run 2: The test set-up incorporated a 2-inch diameter orifice in the forward position of the box with the cable bundle 15 inches aft. Higher heating rates of run 2 produced failures faster and the entire cable bundle failed. Photographs in Figure 6-37 shows the appearance of the bundle before and after the test.

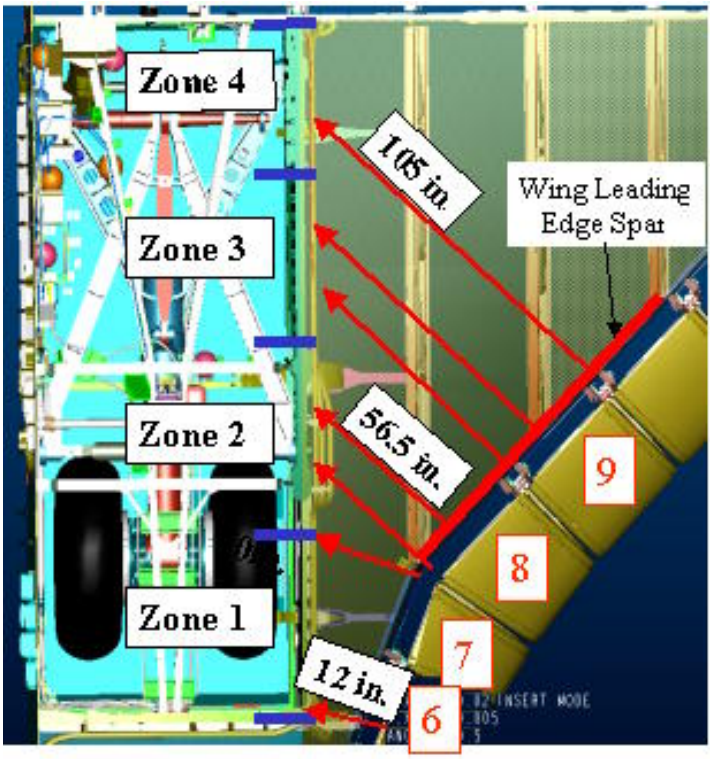
Figure 6-39 - MLG outboard sidewall (looking fwd)

A thermal analysis was performed on the wire bundles, MLG wheel well wall, and wing upper skin shown in Figure 6-39. Separate Thermal Desktop TMM's were created for each hardware region. These math models were used to calculate the required breach sizes and breach locations along the wing leading edge spar that would cause failure of each item. Their best estimated failure times were determined from the flight data. The results of each analysis were mapped against each other at defined zones along the wheel well to determine if a common breach size and location could explain their collective failure. The zones and panel locations are defined in Figure 6-40.
