COLUMBIA

ACCIDENT INVESTIGATION BOARD

Report Volume V
Appendix G.13
October 2003

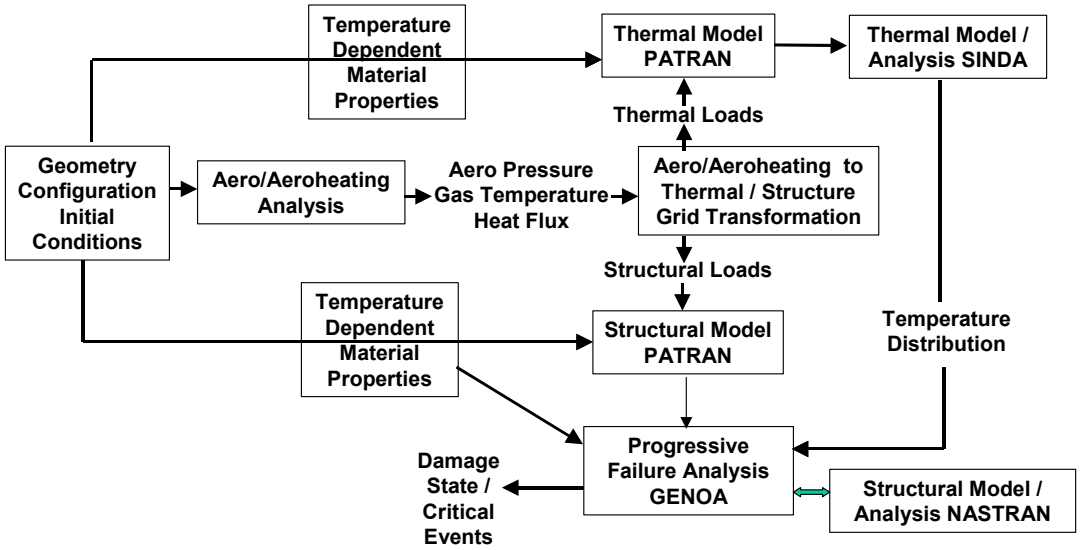
Figure 6-71 - Wing Leading Edge Failure Analysis Methodology

The process, depicted in Figure 6-71, consisted of defining external and internal aerodynamic heating and airloads environments throughout the entry, generating high fidelity thermal response of the internal insulation blankets, wing and spar structure, and RCC panels, and performing a detailed structural failure analysis of the thermally and mechanically loaded system. Multiple failure mechanisms were examined including failure of wing spar insulation, aluminum melting, honeycomb face sheet/core debond and loss of structural integrity, and loss of RCC wing leading edge attachments. This section of the report describes the analysis methodology and solution results for a damage scenario consisting of vehicle reentry with a 6 or 10 inch diameter hole in the left wing leading edge. Predicted temperature distributions and structural analysis results showing material failure and damage propagation during entry are presented and compared with available flight data.

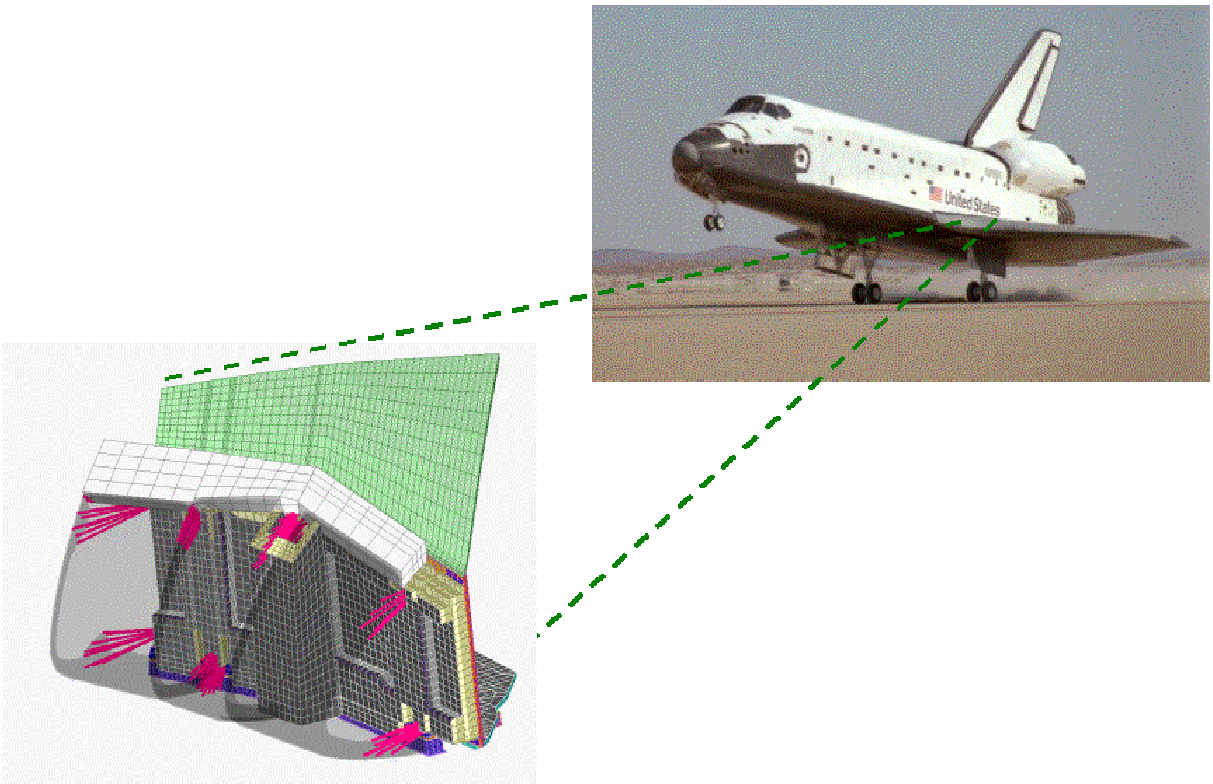
Figure 6-72 - Wing Leading Edge Finite Element Model

To provide a common basis for the multidisciplinary analysis, a detailed finite element model of the wing leading edge covering RCC panels 6 through 8 was developed and is shown in Figure 6-72. In addition to the RCC panels, the model encompassed the associated honeycomb wing spar, internal insulation blankets and earmuff, representative attachment fittings and spanner beam, surrounding wing acreage TPS and underlying honeycomb wing structure.

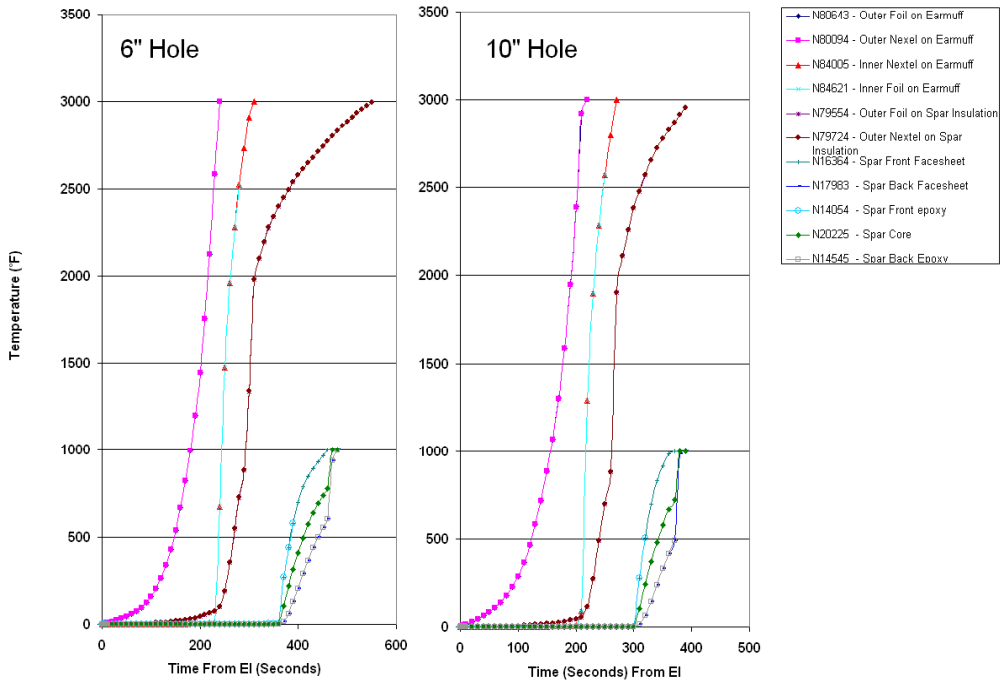
Figure 6-73 – Predicted Wing Spar Insulation and Structure Transients

To simulate the melting failure of affected surfaces within the limited schedule available for the analysis, internal convective heating was applied to interior portions of the model as outer surfaces reached their melting temperature limits. This avoided the time-consuming process of node removal and, coupled with the imposition of temperature limits for failed nodes to prevent nonphysical levels during the analysis, served as a reasonable approximation to the actual structural heating during failure. The heat of fusion for the materials was not accounted for in this study. Resulting temperature histories throughout the insulation and spar are shown in Figure 6-73 for both the 6-inch and 10-inch damage cases.

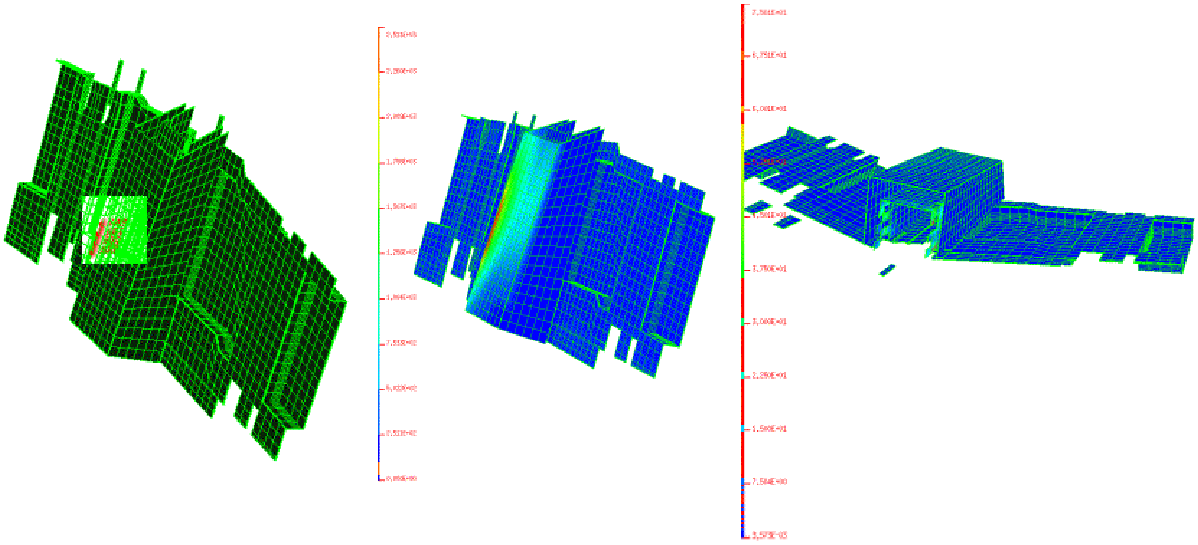
Figure 6-74 - Earmuff Insulation Analysis Results for 10 Inch Hole at t=210 Seconds

Analysis results at these conditions are shown in Figure 6-74 through Figure 6-77 for the 10 inch case and Figure 6-78 through Figure 6-81 for the 6 inch case. Predictions for both damage cases show eventual failure of RCC panels through fracturing and breakup.

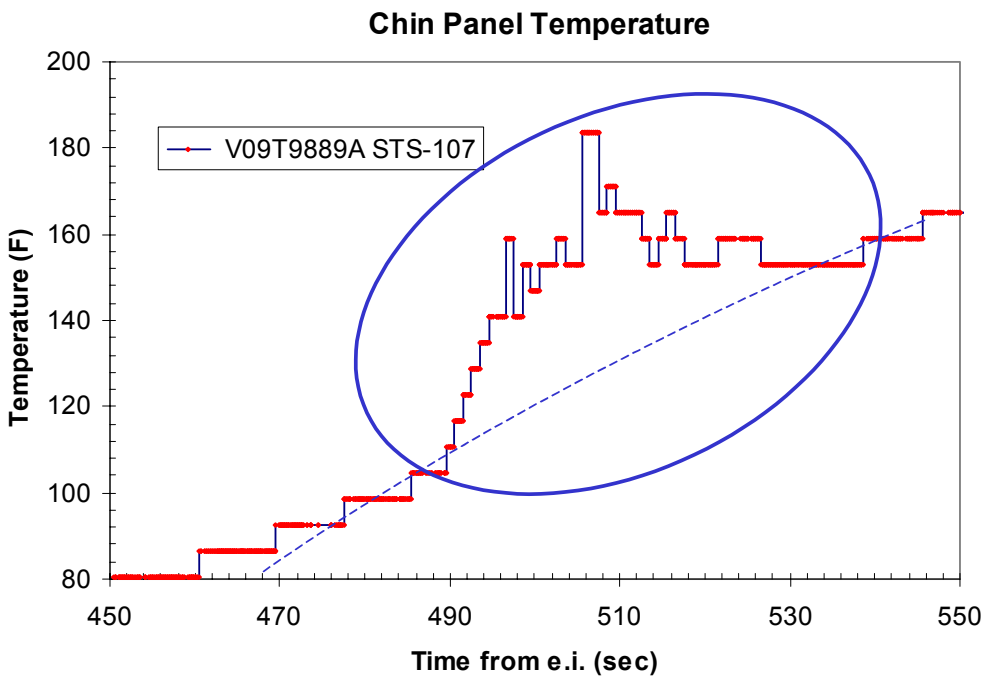
Figure 6-83 - Chin Panel Temperature Anomaly

Starting at 490 seconds from entry interface, a temperature measurement on the RCC chin panel recorded a sharp rise in temperature followed by a drop. Eventually, the temperature measurement recorded a trend that followed the expected nominal transient. The transient is shown in Figure 6-83. It has been concluded that this transient had to have been caused by a data system anomaly rather than an anomaly with the chin panel hardware of thermal environment.

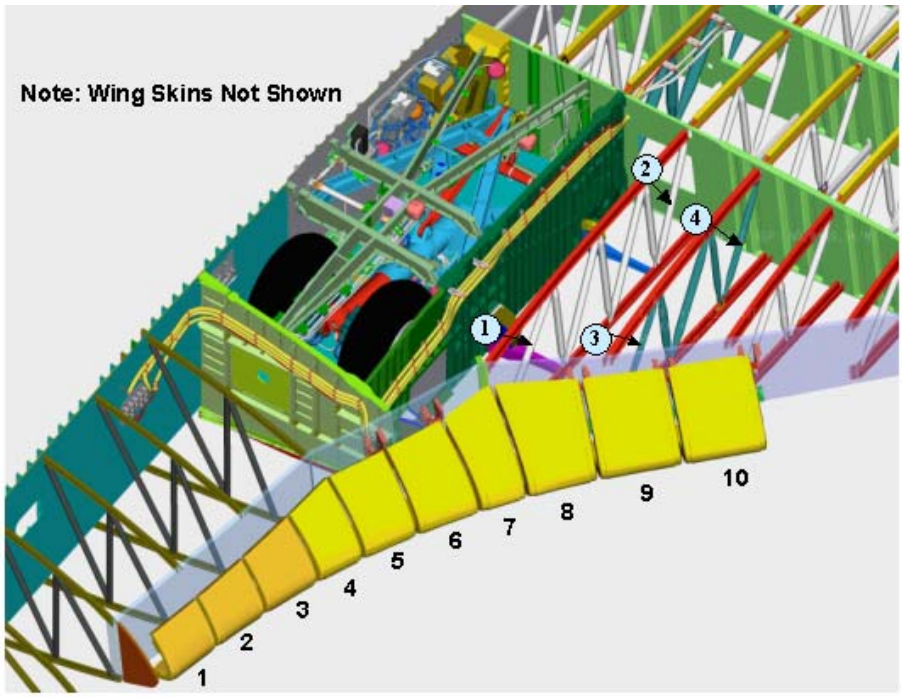
Figure 6-84 - Location of truss tubes (labeled 1-4) studied

A thermal sensitivity study was performed on OV-102's left wing truss tubes. A Thermal Desktop TMM was created to gain an understanding if and when the tubes would fail if exposed to plume heating caused by a breach in the wing leading edge spar. Tubes at various distances from the spar were chosen as shown in Figure 6-84. The size of the breach was varied.

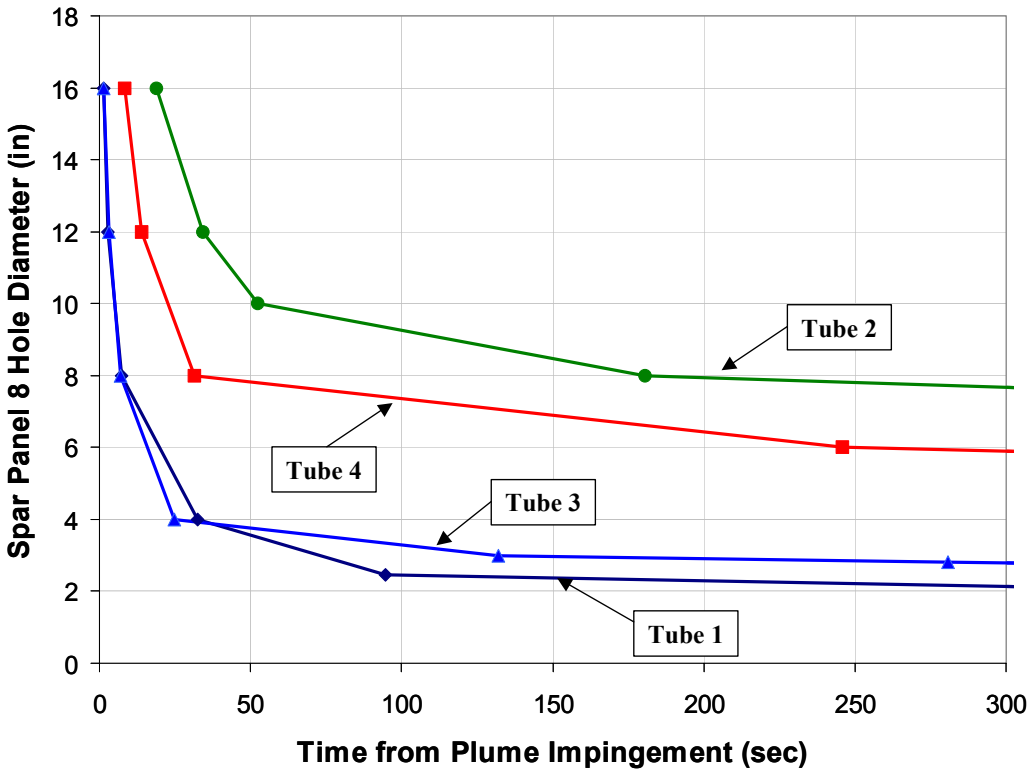
Figure 6-87 - Wing truss tube failure times with respect to breach sizes

Failure was determined when the entire cross section of the tube at the point of plume impingement reached a temperature of 935°F. The failure times of the 4 tubes are shown in Figure 6-87 for varying breach hole sizes.

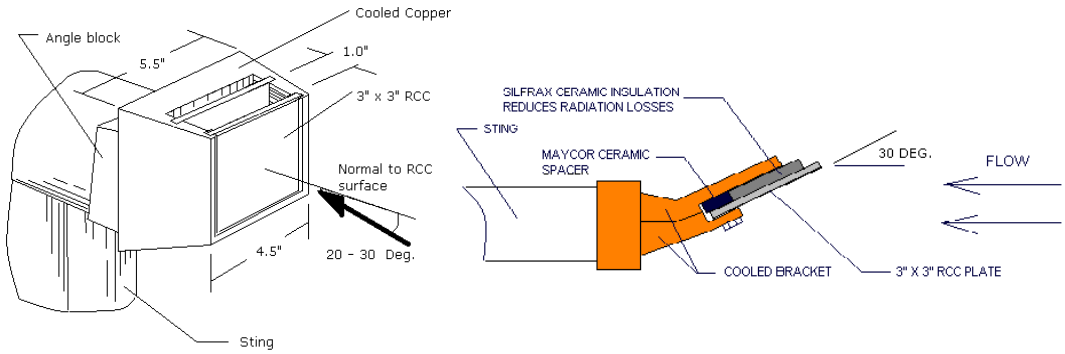
Figure 6-88 – Test Fixtures

Two test fixtures were designed and developed for this test and are shown in Figure 6-88. The single plate fixture was used to simulate flow impinging onto a breach edge with an angle of 20°. The dual plate fixture was used to simulate flow impinging onto a near-normal (70°) surface representative of the RCC panel ribs.

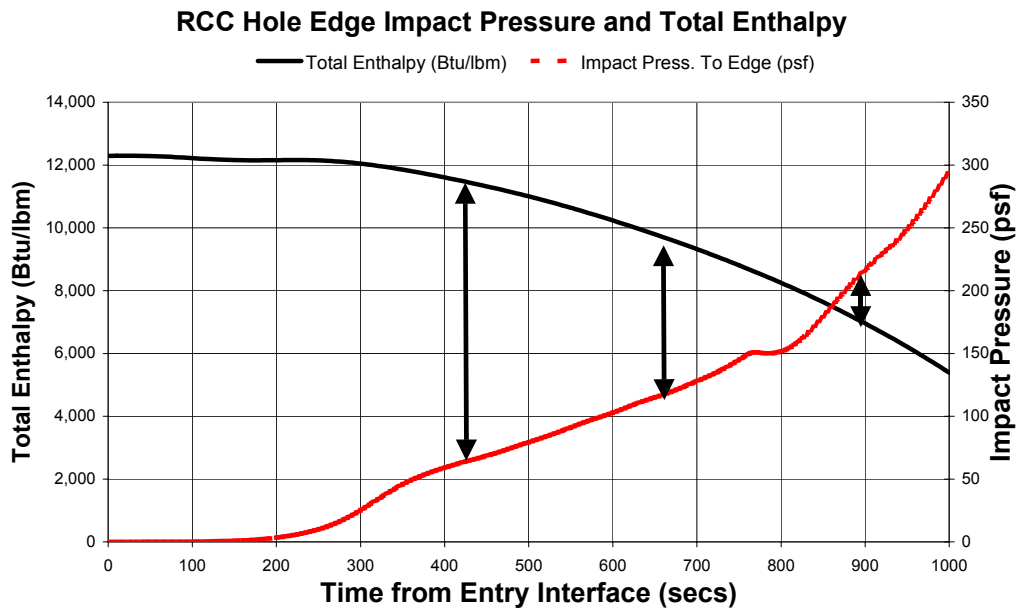
Figure 6-89 – Flight Environment

The test conditions were defined by enthalpy and pressure. The test points were derived from the predicted STS-107 RCC hole edge impact pressure and total enthalpy provided by JSC/EG. Three test conditions were established based on the profile shown in Figure 6-89.

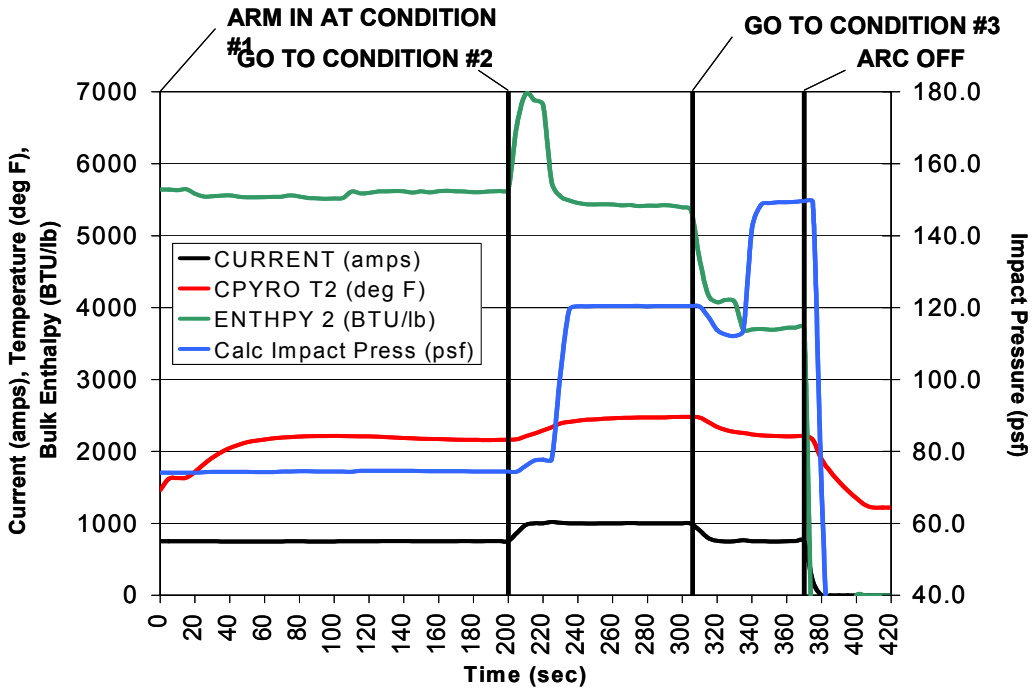
Figure 6-90 -Test Run #__ Actual Profile

The three test conditions were used to simulate a flight profile. For the first two tests, only condition #1 was used. Based on the results from these tests, conditions #2 and #3 were added and the flight profile developed. Figure 6-90 illustrates the simulated flight profile used during testing. It should be noted that the enthalpy specified is the centerline enthalpy and should be multiplied by a factor of two to correspond to the targeted total enthalpy.

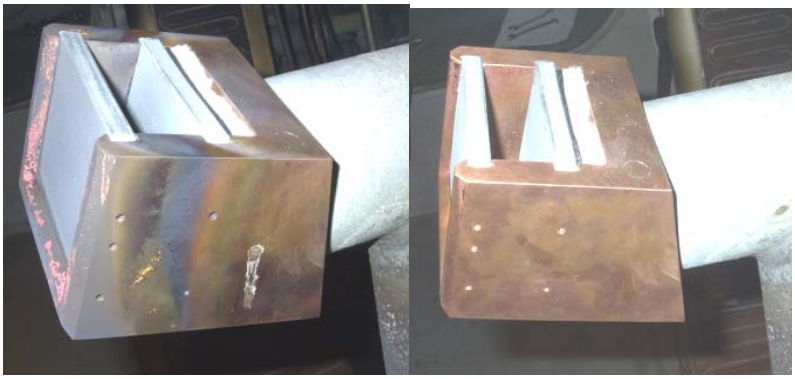
Figure 6-91 -Test #1 Pre and Post Test

Test #1 produced no knife-edging since the conditions could not generate temperatures on the RCC specimen greater than 3250°F. Pre- and post-test photos are shown in Figure 6-91.

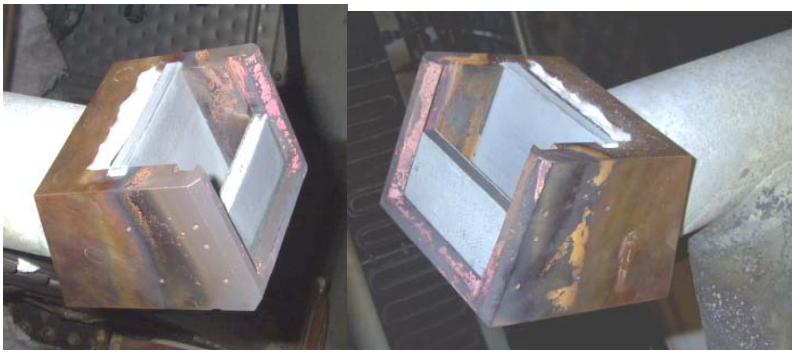
Figure 6-92 -Test #2 Pre and Post Test

Test #2 used the same test conditions as Test #1, but the front specimen was exchanged with an offset RCC plate representing an offset RCC rib. Condition #1 could not produce temperatures greater than 3250°F on the SiC coating, but did oxidize the exposed carbon, leaving a white residue from the impregnated TEOS, as seen in Figure 6-92.

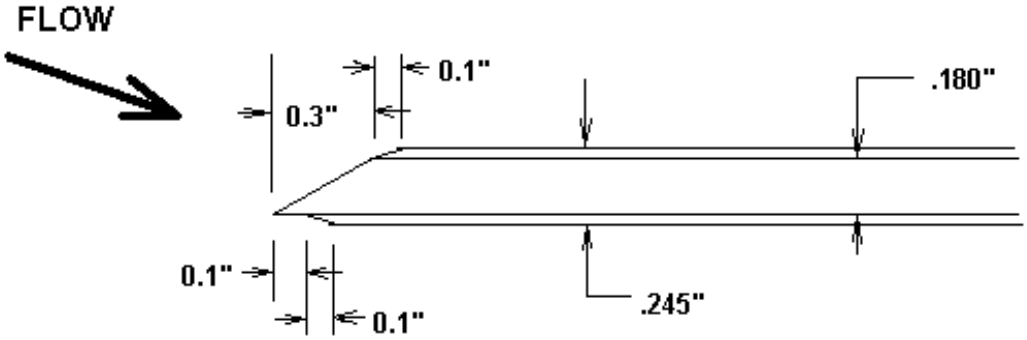
Figure 6-95 – Schematic of knife-edging dimensions

Test #5 used the single plate fixture with a coated RCC specimen. Knife-edging was produced on the main RCC specimen as shown in Figure 8. Test conditions did produce temperatures above 3250°F. The test condition profile was stopped at condition #2 in order to preserve the knife-edging features for posttest evaluation. A diagram showing the approximate dimensions of the knife-edging is shown in Figure 6-95.

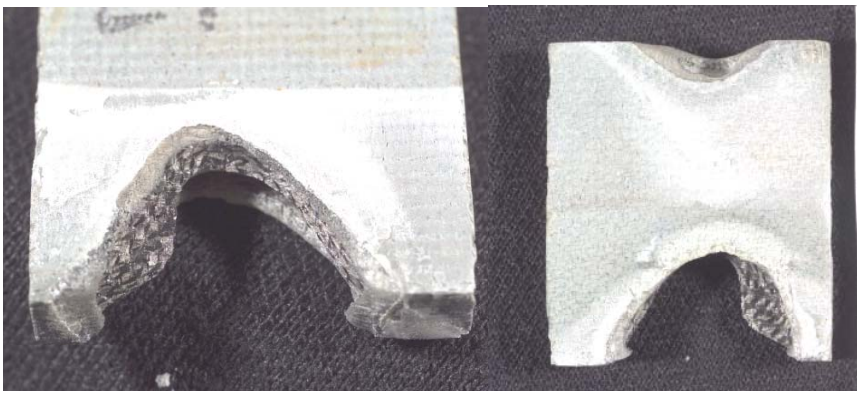
Figure 6-96 -Test #5 Closeout RCC Pieces with Knife-Edging

In addition to the main RCC knife-edging on Test #5, the closeout RCC pieces also produced knife-edging as seen in Figure 6-96. The closeout pieces prevent flow from entering the copper test fixture. The erosion occurred from a secondary shock impinging on the closeout pieces. The knife-edging was sharper than what occurred on the main RCC piece.

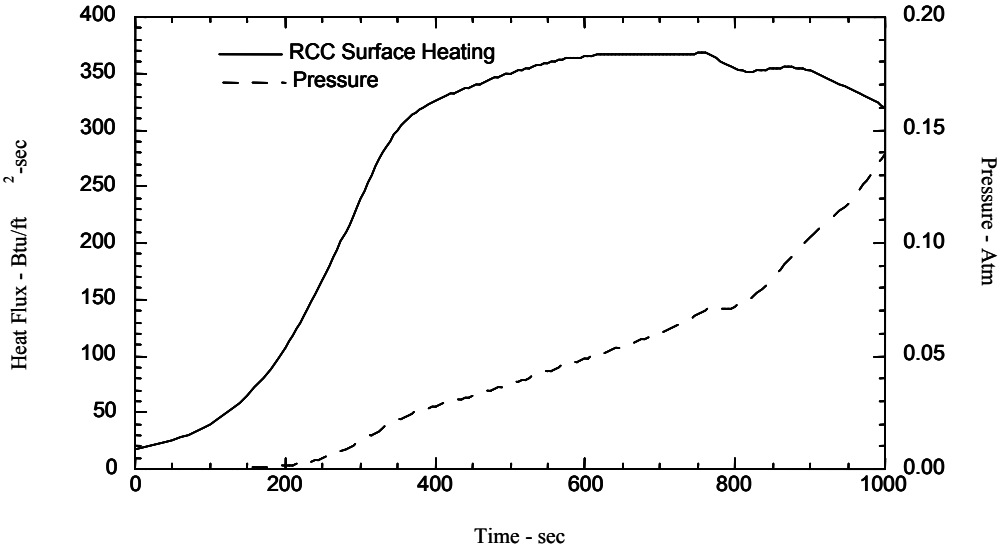
Figure 6-97 – RCC Hole Environment

A 0.75 inch diameter hole in the RCC was assumed for analysis purposes. Figure 6-97 shows the heat flux and pressure environment at the hole while Figure 6-98 shows the resulting RCC surface temperature as a function of time. The predicted RCC temperature of approximately 4800°F is assumed to be consistent with a diffusion-limited erosion regime for bare or uncoated RCC. With this assumption, the erosion or hole growth rate measured for the 2800°F arc jet tests can be used for erosion rate estimates here. The erosion rate in this flight environment and regime is .0032 in/sec. Figure 6-99 reveals the results of the analysis and shows the predicted growth to a final OML diameter of 4.0 inches. The predicted IML (back-face) diameter is slightly smaller at 3.0 inches. Extrapolation of this analysis to higher RCC temperatures (sublimation regime) or larger initial hole diameter is not recommended since the data base is very limited.

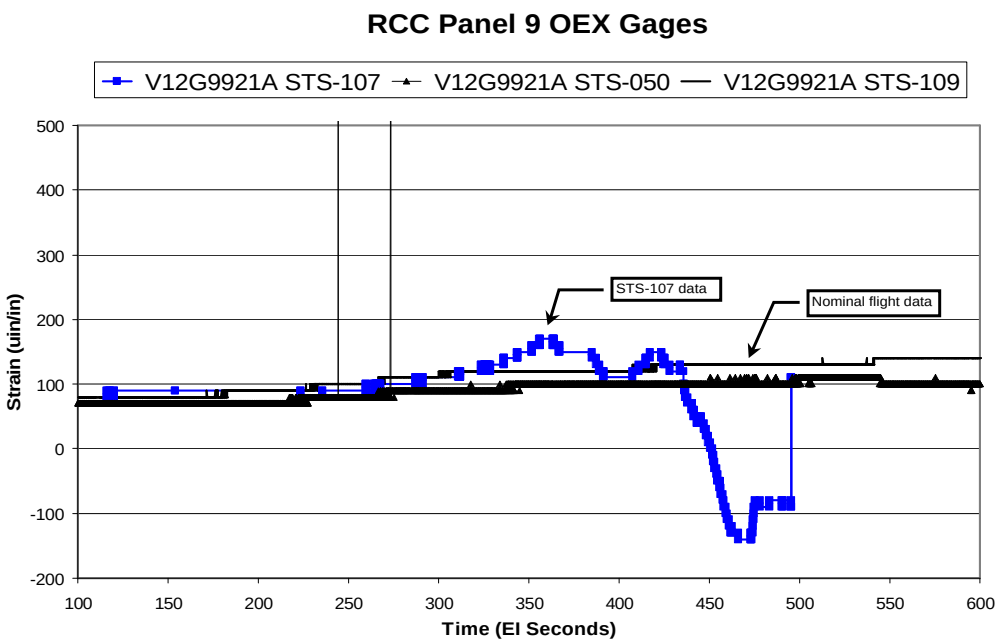
Figure 7.1-1 STS-107 V12G9921A strain gage data overlay with nominal strain gage flight data.

The objective of this analysis was to determine how a significant thermal event in the WLE spar would influence shear strain readings in the spar web shown in Figure 7.1-1. The location of the strain gage is shown in Figure 7.1-11. Primary focus was placed on thermal loading because mechanical loading would not produce the type of shear strain responses seen; maneuver type loads would have been seen on other strain gages and would have registered on the flight control systems. Mechanical load deviations would also be of relatively short duration. Pressure differentials across the WLE spar web would produce out of plane bending, but would not contribute to the shear strains in the web.

The two primary characteristics of the curve that need to be explained are the increase in shear strain with a sudden sign reversal. In addition to recreating the shear strain trends, interest was placed on how close to the thermal event would shear strain gage V12G9921A need to be to record the type of signal seen on STS-107. This gage is located roughly in the middle of the spar web near WLE panel 9. The thermal effects will register on the WLE spar strain gage even though it is some distance from the thermal event. Thermal sensors in the vicinity of panel 9 did not respond to a thermal event until much later. The quick response of the strain gage compared to the thermal sensors allows it to be used as a remote thermal sensor as shown in Figure 7.1-2. Near the boundary of a local thermal event, peak strains are expected because of the large thermal gradient. With increased distance from the thermal event the load will redistribute as illustrated and the influence of the thermally induced strain will eventually become negligible compared to the mechanical strain.

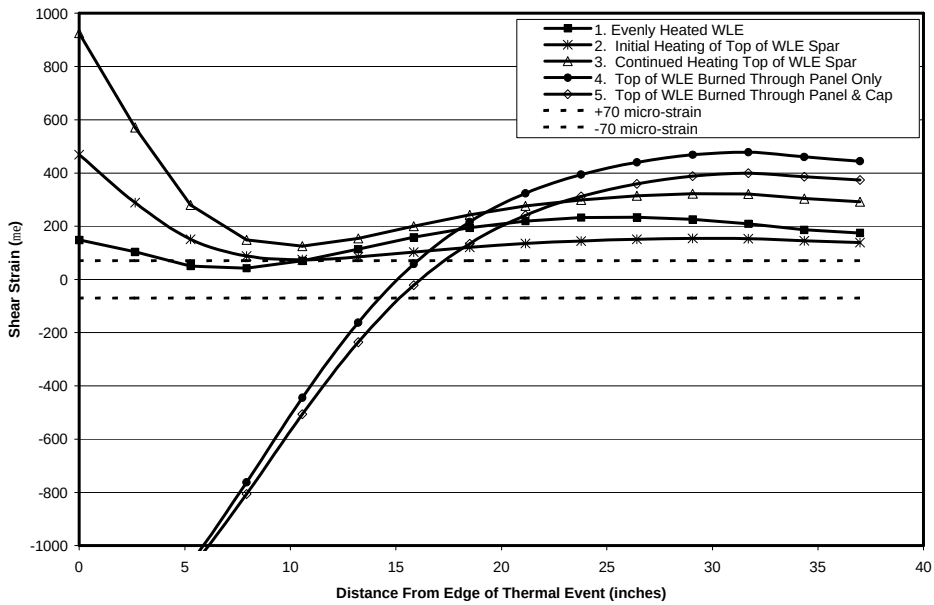
Figure 7.1-8 Shear strain results along midspan of WLE spar outside of the thermal event.

The shear strain results along the mid-span of the WLE spar outside of the thermal event for the five cases are shown in Figure 7.1-8 . The dashed lines on the chart show the amount of increase in shear strain that was seen during STS-107.

Thermal case one shows an increase in shear strain magnitude along the middle of WLE from the edge of thermal event outward but no significant magnitude. It is also noted that the sign remains the same for all locations plotted.

Thermal event five is very similar to case four with increased magnitude. At distances less than 16 inches from the thermal event boundary the shear strain sign is negative and for the range of 16 to 23 inches from the boundary the shear strain is less than noted in the undamaged structure. With increased distance from the thermal event boundary the shear strain magnitude decreases and is relatively unchanging at distances greater than 26 inches from the thermal event boundary.

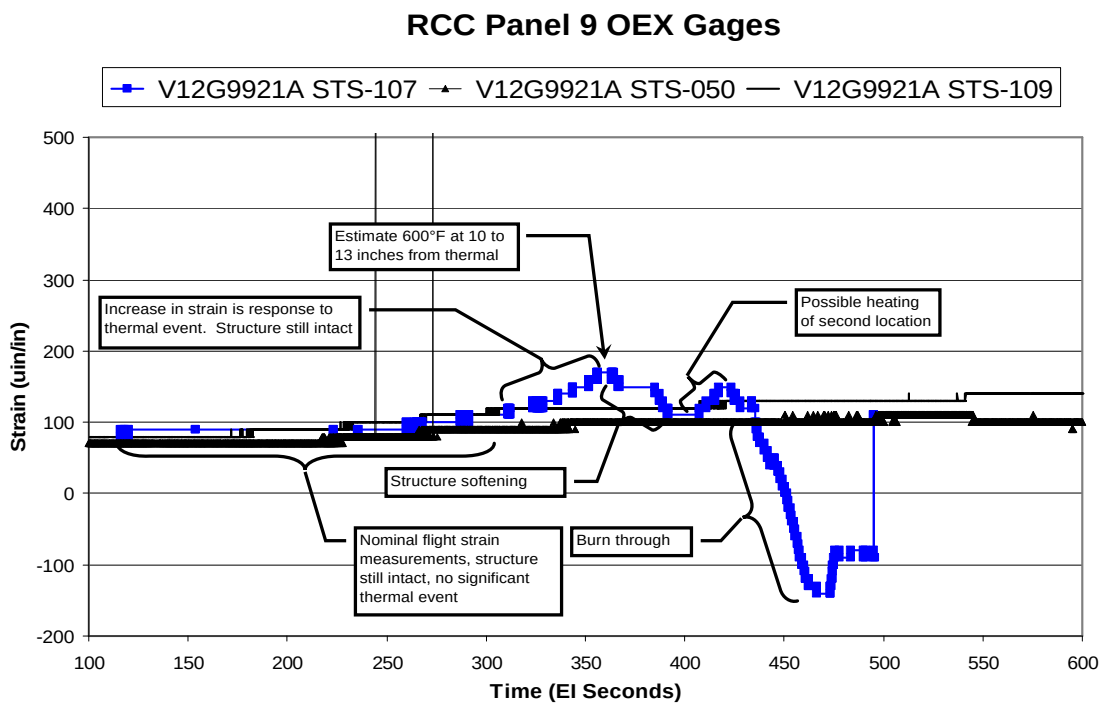
In summary, the main conclusion of this hypothetical scenario is that a loss of WLE spar structure is needed to reverse strain. Although this probably started as a facesheet debond or loss of modulus, it eventually proceeded to loss of the aluminum through melting. Secondly, the strain gage would need to be located in close proximity to the thermal event to record the type of signal seen for STS-107. For this scenario the strain gage would be located within 15" of edge of thermal as shown in Figure 7.1-8.

Figure 7.1-9 Scenario description overlay with nominal strain OEX strain gage data

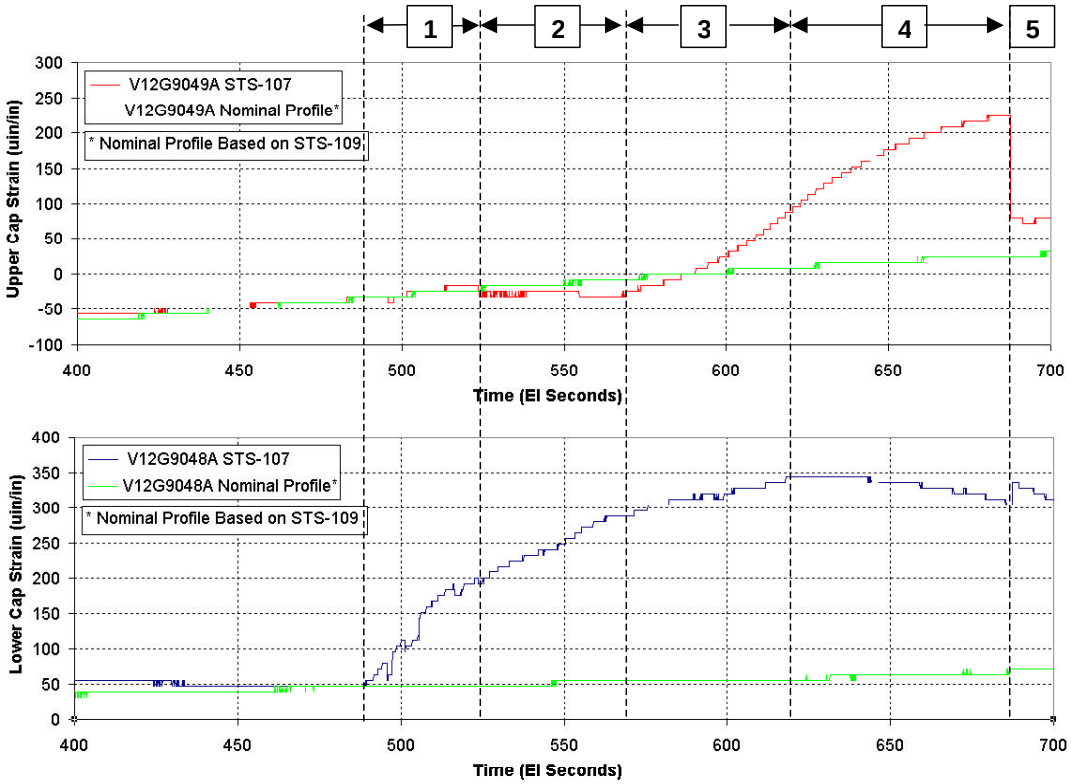
Figure 7.2-2 Observed STS-107 Strain Data versus Reconstructed Nominal Profile

As-recorded STS-107 data was refined in order to isolate suspected off-nominal behavior from nominal loading effects. To do so, a nominal profile, based on STS-109 (previous OV-102 flight) was compared with the recorded data. EI+488 seconds was chosen as an initial data point, up to which STS-107 data is considered nominal. The offset between STS-109 data and STS-107 data at this time was removed to generate a reconstructed nominal profile. Figure 7.2-2 illustrates the as-recorded STS-107 data versus the reconstructed nominal profile, based on STS-109.

Differentials between the nominal profile and the as-recorded profile represent strain values due to off-nominal loading during STS-107.

2. (EI+523 to EI+569 seconds)
   Reversal causes minimal compression (-16 µin/in) in the upper spar cap.
   Tension continues to build to 232 µin/in in the lower spar cap.

3. (EI+569 to EI+618 seconds)
   Another reversal causes significant tension (72 µin/in) in the upper spar cap.
   Tension builds to a maximum (288 µin/in) in the lower spar cap.

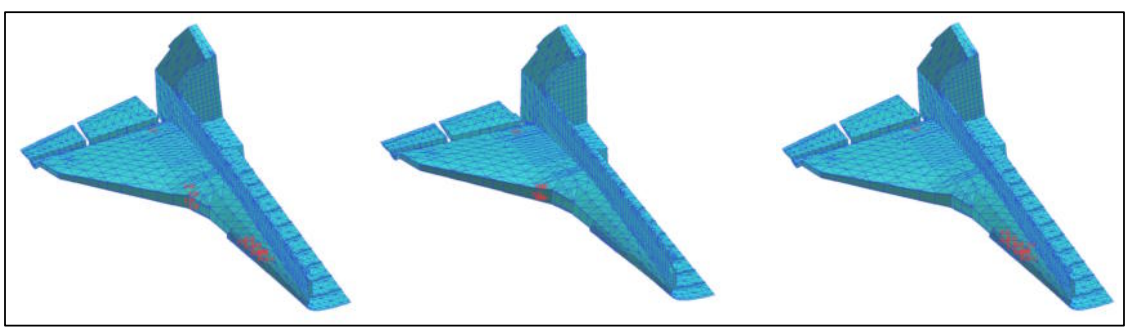
6-1. Generic Honeycomb Modeling Tool.
6-2. Stress report - STS89-0537
6-3. SINDA/FLUINT Version 4.4, C&R Technologies, Littleton CO.
6-4. Alpha Star Corporation, “Phase II Final Report, GENOA Progressive Failure Analysis of X-37 Reusable Launch Vehicle (RLV) Program”, June 24, 2000.
6-5. GENOA

Illustrations of the case 1, 2 and 6 displacement violation nodes are shown in Figure 7.5-9. For case 1, the violations are located in the glove area and near the WLE spar. This is consistent with a loss of load path between glove area and Xo1040 spar. The change in magnitude from undamaged to damaged are relatively small (0.11 inches), however. For Case 2, displacement violations are located at the WLE, which is consistent where the damage was located. As previously stated, the maximum delta deflection was 0.24 inches. The load path between the Xo1040 bulkhead and glove area has been restored, resulting in no violations in the glove area. For case 6, displacement violations are located at the wing glove area, suggesting that the lower panels help provide structural rigidity to elements of the Xo1040 spar.

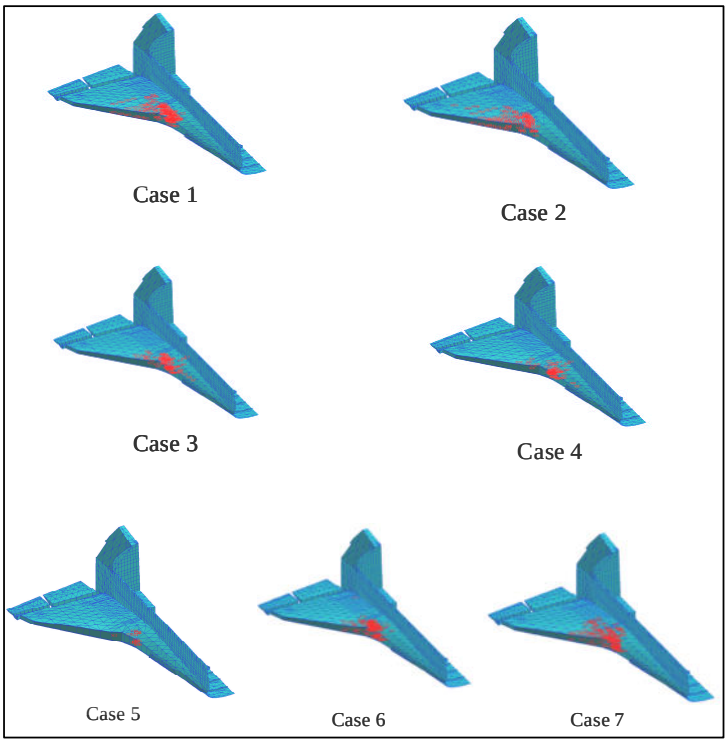
Figure 7.5-10 Stress/Force Violation Dispersions per Case

The stress violation dispersions illustrate load re-distributions within the wing. Dispersions for each of the cases are shown in Figure 7.5-10. Note that cases 2 & 7 show the widest area of dispersion. Case 2 load ratios are highly concentrated around the damaged WLE spar web, with some ratios scattered aft. Suggesting that there is not much load transfer moving toward the inboard wing structure. Case 7 also has high ratios around the damage area, but shows loads being distributed toward the wing-to-fuselage interface. Cases 4 & 5 show the least amount of dispersion, suggesting that the loads being routed around the wheel well is being more evenly distributed than with cases 2 & 7. Highly concentrated load

redistribution is observed for case 1, 3, & 6 around the area of damage. However, the dispersion does not move inward or outward.

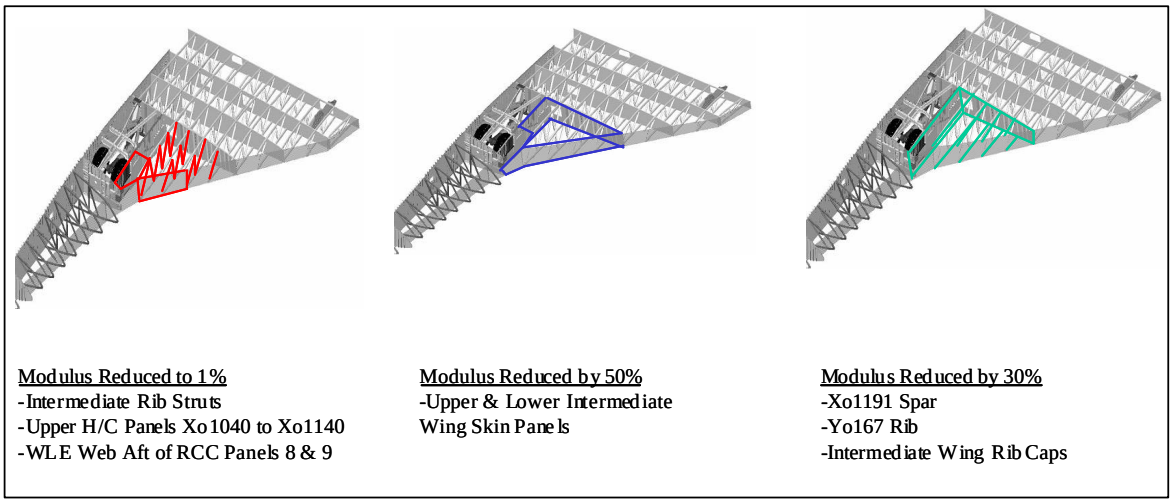
Figure 7.5-11 Refined Wing Damage Case

The study was primarily focused on damage to the intermediate wing section. An attempt was made to model damage as closely as possible to the most probable failure scenario on STS-107, i.e., WLE spar breech at RCC panels 8 & 9. Three types of damage were applied to the FEM for this analysis. The first damage type was at areas where hot gas impingement was assumed to fail the structure. Susceptible structures were all the rib struts in the intermediate wing, the WLE spar behind RCC panels 8 & 9 and the top honeycomb panels just outboard of the wheel well wall. The modulus in these areas was set to 1% of their normal value. The second type of damage was concentrated on the upper and lower intermediate wing panels. The assumption was that the skin panels were affected by hot gas ingestion into the cavity, but not failed. The stiffness for these structures was reduced by a factor of two. The final type of damage was at the intermediate wing rib spars, Yo167 rib and the Xo1191 spar. Hot gas ingestion was assumed to lower the modulus of these locations by 30%. Refer to Figure 7.5-11 for the damage areas and modulus reduction values.

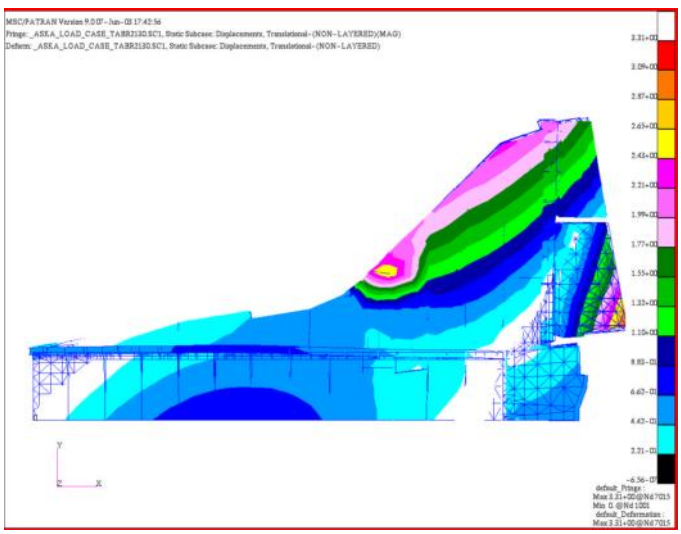
Figure 7.5-12 Refined Wing Damage, FEM Deformation Plot

Figure 7.5-12 shows the deflection of the wing with the refined damage. Significant distortion occurs around the intermediate wing just aft of RCC panels 8 & 9. Beyond this region, the wing deflections increase towards the wing tip. No significant deflections occur inboard of RCC panels 8 & 9. This is due to a denigrated load path from the outboard wing to the inboard wing.

Wind tunnel testing indicated that deflections of up to five inches are required to emulate the aerodynamic profile experienced during STS-107. These results show that the aerodynamic load at Mach 18 was not able to achieve overall wing deflections of this level, even with severe damage.

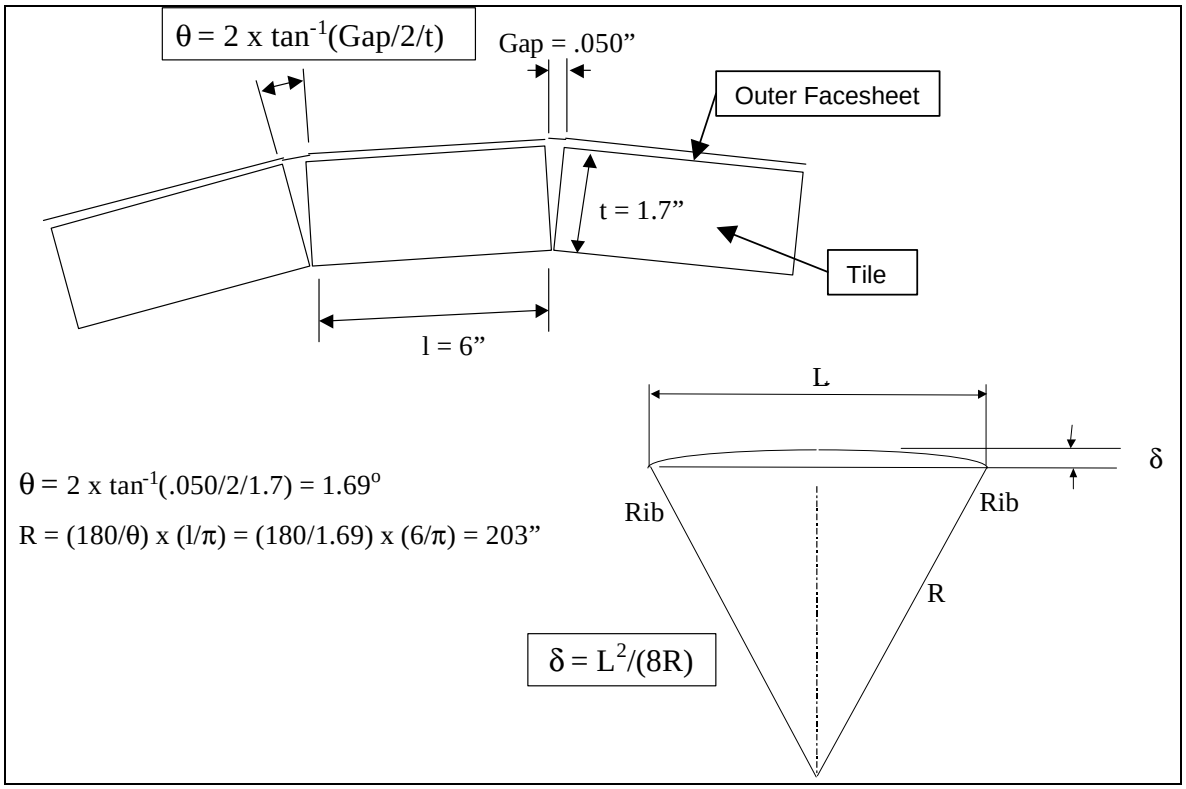
Figure 7.5-13 Calculations for Outer Facesheet and Tile Deflection

The hand analyses show that larger deflections are possible if a face sheet de-bond occurs. Note that this local, non-linear deflection scenario was not modeled in the FEM. The hand analysis results are shown in Table 7.5-13 and Table 7.5-14, with the wing panel layout shown in Figure 7.5-13. The results indicate that deflections are still relatively small without the loss of any ribs. Expanding the analysis to include damaged ribs, however, indicates that deflections of up to 5” are possible with the loss of three ribs and debond of the inner facesheet.

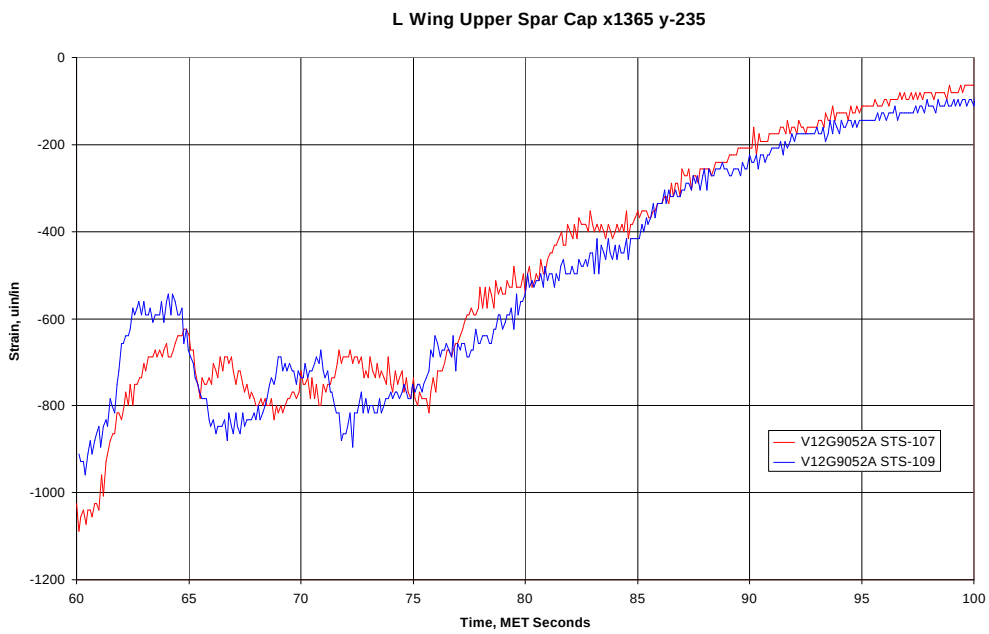
Figure 7.6-7 Interesting Signature Near Suspect Debris Impact Event

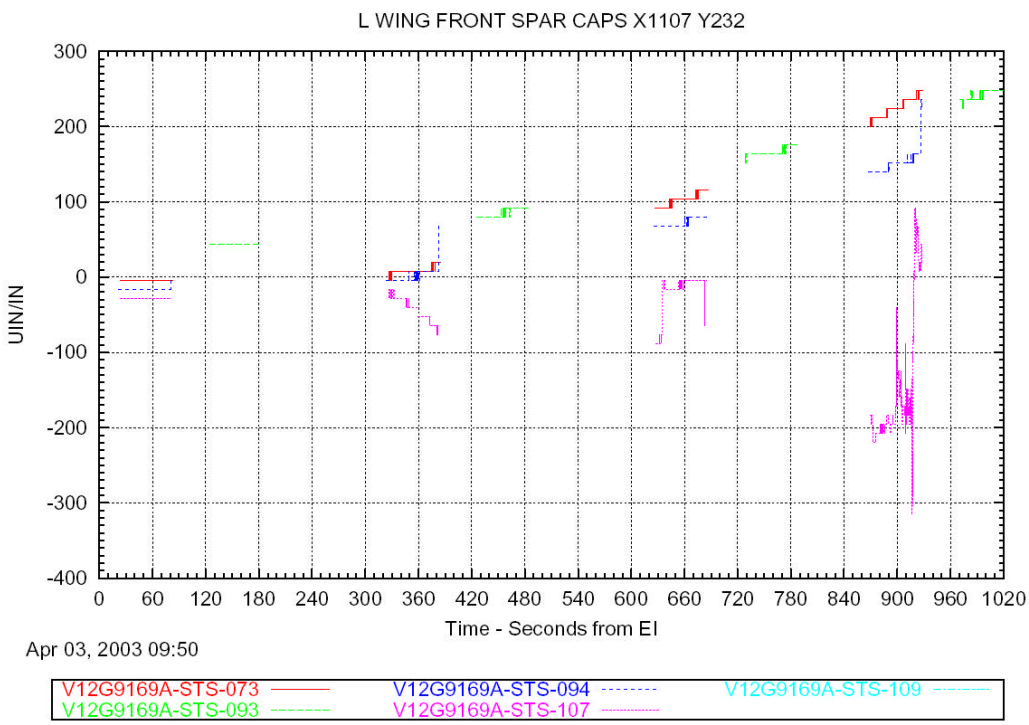
Figure 7.6-9 PCM3 Entry Response With Suspected Off-Nominal Trend

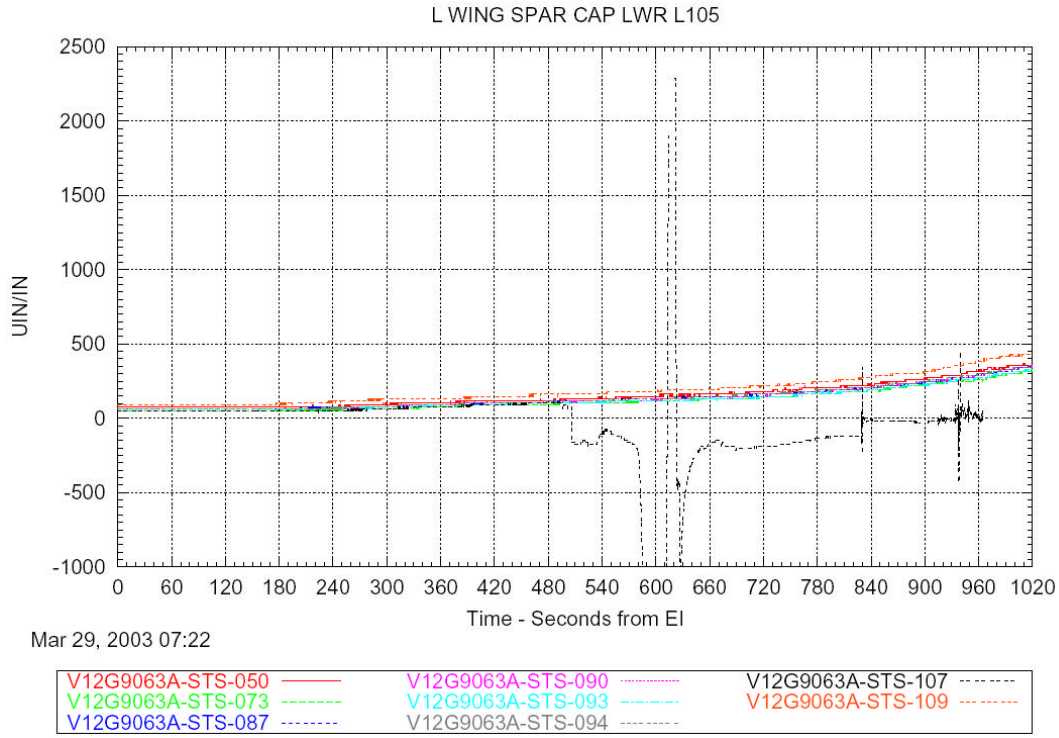
Figure 7.6-16 Left Wing Entry Gage Failure With Subsequent Nonzero Response

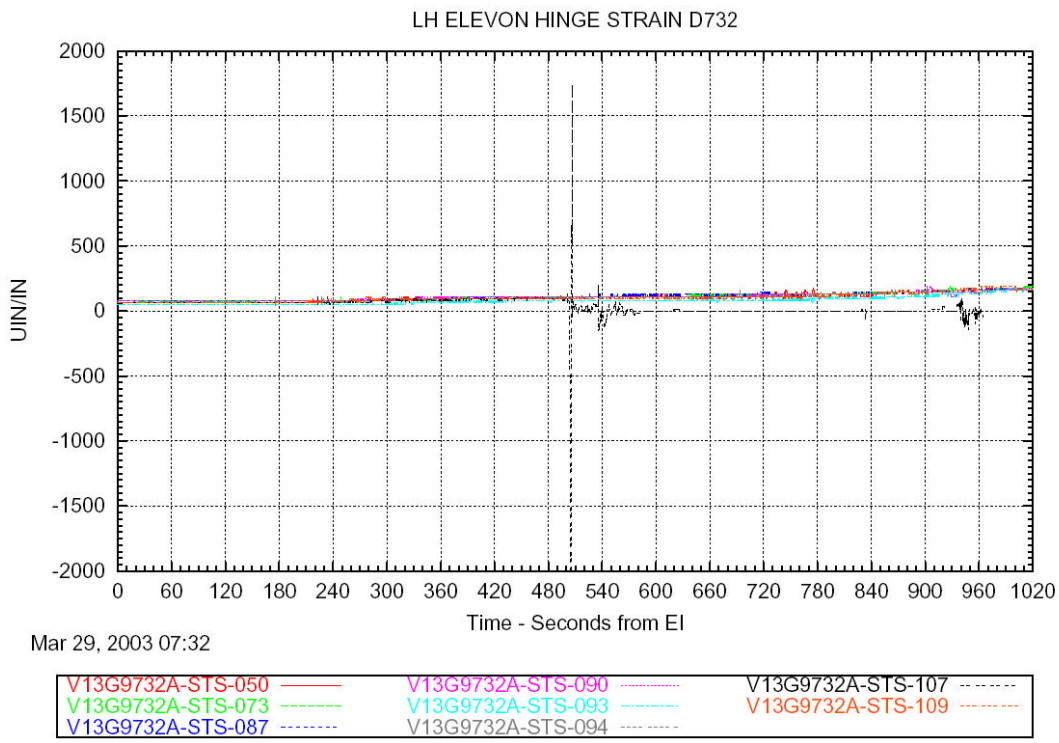
Figure 7.6-17 Typical Left Wing Elevon Entry Gage Failure
