Volume II

Appendix D.15

Maintenance, Material, and Management Inputs

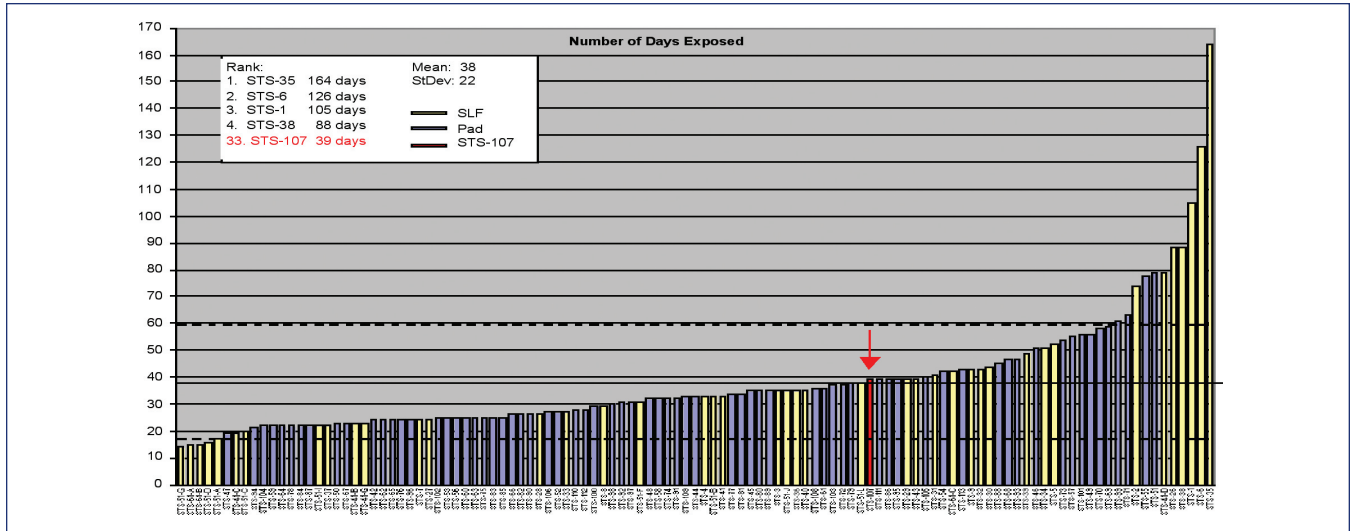
The 164-day exposure for STS-35 occurred over eight months and four launch attempts, from April to December 1990, and illustrates the complexities associated with launching Shuttles. OV-102's initial rollout was on April 22; a Freon system repair added 14 days, but the launch was scrubbed on May 30 due to a Main Propulsion System (MPS) liquid hydrogen (LH2) leak. After troubleshooting and maintenance preparations, OV-102 was rolled back to the VAB on June 12. It was rolled out a second time on August 9, but required a 6-day stand down for telemetry repair. Its September 1 launch was scrubbed on 5 September due to another hydrogen leak. Following maintenance at the pad, the next launch attempt was scrubbed on September 18, due to another MPS LH2 leak. After further troubleshooting and maintenance preps, it was rolled back on October 9. Rollout next occurred on October 14, followed by special LH2 tanking tests for two additional days; however, Auxiliary Power Unit water valve problems and follow-on maintenance and servicing took another 16 days. OV-102 finally launched successfully on December 2. It should be noted that STS-35 is an outlier when compared with all other Shuttle launches. Figure 1.3.2 shows a comparison of exposure time by mission.

Figure 1.3.2. Exposure by Mission: red arrow depicts STS-107, STS-35 is at far right.

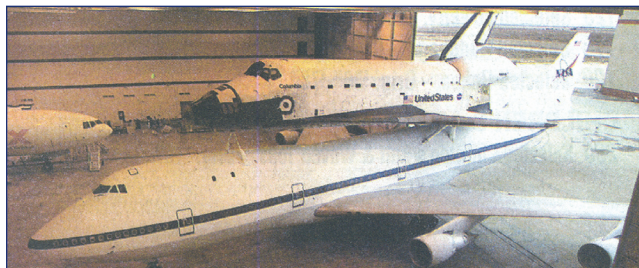
Aircraft (SCA) for a ferry flight to Palmdale, California, it was caught in the rain; 128 pounds/16 gallons of water were removed after its arrival at Palmdale. In February 01, after OV-102 had been mated to the SCA for its return from Palmdale to KSC, it was again caught in a downpour. The mated Orbiter/SCA were partially sheltered in a hangar but, due to

Figure 1.3.4. An Orbiter and SCA partially inside a hangar in Palmdale.

vertical clearance limits, the tails of both craft remained exposed (See Figure 1.3.4). After arrival at KSC, 112 pounds/14 gallons of water were removed. The same February 2001 rainstorm at Palmdale also affected OV-104, which had recently landed (February 20/STS-98) and was being prepared for its ferry flight to KSC. OV-104's "aft fuselage under bay 6 [was] full of standing water" and water was "five inches deep along [the] back of 1307 bulkhead;" 1,600 pounds (200 gallons) were removed after its arrival at KSC.

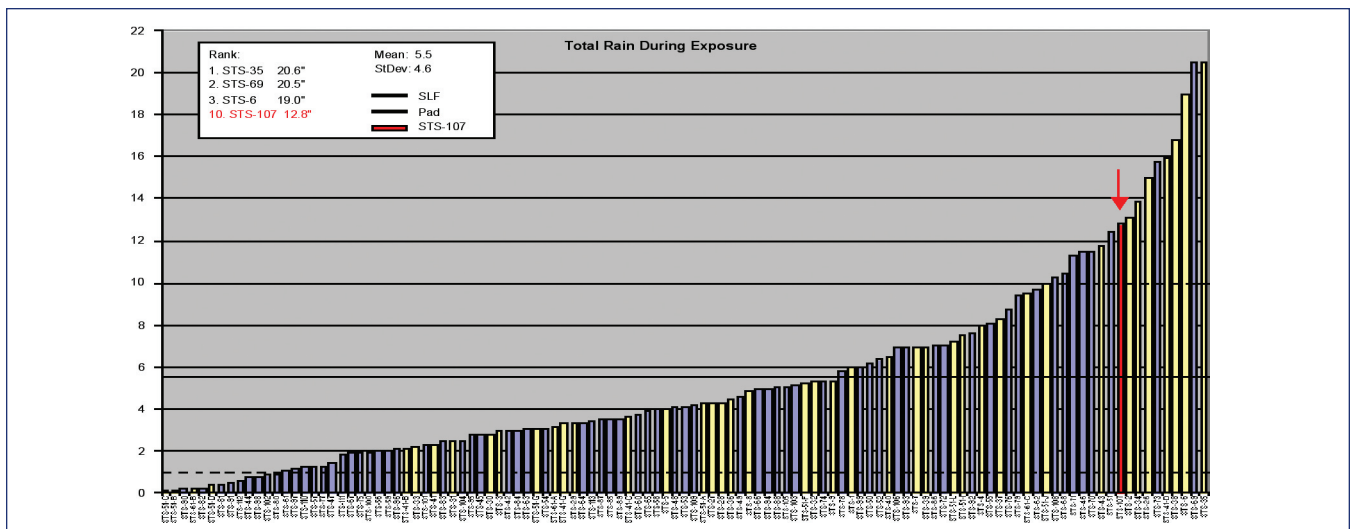
Environmental exposure constraints are clearly outlined in RTOMI S0018.100, Adverse Environmental and Lightning Monitoring at LC39. This publication includes guidance on actions to minimize exposure to rain, hail, winds, freezing temperatures, or tornados. In spite of this existing guidance, circumstances such as those related above, both on the launch pad and during ferry operations, contribute to more exposure than is desirable. Figure 1.3.5 shows rain exposure data by launch, with STS-35 again being the worst case.

Figure 1.3.5. Total rain exposure by launch (arrow denotes STS-107; STS-35 at far right).

Corrosion is a problem in both military and commercial aviation. Due to the Shuttle's critical mission and limited design life (originally projected to be between 10 and 20 years), as well as its now projected use for as much as another 20 years, strict adherence to existing guidance must be reemphasized on an ongoing basis. Furthermore, every opportunity to avoid/minimize/reduce exposure must be taken. Ground Operations should review launches where exposure was more than one standard deviation above or below the mean (Figure 1.3.5.) for lessons that may be applied to reduce exposure. Finally, as some amount of exposure is unavoidable, the Space Shuttle Program must have an intensive corrosion program of inspection, treatment, and prevention. Such a program will factor into the fledgling Service Life Extension Program.

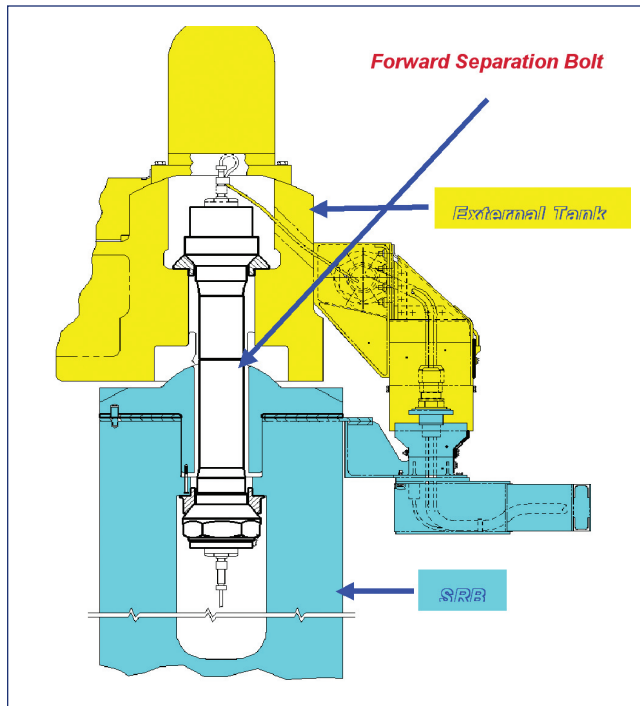
Figure 1.5.1. Diagram of a bolt catcher.

The configuration of the current bolt catcher flight hardware differs significantly from the original qualification test configuration.⁶ First, the attachment of the bolt catcher used in the original test fixture was qualified using through-bolts into a metal that was dissimilar to the ET/SRB attach point. The mounting method used for flight hardware (including STS-107) is bolts threaded into inserts. Second, original catcher testing did not have the SLA applied. Third, the original design load expected during bolt separation was determined to be 29,800 pounds in the 1979 timeframe. During initial tests the bolt catcher failed at the weld. The reason for this failure was determined to be overly rigid honeycomb, which led to the redesign of the honeycomb to reduce its static pressure capability from 1400 to 1000 psi. Finally, during the original test, temperature and pressure data were not recorded for the bolt firing. Instead of conducting additional tests, the flight design configuration was accepted by analysis (of extrapolated test data and the redesign specifications) and similarity. Consequently, predictive failure analysis, in the absence of post-flight evidence for examination (the bolt catcher and upper half of the separation bolt remain with the external tank and are therefore lost on reentry), must also be

In the absence of physical evidence and adequate test data to measure bolt catcher performance against, it must be assumed that the bolt catcher could have played a role in damaging the left wing LESS of *Columbia*. Specifically, the dome could have catastrophically failed at the weld, SLA coating could have come off (in adequately large quantity to damage the shuttle), or a bolt/insert could have failed to hold. Review of radar imaging data reveals objects were liberated from the STS-107 stack at the time of SRB separation (approximately 126 seconds).⁷ Much of this debris is from known sources aft of the Orbiter, and do not present a threat to the vehicle. However, the radar data has been inconclusive, to date, as to whether the bolt catcher could have been a part of the separation debris. Several other methods will be used to investigate the bolt catcher's potential as a source of damage to the LESS Thermal Protection System on *Columbia*. First, review of existing, but limited, data from STS-107. Second, a new set of tests of the as-flown configuration is being performed to better characterize the bolt catcher performance parameters.

The first two Harris bolt catchers failed at an equivalent static load of 54 KIPs (+/- 2 percent), and 57 KIPs (+/- 2 percent), respectively. The third static test (using a Summa manufactured catcher) produced the most alarming results. This catcher failed at 44 KIPs (+/- 2 percent). The second dynamic test of a separation bolt firing produced a derived load on the bolt catcher of 46 KIPs (+/- 10 percent). If these results are consistent with the remaining tests, the factor of safety would be 0.956 for the bolt catcher and is significantly under the NASA design requirement of 1.4. The results of this test do not eliminate the bolt catcher from fault tree consideration and may imply a significant weakness in NASA’s method of certification of critical systems by analysis and similarity.

Remove all remaining Summa and Harris catchers from service until testing is complete (including x-ray evaluation of all welds). Attempt to determine the Factor Of Safety on the Summa bolt catcher and the likelihood that STS-107 experienced an in flight failure of the Summa bolt catchers. Complete design upgrades to the SRB Bolt Catcher and perform qualification testing to certify the new configuration for flight use.

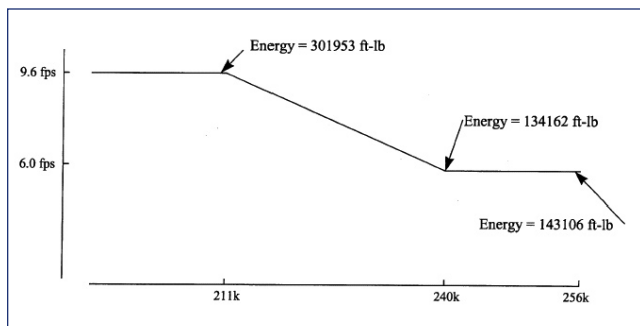
Based on a 6.7 fps sink rate and 11 knot crosswind, reconstructed gear loads were determined to be less than half of design limit load. Figure 1.8.1 shows how energy levels decrease with lower sink rates and landing weights and explains how design criteria can be exceeded without exceeding structural capability. This was verified using MADS accelerometer and strain gage data.

Figure 1.8.1. Energy Levels Based on Sink Rate/Landing Weight.

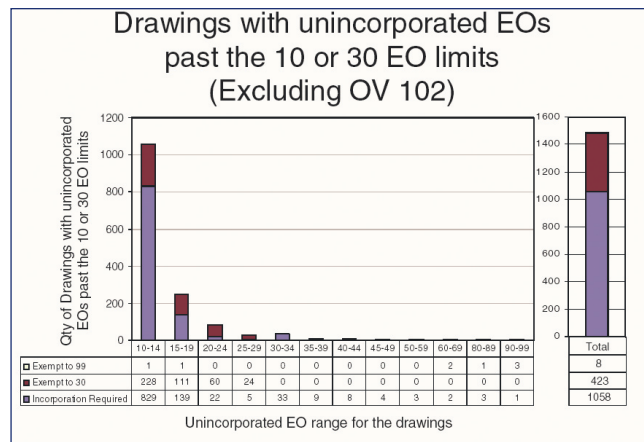
"Previously, the Panel has been concerned with the large number of Orbiter drawings that are out of date. Many EO changes have not been incorporated into the drawings. Although they are noted on the drawings, engineers must refer to additional paperwork to understand the state of the hardware systems. Over 1600 drawings have more than 10 unincorporated EOs. The Orbiter program will update and incorporate all EOs on 59 of the most frequently used drawings by the end of 2003. Also during the year, an effort to address the 589 drawings referenced most frequently after those 59 will begin. Orbiter program management has committed to maintaining the upgraded drawings at no more than 10 unincorporated EOs. The Orbiter Project is now

Figure 2.1.1. Unincorporated Engineering Order statistics.

Figures 2.1.1 and 2.1.2 show the status of the Shuttle Program's technical data in two graphics. The first shows the number of drawings that have greater than 10 unincorporated EOs each. The total figure, as mentioned above is 1,058. However, the significance of this number is further emphasized in the columns that have larger numbers of unincorporated changes but are supposed to be limited to no more than 10 unincorporated changes. Specifically, 90 have more than 20 EOs and 21 have over 40 unincorporated changes. The second graphic shows the number of total releases (new or updated technical drawings or specifications) by year. Over the last 10 years there has been a steady decrease in the number of new releases but incorporations have remained at a significantly lower level and at a relatively slow pace. In 2001 NASA accelerated this pace and has continued at this rate since then.

reviewing the possibility of identifying the safety-critical drawings that should always be kept current. Recommendation 02-8: Identify drawings that are critical to flight safety, update them to include all EOs, and keep them current.”¹¹ (See Figures 2.1.1 and 2.1.2.)

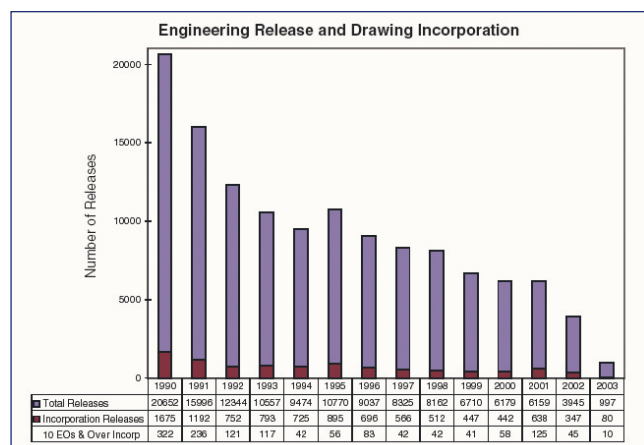
Figure 2.1.2. Engineering Release and Drawing incorporation statistics.

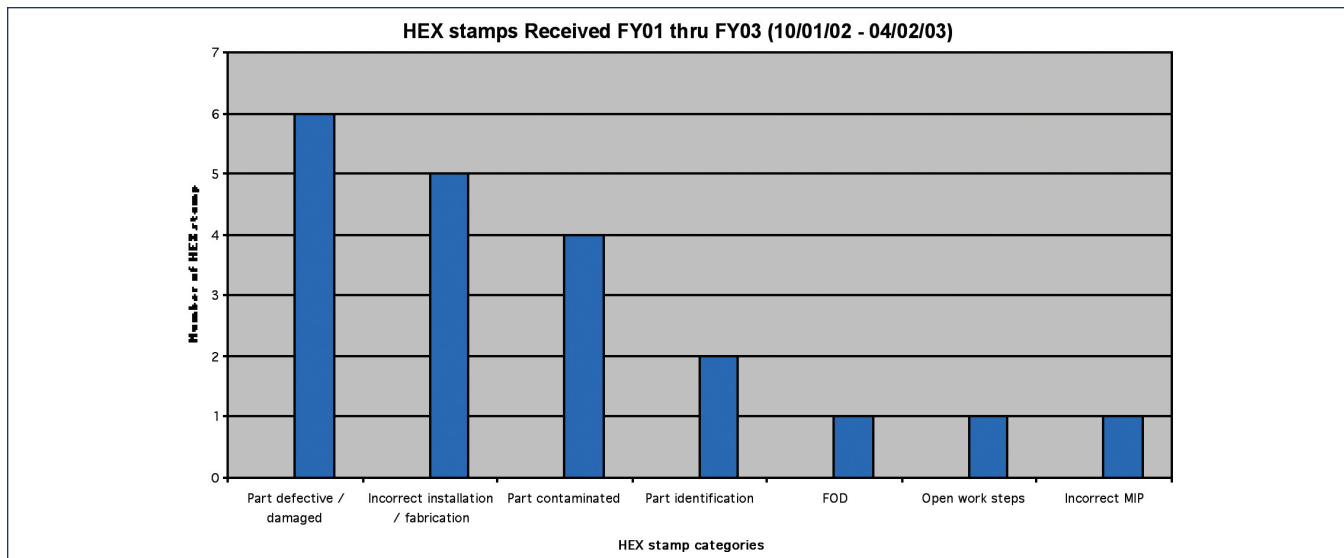
Feedback to members of the Board reflected that NASA QA inspectors feel they do not have authority (or are discouraged from doing so) to reject USA work. Consequently, NASA S&MA does not track reject rates (hexagonal-shaped stamps applied to WADs by S&MA inspectors) for occurrences in which a NASA QA inspector might reject a job closed out by a USA quality inspector. They also assert that inspectors are only authorized to use their Hex stamp to notify the contractor to “stop work.” Use of the Hex stamp is apparently rare, presumably due in part to overall inspector reluctance or potentially NASA’s lack of metrics to track hex stamp issuance. The following data was retrieved for use in this report. Total inspections conducted from FY2001 through

Figure 2.2.1. HEX stamps received between October 1, 2002 and April 2, 2003.

March 2003 that would have been subject to potential hex stamp use were 141,247. During that same period only 20 hex stamps were issued for various operations. (See Figure 2.2.1) HEX stamps received in FY2001, FY2002, and current FY2003 have been reviewed and the conclusion drawn is that the number of HEX stamps received compared to the number of inspection opportunities and hardware items completed/shipped provided too few data points for extensive analysis. According to several sources, this practice has been curtailed due to previous practices of using the stamps as a “hammer” against the contractor. The more common practice is for the inspector to refuse to buy the discrepant job, and offer to come back later once corrective action is taken. Such instances are not tracked by any measurement.

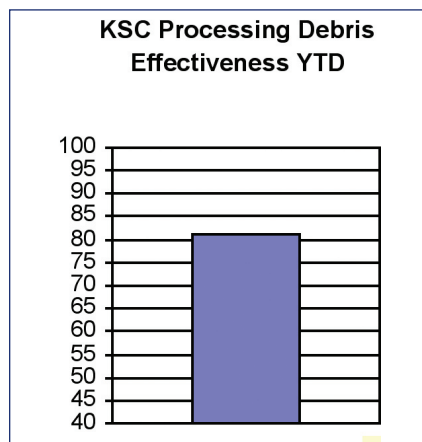
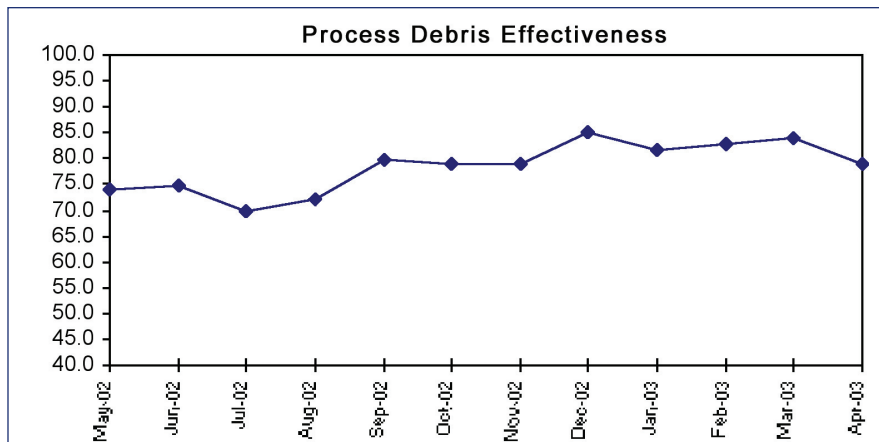
The NASA FOD program does have some outstanding aspects. The USA FOD program includes daily debris walk downs by management to ensure workers comply with the “clean as you go” USA policy. This program is noteworthy but statistics kept by USA show its success rate varies between 70 and 86 percent.²⁶ (See Figures 2.2.2 and 2.2.3.) The danger of migrating debris begins while the job is in work. FOD prevention must be considered as critical as clean up, regardless of timing and division of labor between USA and NASA quality responsibilities.

Figure 2.2.2. Process debris performance metrics.

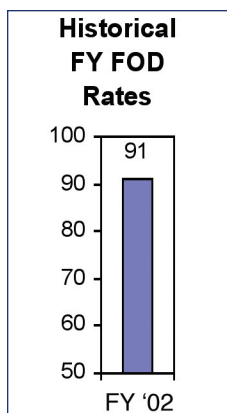
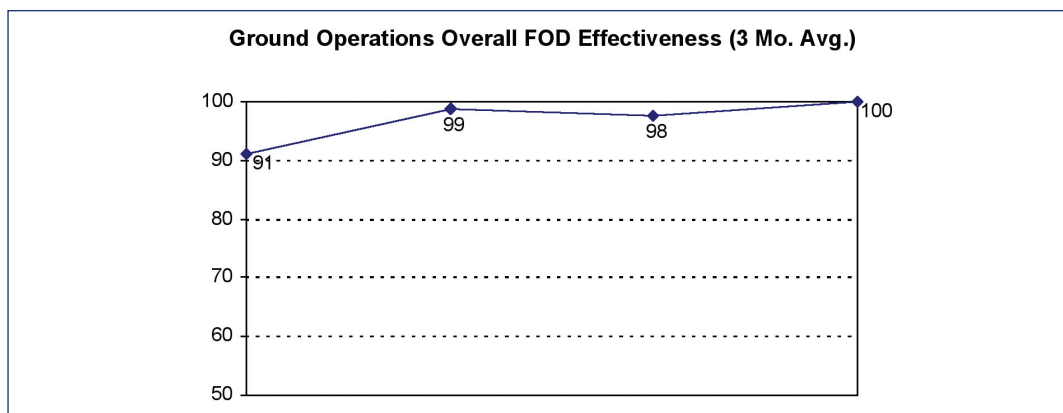
Figure 2.2.3. NASA FOD Metrics.

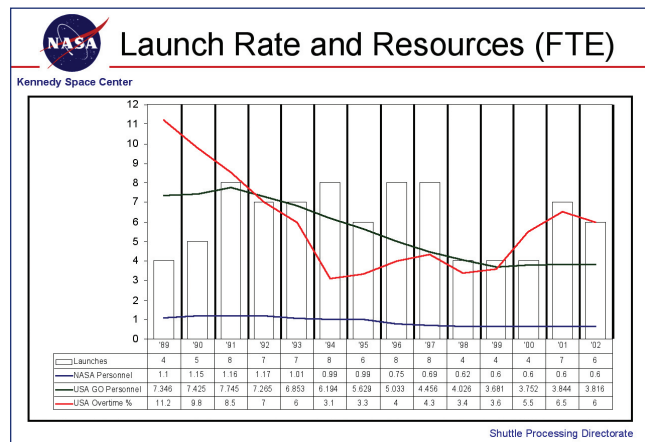
NASA's resources have been trimmed and processes streamlined in efforts to control/reduce the cost of operations (see Figure 2.4.1). While this has happened in many areas, one of the most obvious examples is the reduction of the combined NASA/USA workforce at Kennedy Space Center (KSC), which totaled over 8,800 in 1991. By 2002, this workforce had been downsized by slightly more than 50 percent to approximately 4,400. Shuttle launches over the same period had decreased disproportionately by only 25 percent, from eight to six. Another example of efforts to improve efficiency and lower costs was the relocation of Orbiter Major Modifications (OMM) from Palmdale, California, to KSC, starting with OV-103 (*Discovery*) in September 2002. Although the last four OMMs at Palmdale had required anywhere from 324 to 448 equivalent personnel, it was estimated that that OMMs could be supported at KSC with only 235 additional equivalent personnel due to more effective utilization of the existing KSC workforce. However, during the first 9 months of OV-103's OMM, an average of 307 EP have been required, a 31 percent overrun of the initial estimate.

Figure 2.4.1. Space Shuttle launch rate versus Full Time Employee resources.

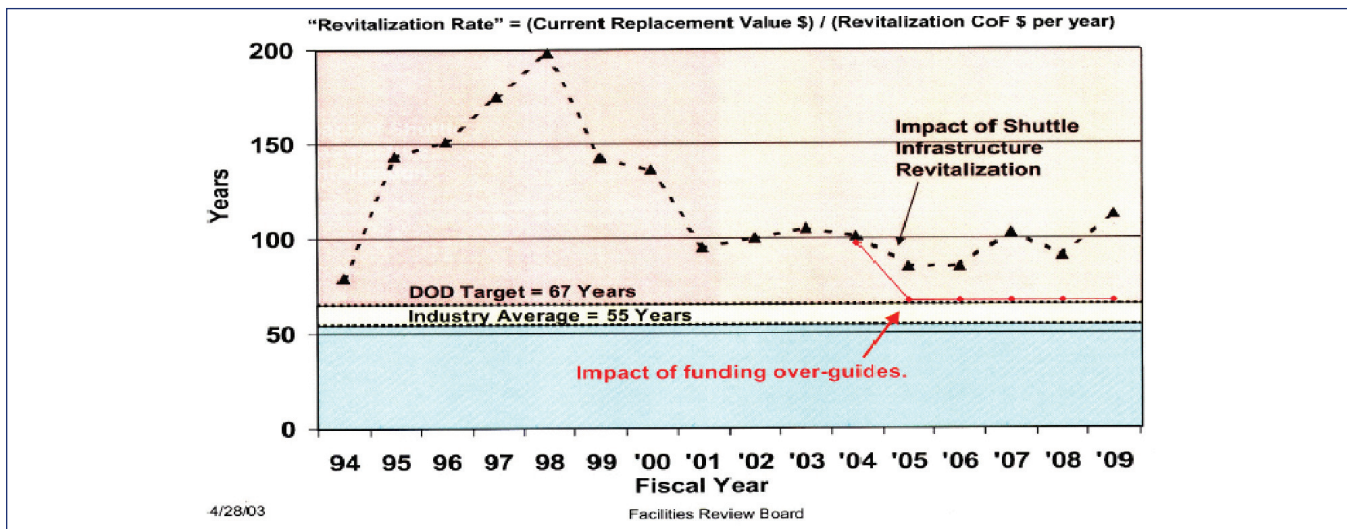
Figure 3.2.6. NASA Facility Revitalization Rates.

At the tactical level, KSC’s approach toward better schedule integration through the recent establishment of master planners for horizontal and GSS operations holds great promise. Their adoption of commercial practices, such as CorrPro’s Basecoat database, is also highly noteworthy, and they should explore further application beyond corrosion. KSC should do a cost/benefit analysis of building additional shel-

ters for its ground support equipment, much of which is left outdoors. They should also perform trending and analysis of infrastructure/ equipment support costs factored over unit of output wherever possible, rather than simply tracking costs, as rate comparisons will facilitate tradeoff/investment decisions. Finally, KSC should examine current launch pad maintenance practices and make every effort to reduce or, better yet, eliminate zinc fallout.
