STS-107 Image Analysis Team Final Report

This Appendix contains NSTS-37384, STS-107 Image Analysis Team Final Report in support of the *Columbia* Accident Investigation, 30 June 2003.

STS-107 Image Analysis Team
Final Report
in support of the
***Columbia* Accident Investigation**

June 30, 2003

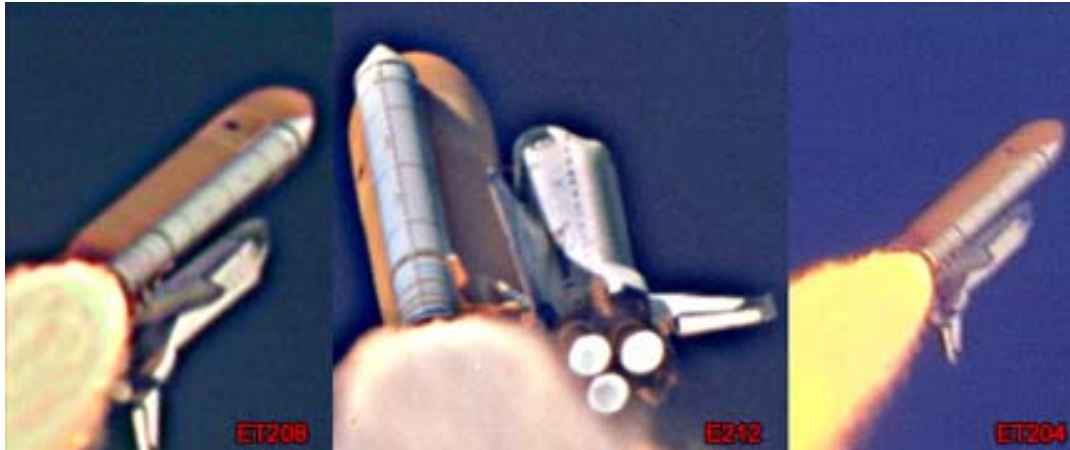
The ET-208 video camera provided the best view of the underside of the left wing and the debris strike area (Figure 4.1.1b). However, the moment of impact was not recorded due to insufficient time resolution of the imagery, limited by the camera frame rate. The

Figure 4.1.1b Frames from ET-208, E-212 and ET-204 cameras showing the respective views

The 35 mm film camera E-212 imaged the top side of the Orbiter's left wing, and provided the best high-resolution view of the debris before it disappeared behind the left wing prior to impact. The E-212 views show the debris as it is first seen originating from the vicinity of the External Tank (ET)/Orbiter -Y bipod attach area, and show the post-impact debris cloud and debris fragments.

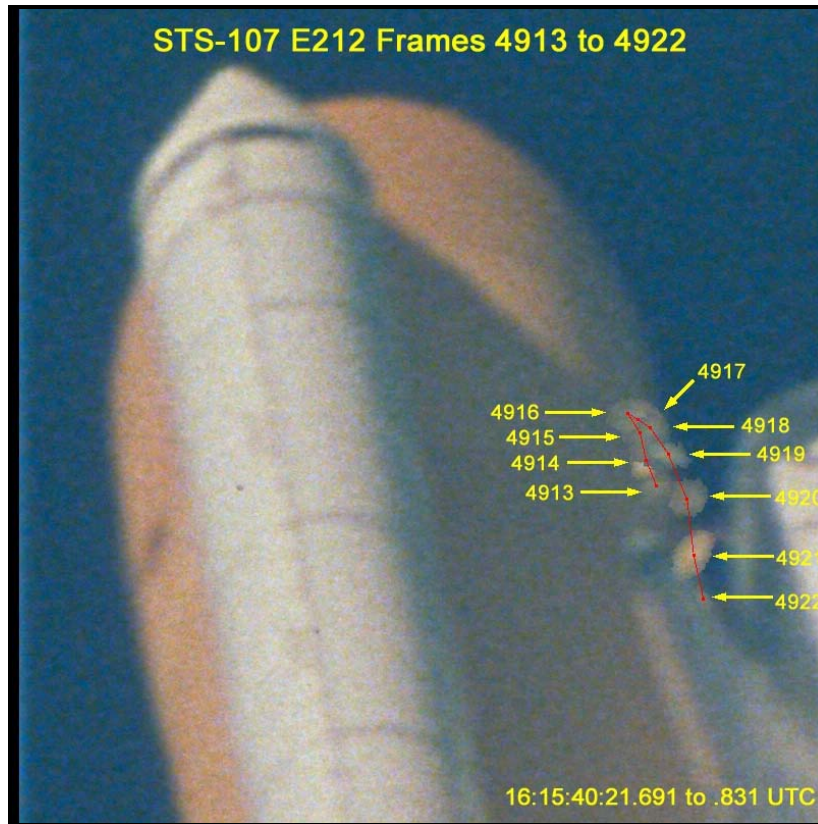
Figure 4.3.2.1e Composite image showing the trajectory of the major piece of debris (Object 1) mapped from camera E-212, frames 4913 through 4922.

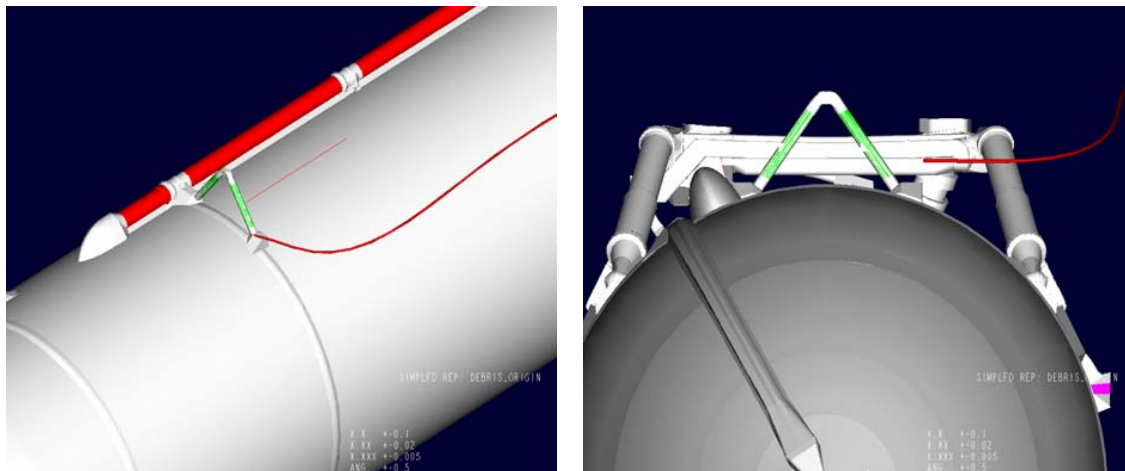
Figure 4.3.2.2b 3-D model of the debris trajectory (red curve) relative to the external tank, based upon ET-208 and E-212 camera imagery

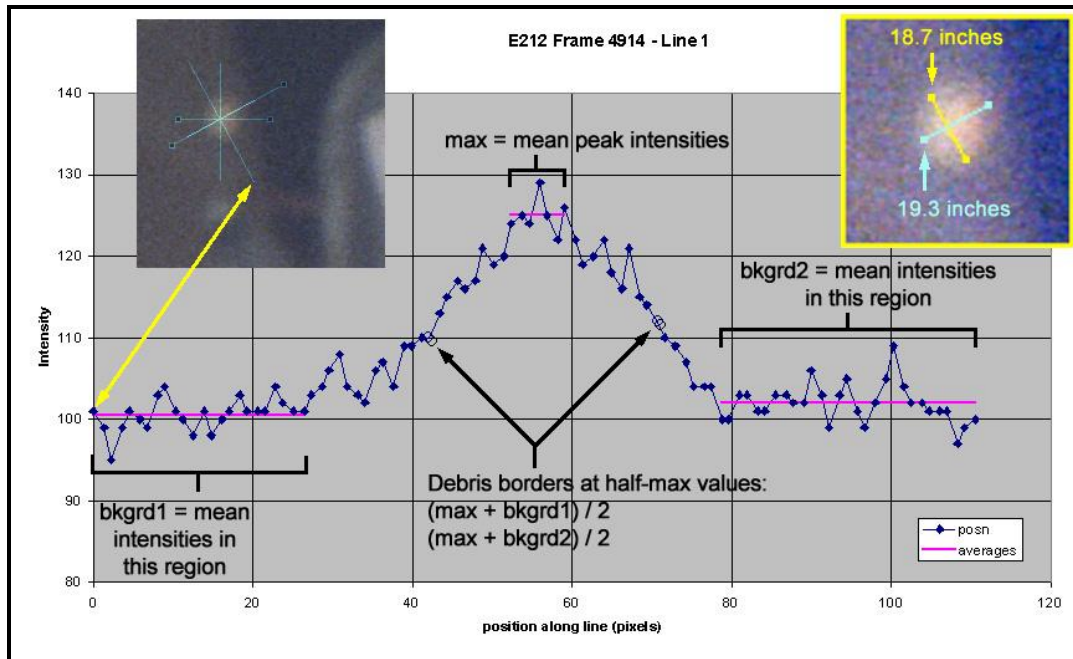
The uncertainty in the debris size measurements of approximately +/- 3 inches was derived from a +/- 2-pixel uncertainty in locating the debris borders at half-maximum values.

Figure 4.3.2.3 Debris size measurement methodology full width at half maximum intensity profile. The curve represents the image intensity values for a transect across the debris in one frame 4914, illustrated in the upper left image.

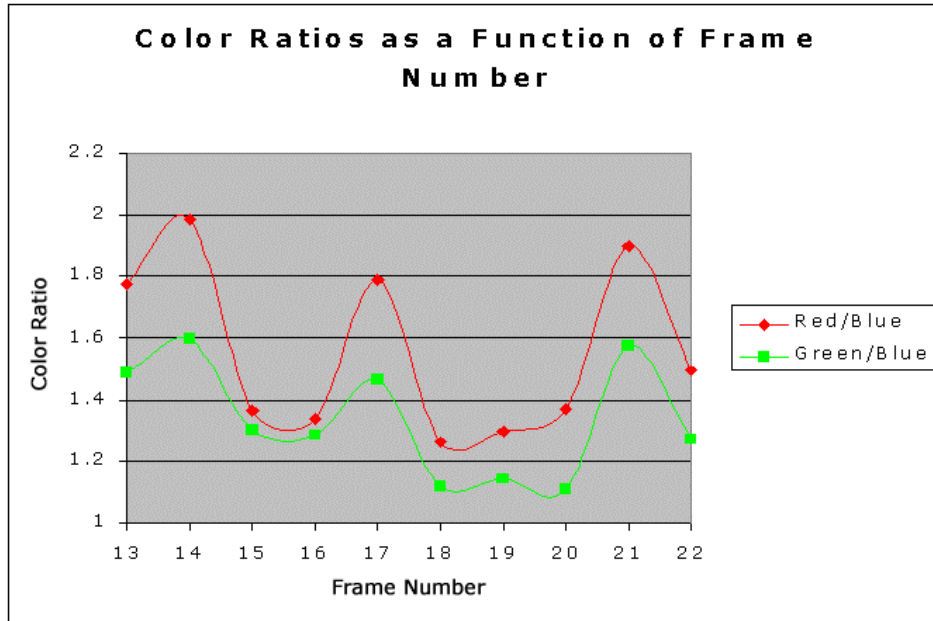
To begin the analysis, the red, green, and blue color channels of the debris were recorded for each frame on E-212 in which the debris was observed prior to impact. Ratios of the green to blue and red to blue were then calculated and plotted as a function of time (see Figure 4.3.2.4). The use of color ratios reduces the effect of variations in illumination and makes the analysis more sensitive to color change. The plot shows a definite sinusoidal pattern with a frequency of approximately 18 Hz. Details of this analysis are given in Appendix 4.3.2D. In the absence of any other data for measuring rotation, the best estimate of the debris rotation rate based upon the imagery is approximately 18 Hz.

Figure 4.3.2.4 Color ratio analysis of debris from E-212 frames

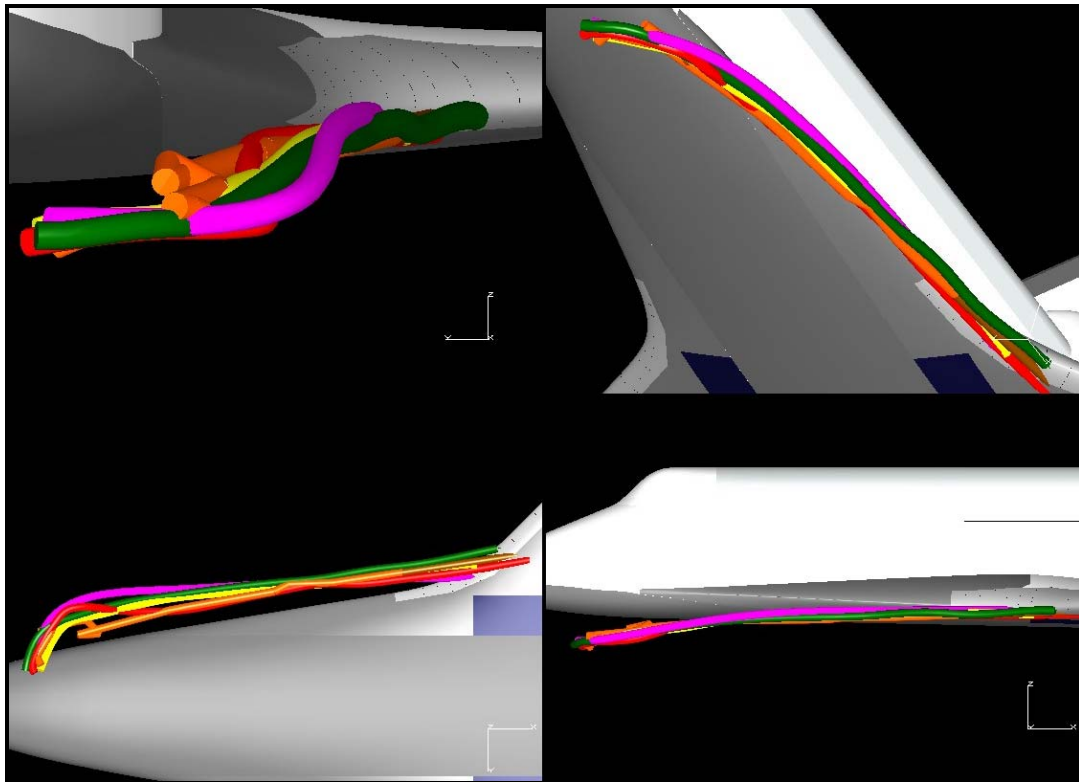
Figure 4.3.2.5a Debris trajectories derived by separate independent analyses.

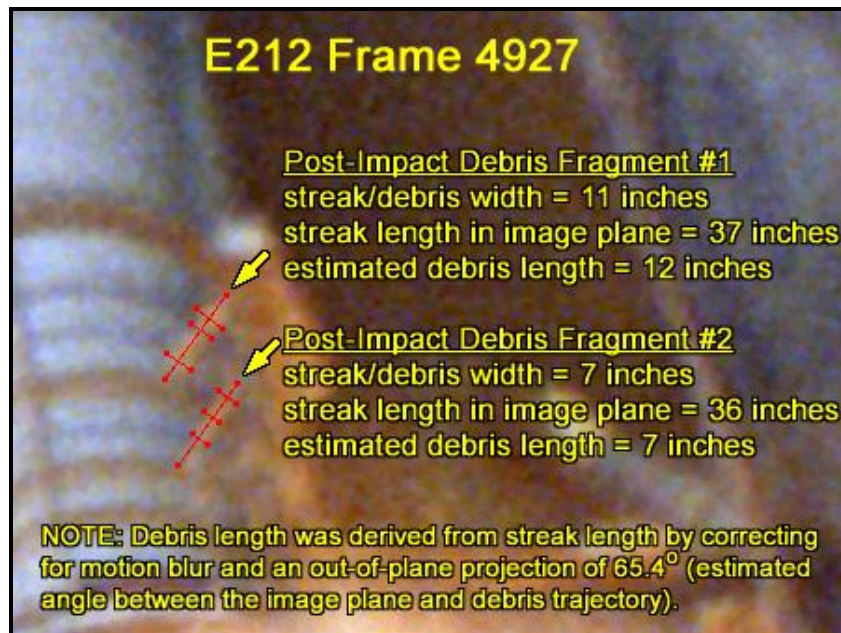
Figure 4.3.2.6c Post-impact debris size measurements

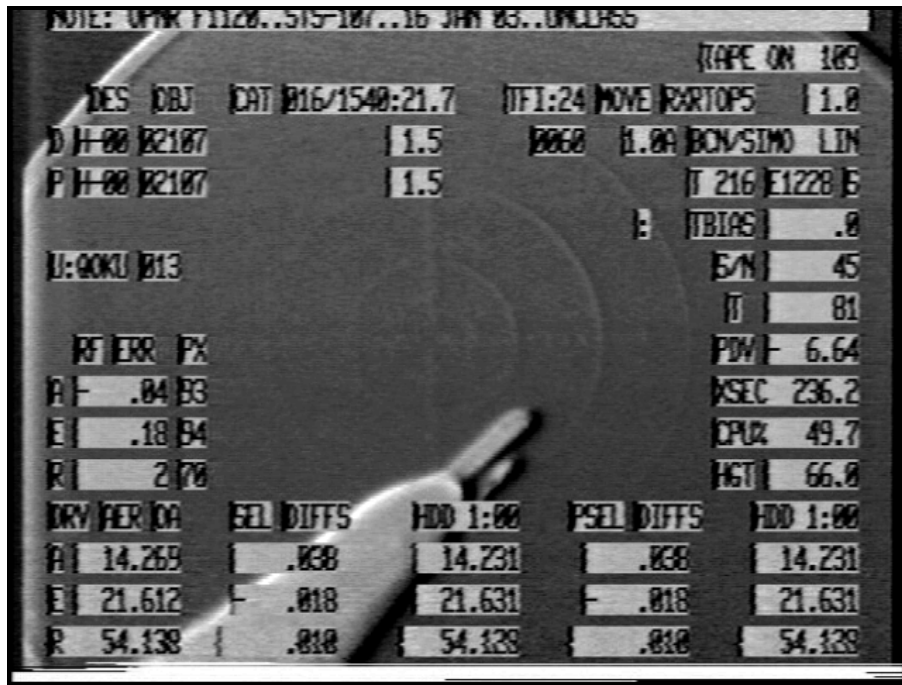
Figure 4.4.2 Patrick AFB 0.14 radar boresite view taken at the time of debris strike event approximately 81 seconds after launch.

The radar data was classified and not available to the NASA Image Analysis Team. However, six optical videos (bore-sighted with the radar) were screened by Image Analysis Team members at KSC and JSC. The detail visible on the Air Force metric optics video is significantly less than can be seen on the NASA long range tracking imagery (Figure 4.4.2). No anomalous events were noted during the screening of the STS-107 launch metrics video that was bore-sighted with the radar tracker. The only event seen on a CSC digital video file was a piece of debris exiting the SRB plume at 17 seconds MET.

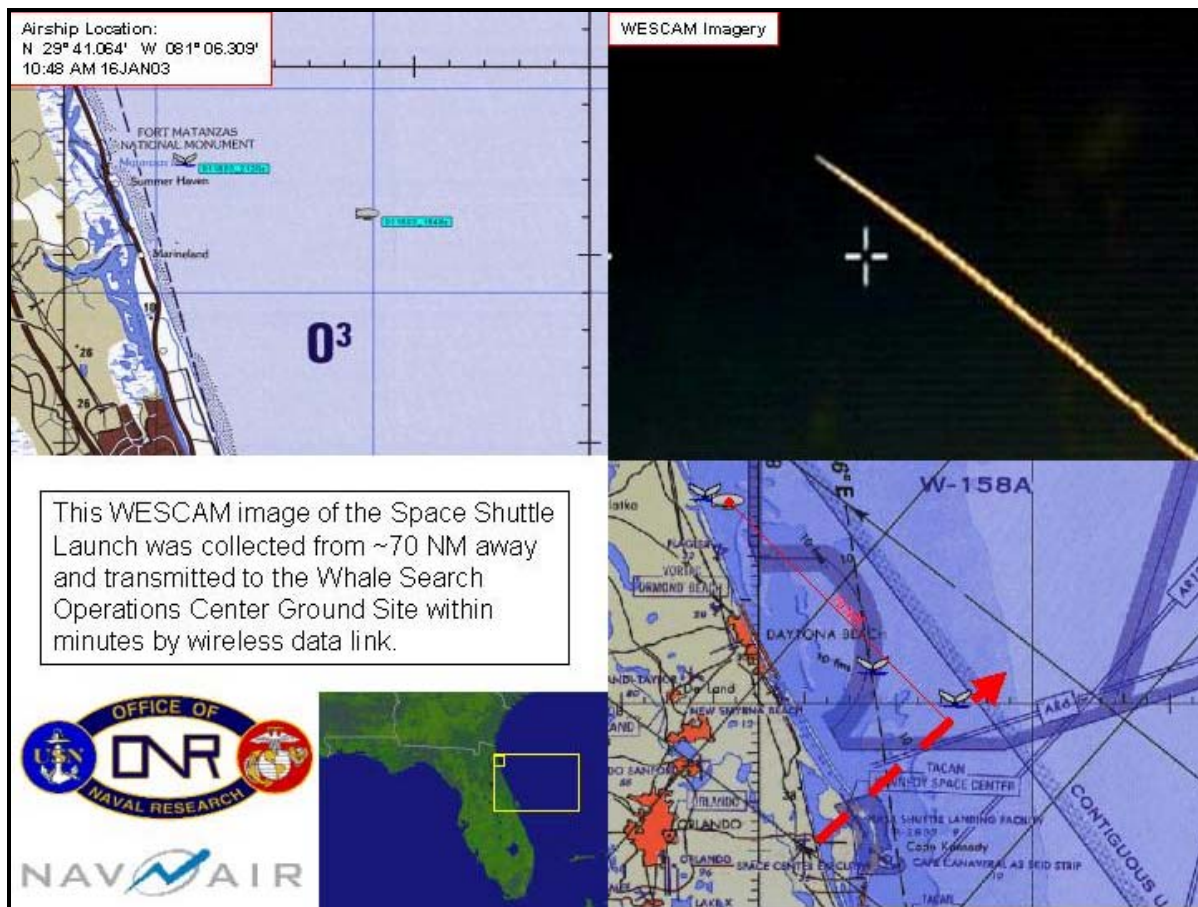
Optical video of the STS-107 launch was acquired by the U.S. Navy "WESCAM". The view was taken from an Airship 70 NM at sea off the coast of Florida and transmitted to the Whale Search Operations Center Ground Site by wireless data link. The Shuttle is extremely small in the U.S. Navy WESCAM view, at the end of a long engine exhaust trail (Figure 4.4.3). The U.S. Navy identified one area of possible debris emanating from the exhaust trail far aft of the launch vehicle.

Figure 4.4.3 U.S. Navy airship location and image

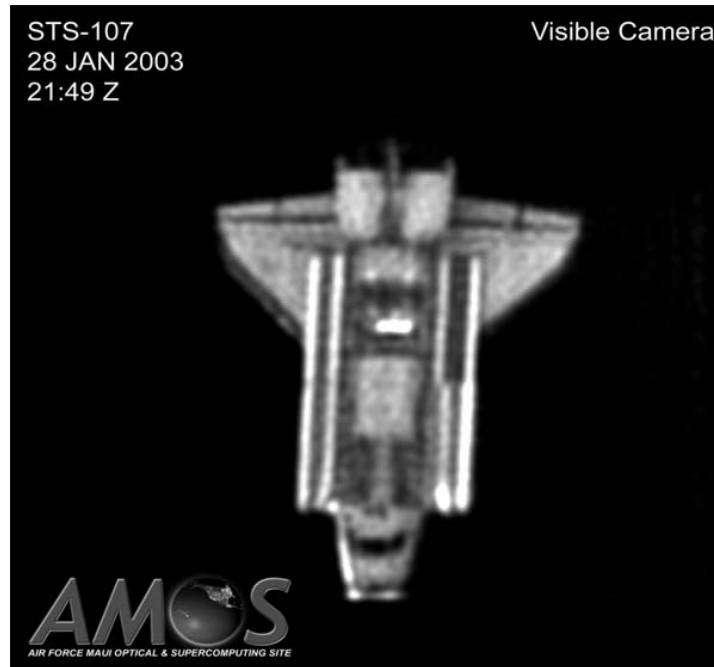
Figure 5.3.2.1 AMOS image of Columbia (taken January 28, 2003)

The Air Force Maui Optical and Supercomputing Site (AMOS) acquired photographs of Columbia while on-orbit during the STS-107 mission (Figure 5.3.2.1). The pictures were taken at approximately 21:49 UTC on January 28, 2003. All of the AMOS views are grainy and only major features of the Orbiter upper (+Z) surface are visible.

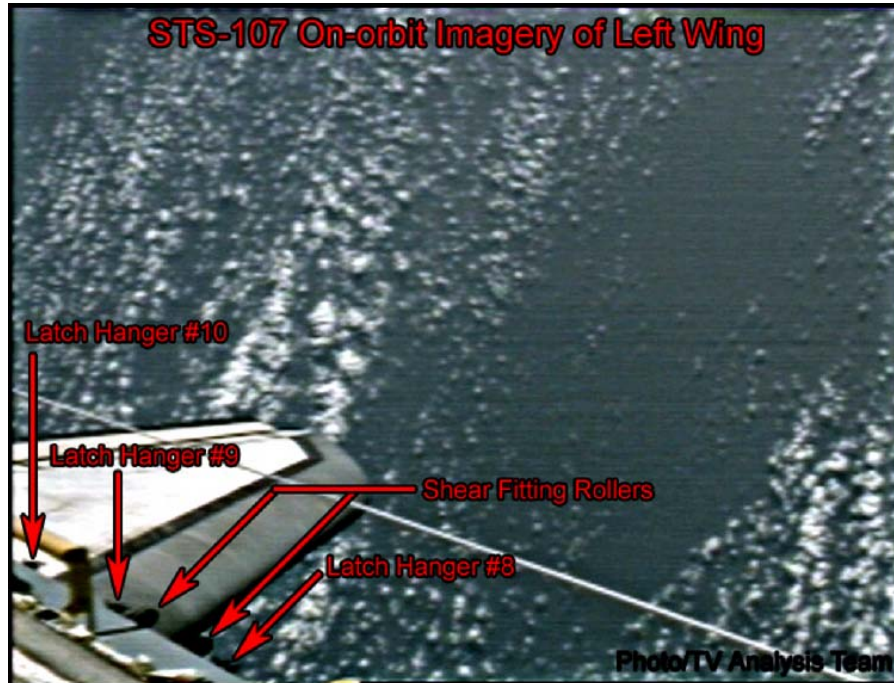
that the dark feature was a portion of the payload bay latch mechanism, which extends to the side of the latch and partially obscures the leading edge of the wing in the view. The latches and rollers were identified and labeled as seen in Figure 5.3.2.3b. The same feature was observed in a previous mission image (STS-68) when the Shuttle was in a similar orientation and with a similar view and lighting of the left wing.

Figure 5.3.2.3b Payload bay door latches/rollers superimposed on Orbiter left wing

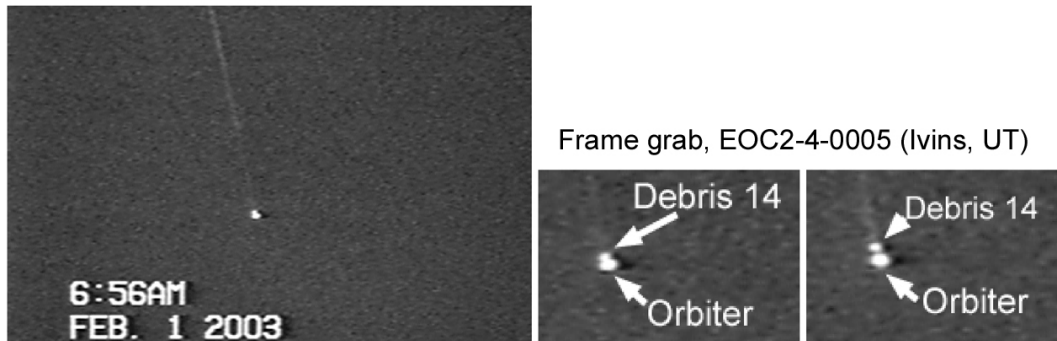
Figure 6.1 Example of full frame grab of a typical re-entry video, and an enhancement showing the separation of debris 14 at 13:55:58 UTC.

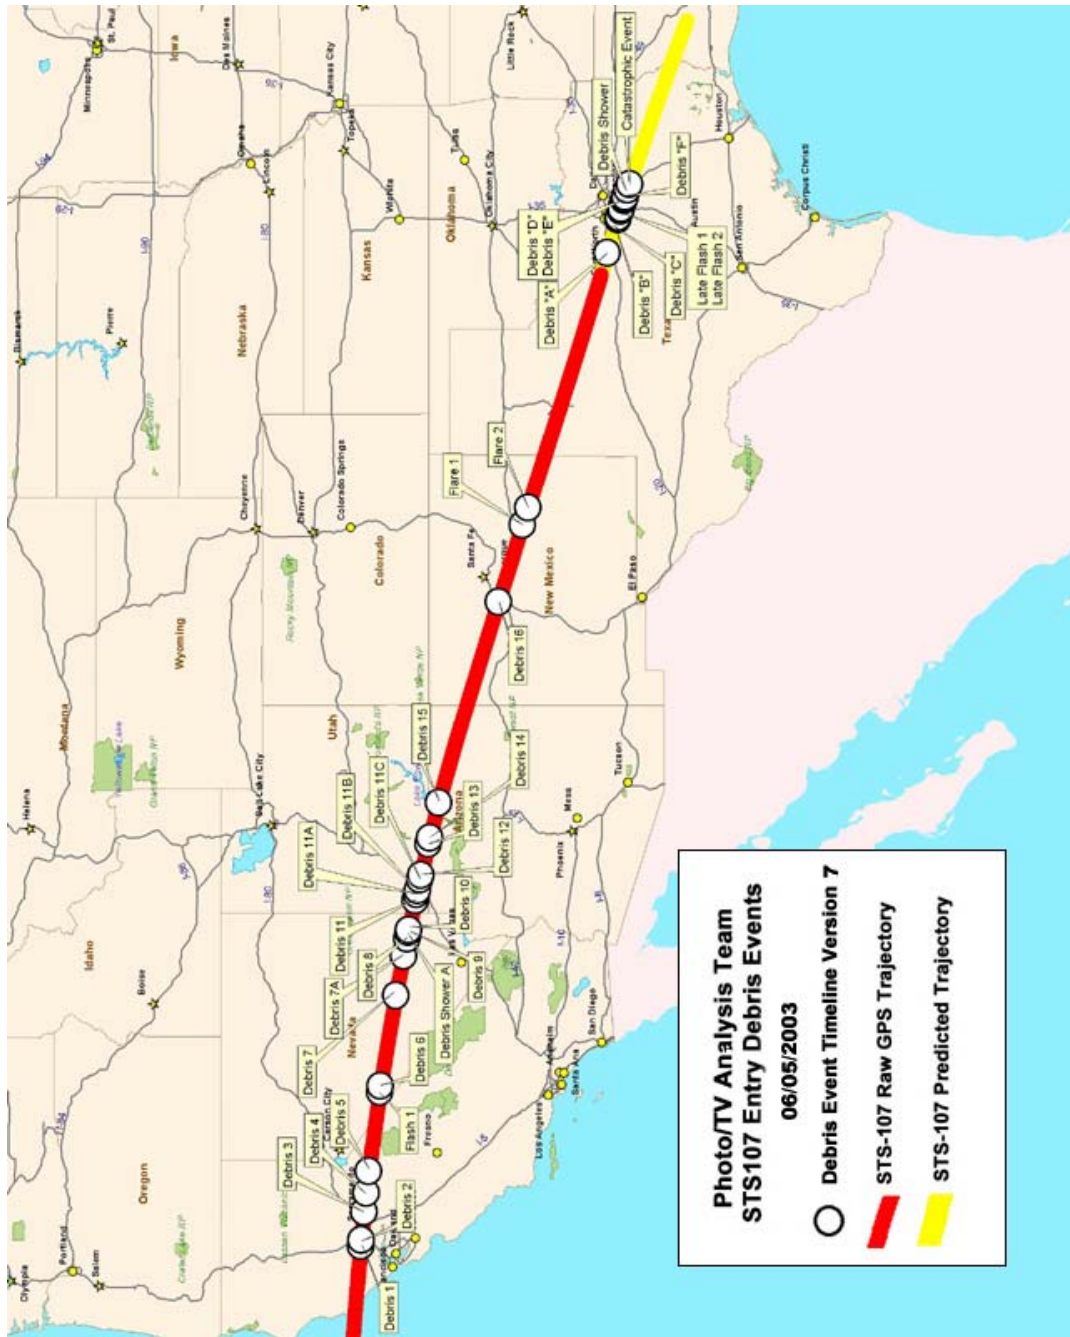
Figure 6.3.2a Map summarizing locations of observed debris events during STS-107 re-entry. Details for each event are found in Table 6.3.2.

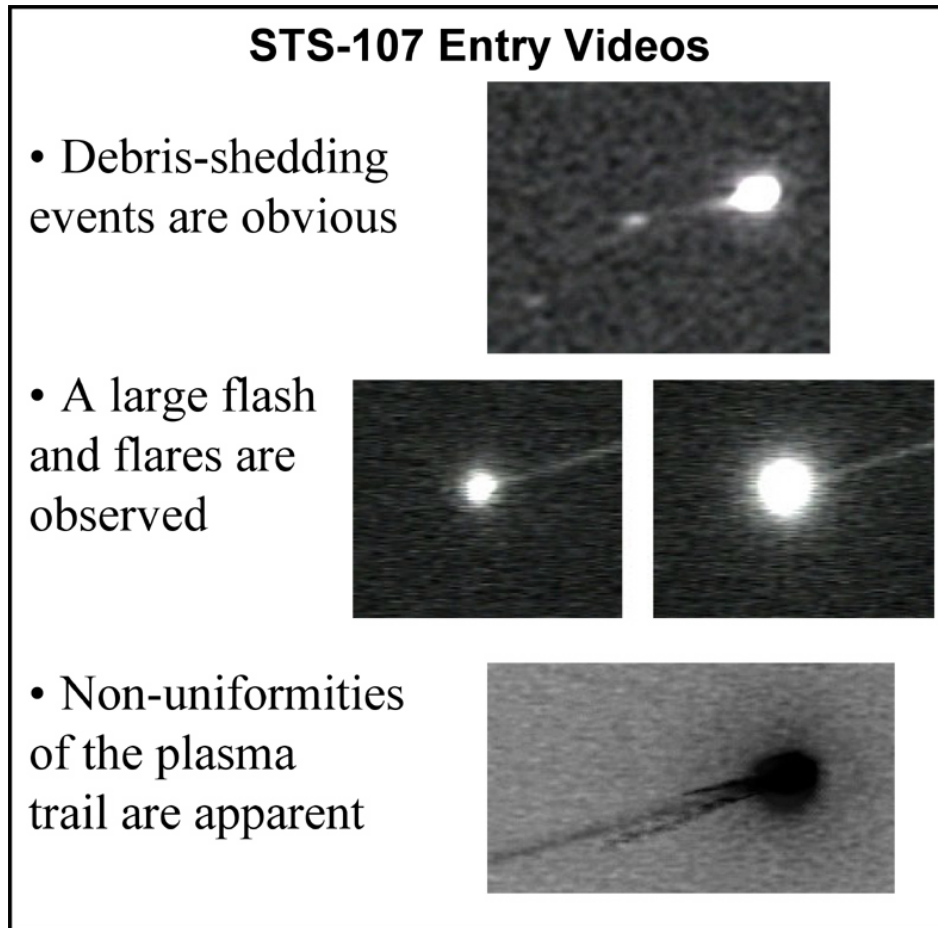
Other characteristics of nominal re-entries include the observations that no debris-like events are observed at any time, and no “Flashes” or “Flares” are observed at any time. In fact, no non-uniformities of the plasma trail are observed (other than the RCS quenching effect). Figure 6.3.3c summarizes these differences.

Figure 6.3.3.c Summary of Events not seen in Nominal Re-entry Video

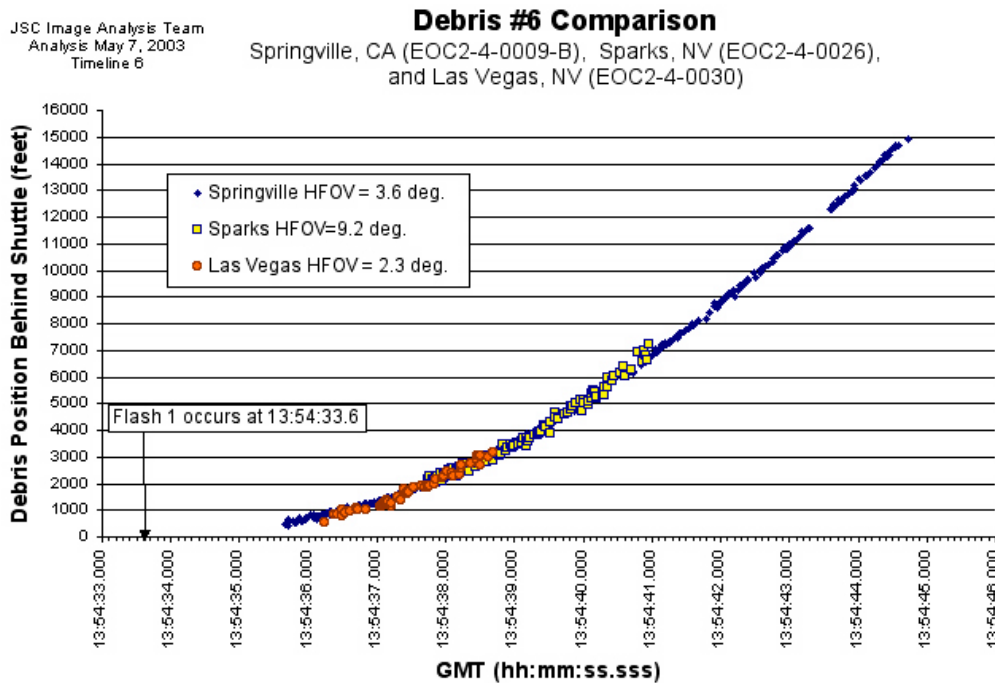
the debris, and the ballistic coefficient of the debris (which is directly related to its deceleration). The debris decelerations were then used by the Image Analysis Team's Luminosity Working Group to calculate debris mass. While Figure 6.3.4a shows very good agreement in the relative motion for Debris 6 for the three separate videos analyzed for this event, there was some disagreement for the motion of Debris 14 (Figure 6.3.4b) for the four videos analyzed for this event. Possible explanations for the Debris 14 discrepancy include the following: errors in the in the assumed focal lengths (fields-of-view) for some observers; errors in the precise timing of the videos; significant motion of the debris out of the Orbiter trajectory path causing an unmeasured component of its motion to be missed by observers in Utah. The last explanation is based on the fact that observers from Utah were directly under the Columbia flight path and were looking eastward, so if the debris dropped enough in altitude, it might appear to move away more slowly relative to observations from Flagstaff. Details about the relative motion analyses including determination of the camera fields-of-view are discussed in Section 6.2, Methods.

Figure 6.3.4.a Debris 6 position relative to Orbiter as measured from three videos, identified by their EOC number.

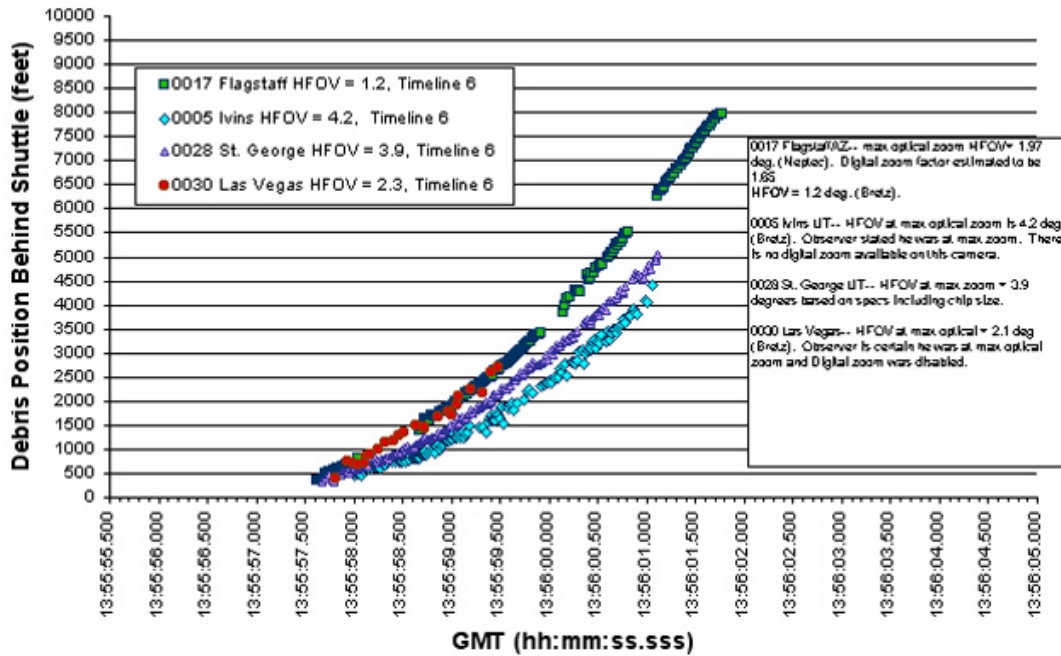
**Comparison of Debris 14 Analyses
between St. George(2-4-0021, 2-4-0028) Mins (2-4-0005)
Flagstaff (2-4-0017) and Las Vegas (2-4-0030)**

Figure 6.3.4b Debris 14 position relative to Orbiter, measured from four videos, identified by their EOC number.

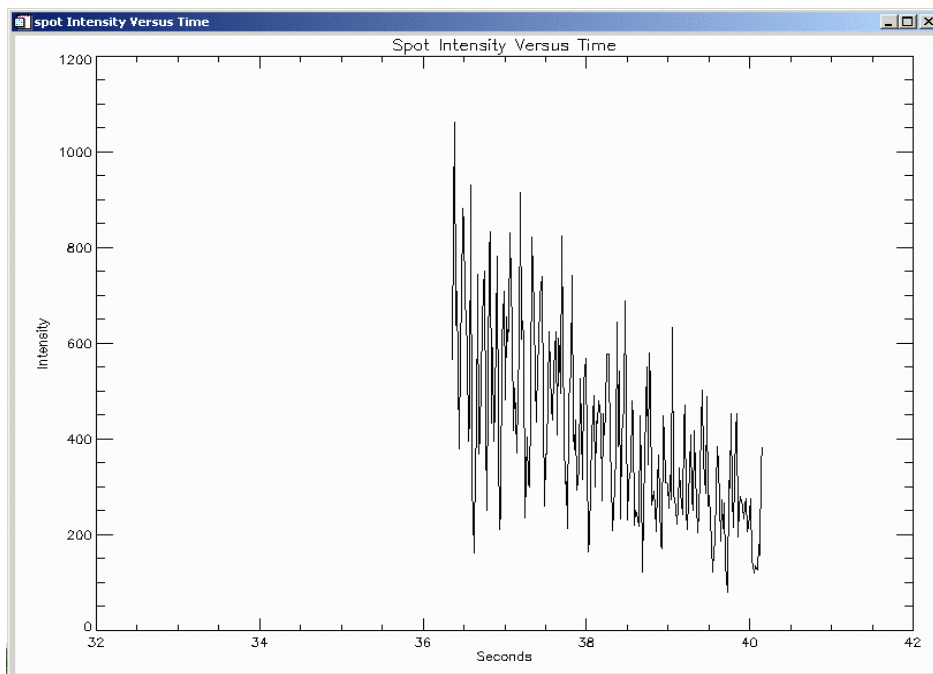
However, light curves for the Orbiter and debris events (e.g., Figure 6.3.5a and b) indicate that the debris experienced moderate amounts of ablation. This assumption is consistent with observations of ablation on pieces of debris recovered in the East Texas debris field. Hence, the approach modeled on moderately ablating debris provides mass estimates of 87 kg (190 lb) for Debris 6, 55 kg (120 lb) for Debris 14, 0.2 kg (0.44 lb) for Debris 1, and 0.3 kg (0.66 lb) for Debris 2.

Figure 6.3.5a Debris 6 intensity versus time (seconds after 13:54:00 UTC). The debris intensity decreased over the measurement interval. The light curve suggests that the debris was ablating by approximately 2% per second.

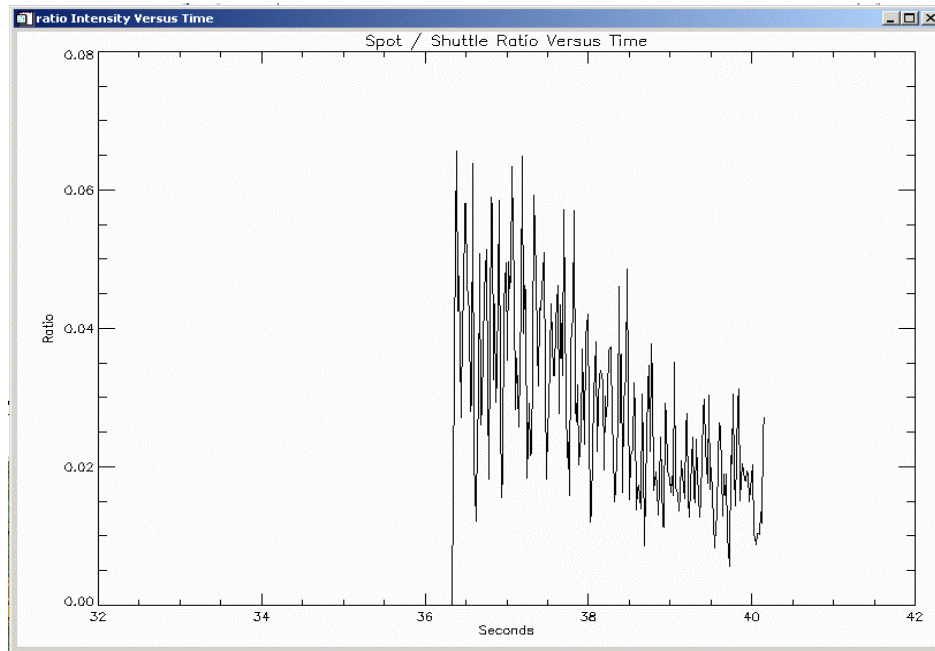
Figure 6.3.5b Field-by-field Debris 6/Shuttle intensity ratio versus times (seconds after 13:54:00 UTC)

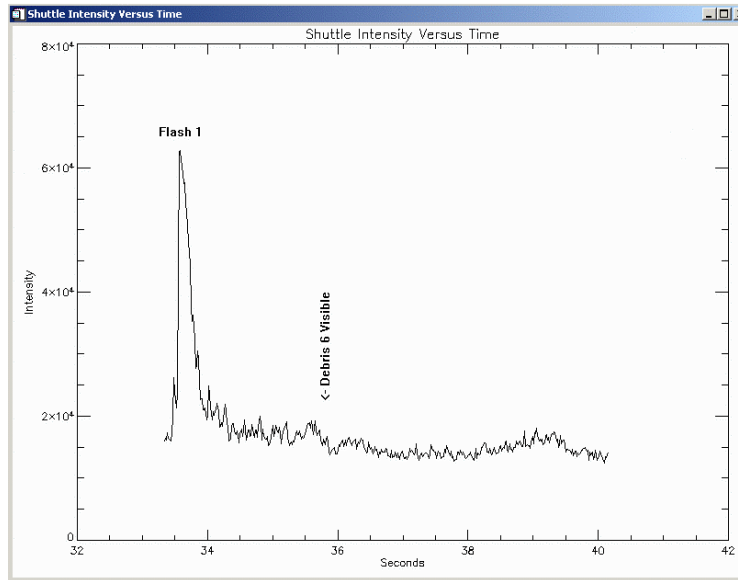
Figure 6.3.6b Preliminary Orbiter light curve from the Springville, CA video. The Orbiter signature remains bright after the flash, until Debris 6 is observed to separate from the Orbiter.

Physical interpretations of the relationship between the Flash and Debris 6 are being evaluated, but we believed that Flash 1, and the subsequent shedding of Debris 6 was a major structural event on the Orbiter, and the RCS firings were a response to events on the Orbiter. One model for the Flash optical signature assumes that when Debris 6 separated from the Orbiter it also released a mass of small material (possibly TPS or blanket particulate, each particle less than 2 mm diameter), which decelerated rapidly. The rapid deceleration and large interaction of the particles with the atmosphere would increase the brightness in the chemiluminescent “plasma” trail, causing light to be emitted for a short time and resulting in the Flash.
