# Volume IV

## Appendix F.2

## “Follow the TPS”: An Analysis of What Occurred to the Thermal Protection System (TPS) During the Flight of Shuttle Columbia on STS 107

J. O. Arnold <sup>†</sup>, H. E. Goldstein <sup>‡</sup>, and D. J. Rigali <sup>λ</sup>

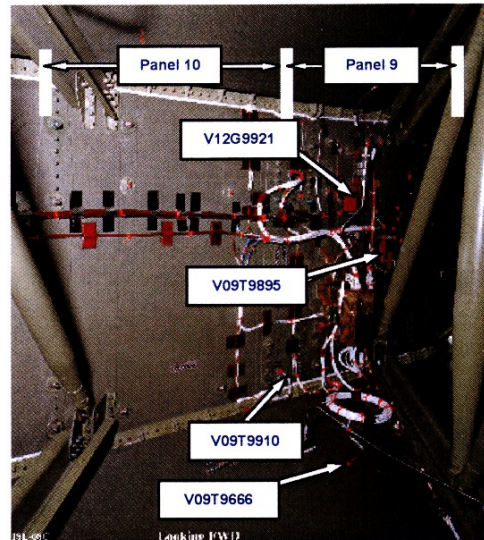
Figure 9: Photograph of Rearward Side of Columbia's Left Hand Wing Spar, Looking Forward. OEX Sensor Locations are Depicted.

Figures 9 and 10 depict the physical location of the MADS/OEX sensors in the Panel 9/10 area of Columbia's left wing. Figure 9 is a photograph of the backside of the wing spar, looking forward. The approximate locations of RCC Panels 9 and 10 are shown near the top of the photograph. Fortunately, this region of the wing on Columbia was instrumented for the Orbiter Experiments (OEX) activity early in the Shuttle Program, and the instruments were still operational and recording data during STS 107. Data from four sensors are extremely valuable in helping understand the temporal events leading up to the failure of the wing leading edge system: V12G9921, a strain gage mounted to the spar; V09T9895, a thermocouple mounted to the back of the spar at the Panel 9 location; V09T9910, a thermocouple mounted to the clevis which held RCC Panel 9 in place (under an "earmuff" which insulated the clevis); and V0T9666, a thermocouple mounted in a tile in the lower wing, near the tile surface, close behind the number 9 carrier panel tiles. V09T9910 is imbedded in the RCC mounting hardware, which secures the panel to the spar.

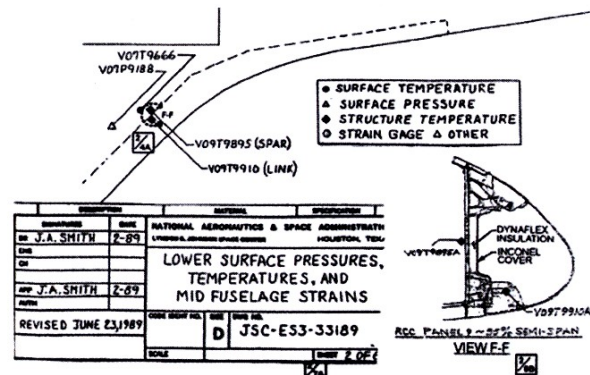
Figure 10: Portion of an Engineering Drawing Depicting the Location of OEX Sensors.

To help visualize the geometric location of the sensors, Figure 10 shows portions of an engineering drawing from a document describing the OEX instrumentation. As can be seen, top and side views are shown along with a key identifying the type of sensor.

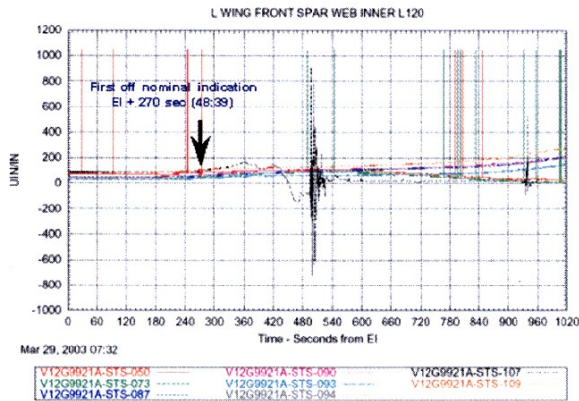
Figure 11: OEX/MADS STS-107 Flight Data.

Figures 11 through 13 show data from the two sensors (one strain and one temperature) discussed in Figures 9 and 10. The information from these sensors is very significant in determining the progression of events as the thermal damage from the initial breach progressed to burn a hole through the wing spar. In addition to the data

obtained on STS 107, sensor traces taken on other flights, with similar entries are displayed with different color codes. Other investigators have made detailed analyses of these signals and data from many more sensors, but herein, only major events, appropriate to our “Follow the TPS” theme are discussed. In each plot, there is an indication of the first off-nominal or “out-of-family” event that will later be used in comparing flight data to the hypothesized events causing loss of vehicle and crew. The units in Figure 11, measured by the temperature compensated strain gage are micro inches/inch.

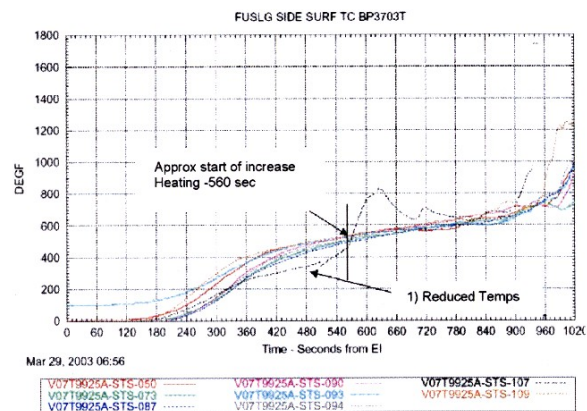
Figure 17: Representative Fuselage Sidewall Thermocouple Data.

Figure 17 displays the left fuselage sidewall thermal profile for thermocouple VO7T9925A in the standard MADS/OEX format wherein the data for STS 107 are compared to those from other, similar entries of Columbia. As can be seen, there is an out-of-family lower temperature trend at EI + 360 seconds, correlating to GMT 13:50:09. This early below nominal, and later, above nominal temperature observation on the fuselage sidewall, for a number of thermocouples has been explained by the NASA team led by J. Caram (Reference 16) to arise from flow disturbances propagated from the wing leading edge. The study depends upon a combination of hypersonic wind tunnel data and CFD analysis. The reader interested in detail is referenced to this report and the Aerothermodynamics section of the CAIB report (Reference 17).

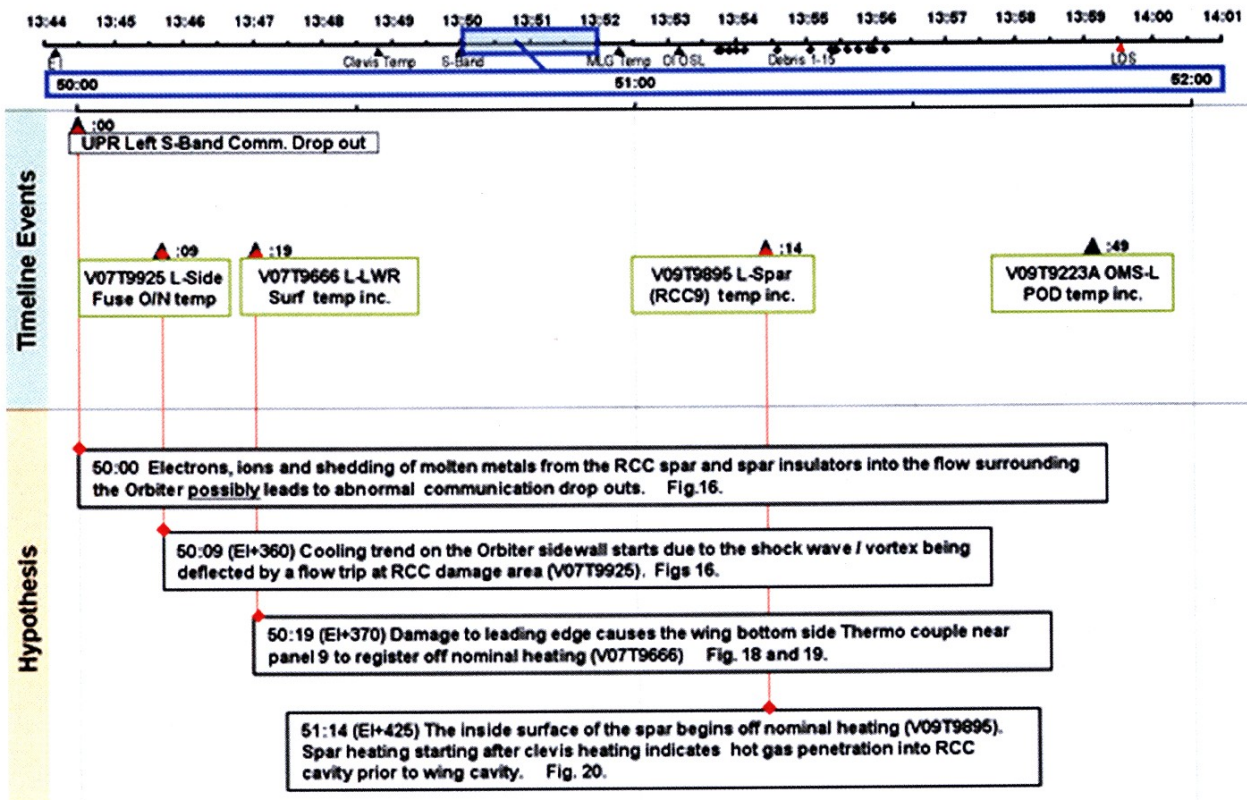
Figure 21: Timeline Versus Hypothesized Events – 13:50:00 to 13:52:00.

Figure 21 graphically depicts the timing of communication drop out and additional events recorded by the OEX sensors. The captions are self-explanatory. The MADS/OEX off-nominal data in the wing leading edge and spar are additional evidence that a breach existed in the RCC at the EI. The below nominal temperatures recorded on the fuselage sidewall is consistent with the hypothesized damage in the wing leading edge in the RCC Panel 5-8 area. The spatial correlation by the streamline analysis in Figure 19, showing how the outflow from the lower juncture of RCC Panel 8 and 9 can affect the lower tile thermocouple behind Panel 9 and the above nominal behavior of thermocouple V07T966, is additional and compelling evidence for the existence of a breach in the Panel 8/9 area. It is clear from this figure that the temporal evolution of the heat flow shows that the hot gas penetration began in the cavity in the wing leading edge prior to heating in the wing box behind the spar.

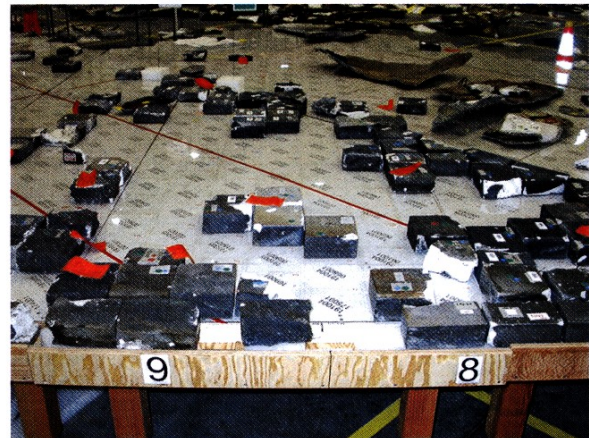
Figures 35 and 36 show photographs of recovered tiles affixed to a 110 percent scale drawing of the left wing tile field. Here, a key of circular dots was used: Red means a tile is not in its final location, blue means a tile is in its final location and has been positively identified. Yellow means the tile failed at the densified layer, near the bond line and green means the tile failed owing to internal heating. In this case the Koropon/SIP failed or the Strain Insulation Pad (SIP) failed due to overheating. Koropon is the primer coating the aluminum skin.

There is a distinct pattern of RCG coated tiles, in the general X-direction downstream of Panels 8 and 9, outboard of the wheel well where the tiles appear to have little of the dark metal deposit (aluminum - rich) generally seen on the recovered tiles. These normal-appearing tiles all have been identified to have failure at the tile/Koropon bond line and departed from the wing surface prior to a major outflow of molten aluminum. This is indicative of extreme heat, inside the wing behind Panel 8. It then seems probable from this observation that the breach in the wing spar occurred at the Panel 8 location, and this is consistent with the observations discussed above. Ballistic analyses of the trajectories and the geographic location of the recovered tiles (both those detached owing to bond failure and those that did not) suggest they came off from about 100 nautical miles west of their recovery location in Texas.

Figure 36: View of Tile Table from RCC Panel 8/9 Area.

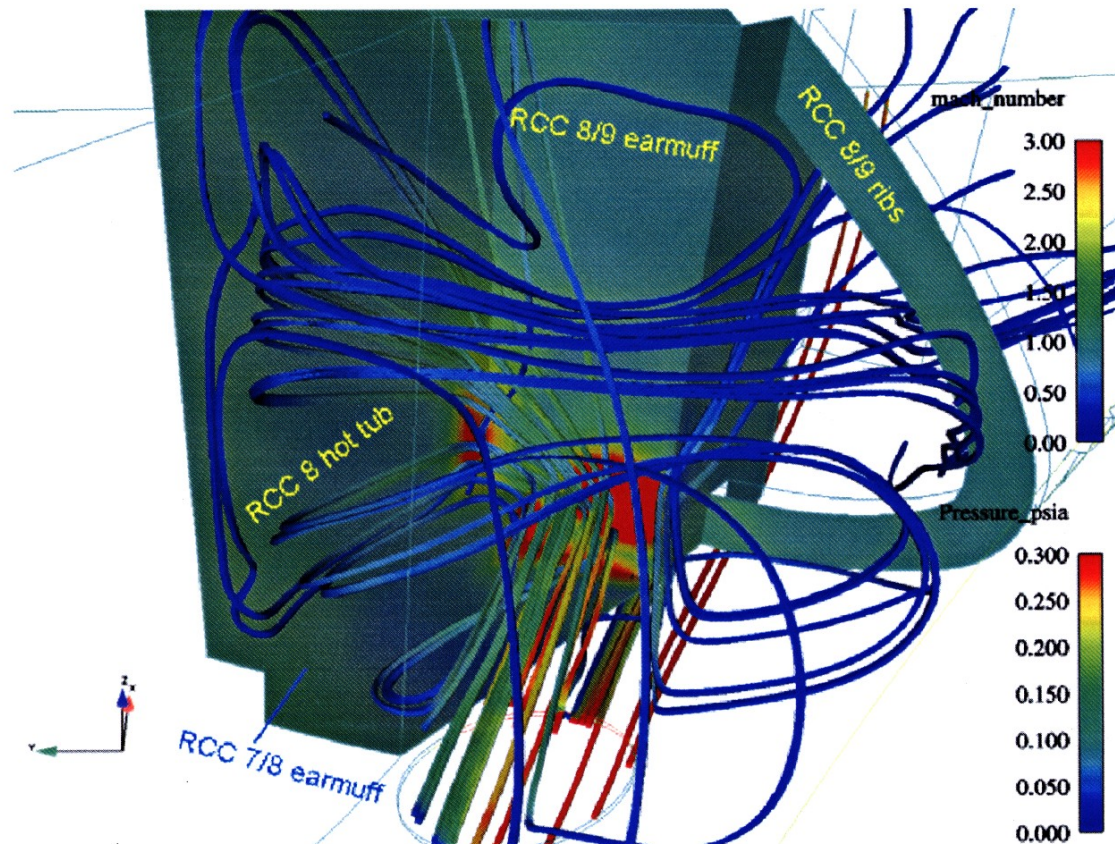
Figure 37 depicts a view of the CFD results (Reference 22) from the front of the leading edge with the acreage of the panels rendered transparent. The hole in RCC Panel 8 is outlined on the lower left corner of the figure. Streamlines are color coded by Mach number and pressures on the earmuff and spar insulation “hot tub” are displayed by the color-coding shown in the figure. As can be seen, the subsonic flow is complex and the jet creates a significant high-pressure zone on the RCC 8/9 earmuff.

Figure 37: Results Adopted From Reference 22, Showing Streamlines From a 10" Diameter Hole in RCC Panel 8 (the Hole is Shown at the Lower Left). Acreage of RCC is Rendered Transparent. View is From Front of the RCC WLESS. Flight Conditions are Mach: 24.9, Altitude: 243 k ft, as in Figure 19. Pressure of 0.30 psia is Equal to 43.2 psf.

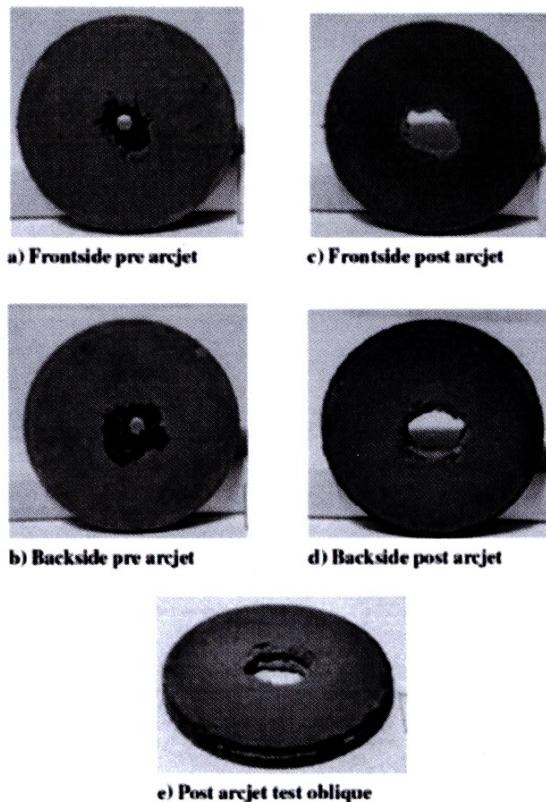
Figure 40 displays photographs of the test article number 1159 pre and post arc jet test. Test conditions resulted in a surface temperature and pressure on test article number 1159 of 2500 °F and 50 psf, respectively. The exposure was for 450 seconds. Figures 40 c) -> 40 e) show that in this case, the hole growth grew by oxidation of the exposed carbon-carbon substrate. The oblique view in Figure 40 e) illustrates the “dishing out” of the carbon sandwiched between the SiC front and back coating. For these test conditions, Curry, et. al., did not expect hole growth owing to loss of the SiC coating because of its stability up to temperatures in the range of 2800-3000 ° F and this was confirmed by the tests.

Figure 40: NASA/JSC Model Number 1159, Pre and Post Arc Jet Exposure at 2500 °F and 50 psf, 400 Second Exposure. (Reference 5).
