# Volume V

## Appendix G.12

### Crew Survivability

## Crew Survivability Report

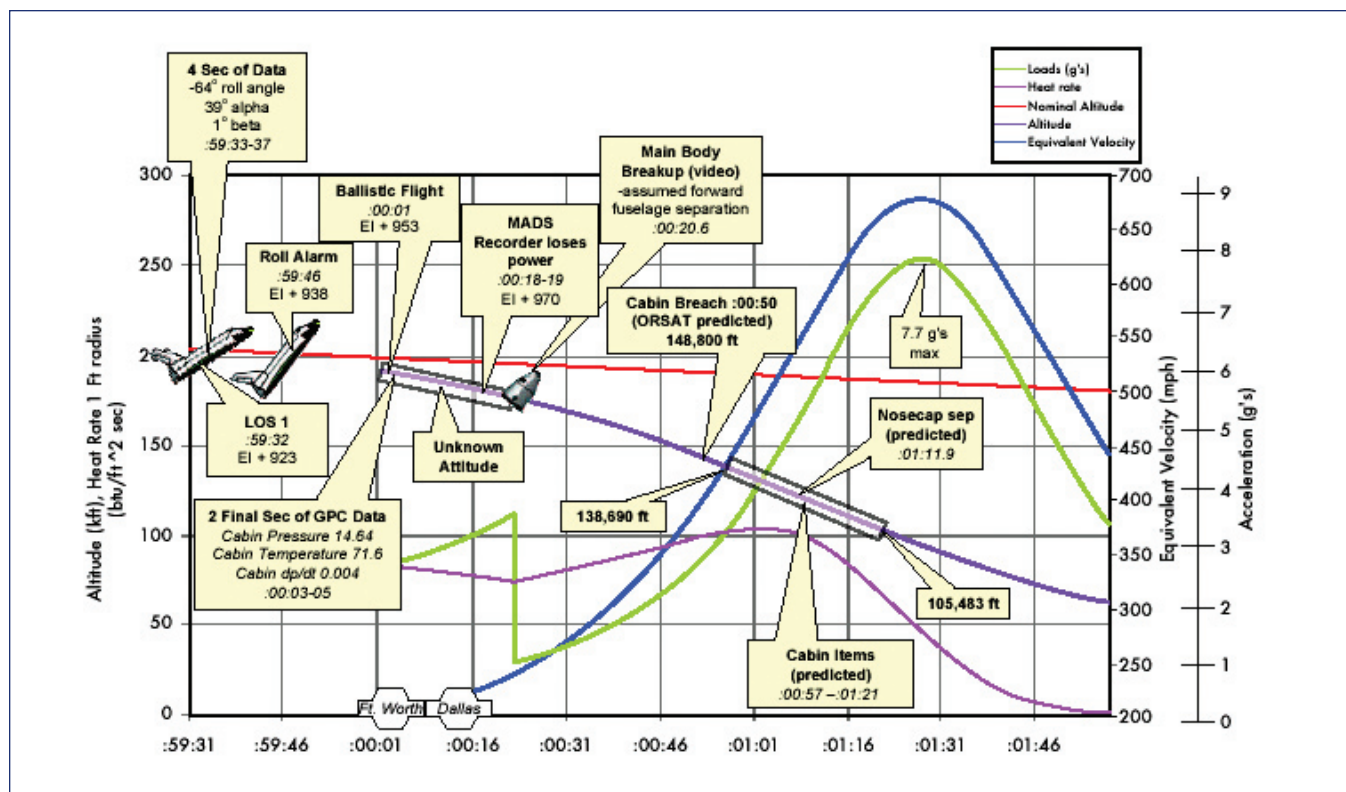
An overall summary of the disintegration scenario can be seen in Figure 1. In addition to the timeline markers are some predicted events as well as load and heat rate calculations for the crew module on its trajectory. The band superimposed on the trajectory (starting about 14:00:58) indicates the window within which all of the debris analyzed originates. This would indicate that the destruction of the crew module took place over approximately 24 seconds. It is significant to note that the heat rate peaks near the beginning of this period while the load environment is increasing throughout the period. Thus, it is postulated that the cabin was exposed to significant heat load together with an increasing load environment. This resulted in the complete destruction of the vehicle and is also consistent with the structural analysis of the CM debris.

In spite of the diversity of items analyzed, and the uncertainty in the circumstances of their release, the analysis demonstrates that they cluster about an area along the trajectory that is about 24 seconds long which began at an altitude of approximately 140,000 feet and ended at 105,00 feet. A thermal entry model, ORSAT, was used to predict when entry heating would cause structural failure of CM. ORSAT predicted approximately 140,000 feet, which is consistent with the independent aerodynamic model. Another corroborating piece of evidence of ORSAT's ability to accurately predict heat-induced damage is its prediction of the thermal damage to helmet visors. ORSAT forecasted that the laminate

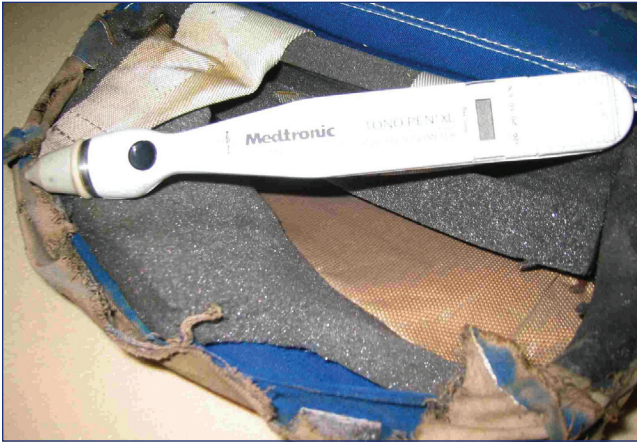
Figure 2.

Approximately 45% of the original crew module mass was recovered. Some major structural elements recovered, included portions of the forward and aft crew module bulkheads, window frames, mid-deck floor components, airlock and hatches. About 70% of the flight deck panels, and 80% of the mid-deck floor were recovered. Less than 20% of locker metal structure and fragments of the plastic and composite material of the locker trays were recovered. The Mid-deck Access Rack (MAR) was found nearly intact. Although some foam, fabric and paper were recovered, the bulk of the items recovered consisted of metal, plastic and composite materials. It is estimated that less than 30% of items stowed in the lockers were recovered. The EVA tool and suit debris (stowed mostly in the airlock for entry) were weighed, with 40% of the original mass recovered. The condition of the recovered debris items varied widely; from highly melted, twisted and torn, to near pristine (Figure 2). Overall, the damage distribution of crew module debris is consistent with surrounding debris from the forward fuselage structure.

Debris recovered from the crew module experienced noticeably less aerodynamic heating than other portions of the vehicle. Primary and secondary structure elements failures occurred at high temperatures evidenced by broomstraw<sup>2</sup> fractures. Five major attach points that suspend the crew module inside the forward fuselage were recovered, the port and starboard side fittings were recovered with evidence of high heating.<sup>3</sup>

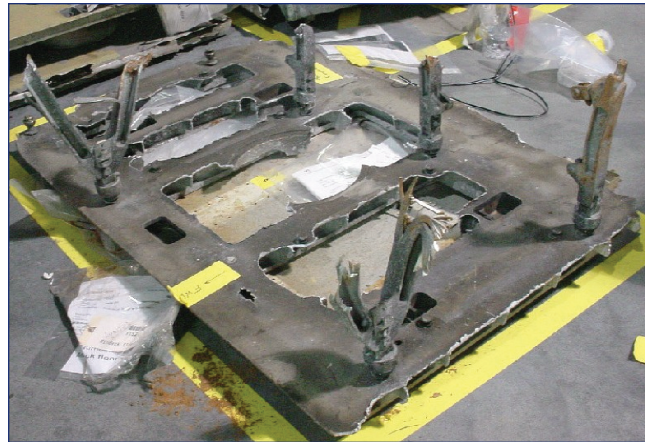
Figure 3.

Approximately 80% of the mid-deck floor was recovered. Generally, mid deck floor panel and structure components experienced heating, but not of sufficient magnitude to cause melting of metallic components (with the exception of the LiOH door (Figure 3) and a few very localized areas on two recovered structure items). Heating was however sufficient to cause significant damage to the Aeroglaze topcoat (paint) and in some cases the Koropon primer.
