Volume II
Appendix D.20
Bolt Catcher Debris Analysis

SUBJECT: CONTRACT F08650-00-C-0005: **TECHNICAL NOTE – BOLT CATCHER DEBRIS ANALYSIS FOR SHUTTLE STS-107 (CDR A205)**

Technical Note 25 June 2003

BOLT CATCHER DEBRIS ANALYSIS FOR SHUTTLE STS-107

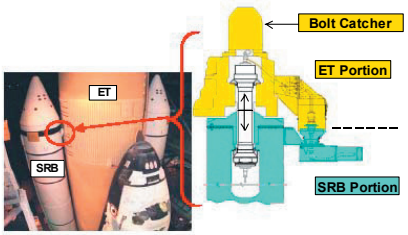
Fig.1. Forward Bolt Assembly and Attachment

Each SRB is attached to the ET with one forward separation bolt enclosed in a forward separation bolt assembly (Fig. 1). At SRB separation, approximately two minutes into flight, the forward separation bolts are broken into halves by explosive charges at each end of the bolts. The SRB half of the bolt is captured in the SRB forward skirt (Fig. 2) and stays with the SRB throughout the remainder of its flight. The ET half of the forward separation bolt is forced into the Bolt Catcher/ET portion of the separation bolt assembly (Fig. 2), which remains attached to the ET and is jettisoned into the Indian Ocean.

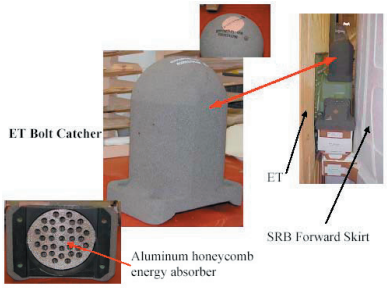
Fig. 2. ET Bolt Catcher

An ET Bolt Catcher is composed of an aluminum casing, covered with a Super Light Ablative (SLA) coating. In the opening at the base of a Bolt Catcher, a honeycombed aluminum disk exists to absorb the explosive energy of the bolt as it separates the SRB from the ET (Fig. 2). Bolt Catcher dimensions are shown in Fig. 3.

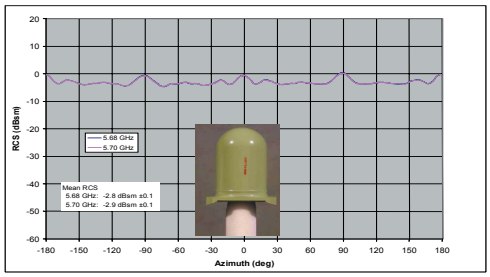
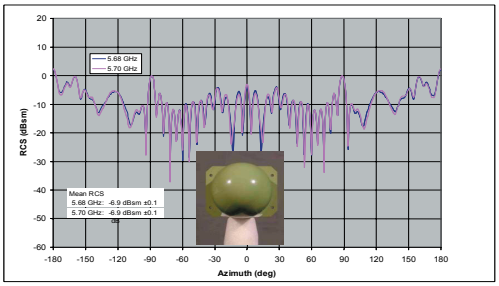
A Bolt Catcher's radar return signature characteristics, as well as its mean and maximum RCS, were established in controlled testing at the AFRL, WPAFB. The testing was conducted within the ER radar operating parameters of 5690 MHz frequency and linear vertical polarization. These signatures and measurements were used as an approximation of the signal that may be returned from a Bolt Catcher if captured by the ER tracking radar. Fig. 4 and Fig. 5 present the results of the AFRL C-Band tests. Note that all measurements done at the AFRL were taken from a Bolt Catcher without SLA coating. All comparisons made in this report use these numbers. Although no RCS information is available for a Bolt Catcher with an SLA coating, the maximum RCS magnitudes are not expected to be significantly different from that of an uncovered Bolt Catcher due to the thickness of the coating (1.52 cm) relative to the radar's wavelength (λ), which is 5.27 cm or 0.29λ, and the low radar reflectivity of SLA. A 230-cm^2 plate with SLA coating has an RCS of -32 dBsm vice 3.9 dBsm for a similarly sized metal plate without SLA coating [ref. 4].

Fig. 4. ET Bolt Catcher, Vertical Mount, Vertical Polarization, C-Band

Fig. 5. ET Bolt Catcher, Horizontal Mount, Vertical Polarization, C-Band

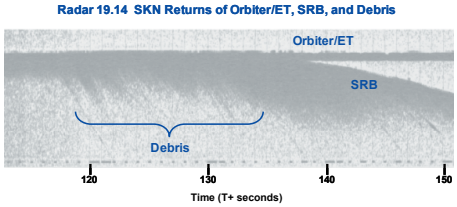
Fig. 6. Radar 19.14 RTI, T+113 s – T+150 s

Examination of the RTI charts for Radar 19.14 and Radar 28.14 shows a large cloud of debris particles after SRB separation with some distinct particles discernable from the cloud (Fig. 6 and Fig. 7). The possibility exists that more debris was present than was detected, as the separating SRB and/or its plume may have masked signals from separating objects.

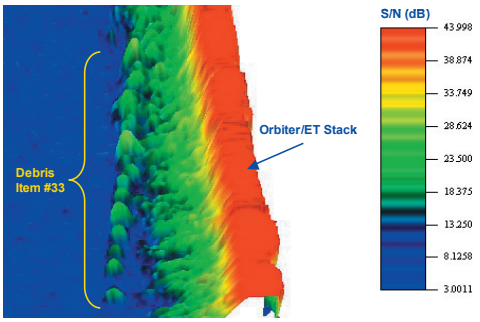
Fig. 8. Item #33 RTI Contour Plot

Debris Item #33 (Fig. 8) is first observed at T+128 s, one second after the SRB separation command was issued. The item has a range separation rate of 520 m/s (with a 120 m/s uncertainty), and is visible for two seconds. The signal return of this item is significantly stronger than any of the debris detected by any radar from SRB separation through the remainder of the mission, indicating a larger or a more highly reflective item than any of the other detected debris items. An RTI contour plot depicting debris Item #33 separating from the Orbiter/ET stack is shown in Fig. 8.

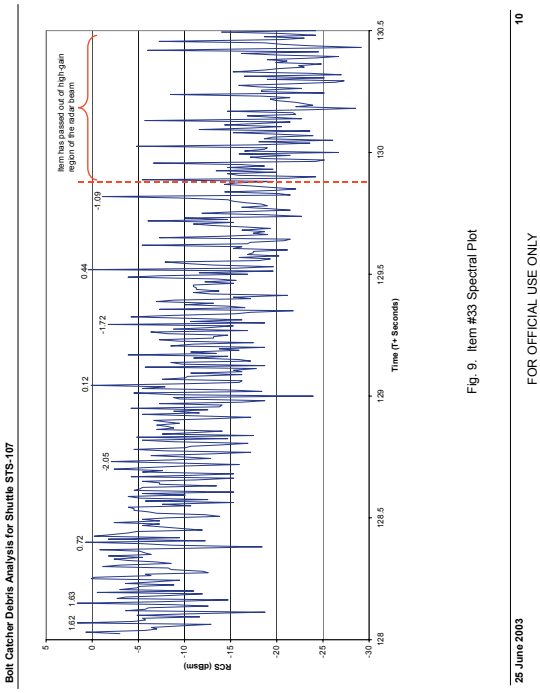
Fig. 9. Item #33 Spectral Plot

Item #33 radar signatures are shown in Fig. 9. Analysis of the peaks in this figure suggests a tumble rate of at least 310 degrees per second. At this rate, the 160-PRF of the observing radar limits the speculars to a maximum resolution of 1 point for every 2 degrees. The low resolution of the signature data limits the information that can be extracted from this data. Comparison of the radar spectrals with the Bolt Catcher RCS data gathered at the AFRL (Fig. 4 and Fig. 5) does not eliminate Item #33 as a candidate for a Bolt Catcher, but the low resolution of the signature prevents positive identification. Although the radar signature analysis to determine the shape is inconclusive, the signature peak magnitudes provide information of the maximum RCS of the item, which can be translated into approximate sizes for selected shapes.

Radar 28.14 has a 3-dB beamwidth of 0.38 degrees. As the debris item is moving out of the main radar beam, the debris can be expected to fall out of range for reasonable estimation of true RCS when it exceeds the half-beamwidth point. This is consistent with the signature data; the debris item begins to pass out of the high gain region of the radar beam at T+129.8 s, at which point the item has moved approximately the distance of the radar's half beamwidth. Item #33 spectral data after T+129.8 s was not used in this analysis.

Analysis of the speculars shows that the RCS peak amplitudes of Item #33 returns are consistent with the peak amplitudes for the nose, broadside, and base of an ET Bolt Catcher as determined by measurements at WPAFB (Fig. 4 and Fig. 5). All peak RCS amplitudes for Item #33 are within the uncertainty values established in Revision 1 of the original Technical Report [ref. 2] to be matched to the RCS of the individual facets of a Bolt Catcher; nose, broadside, and base. The AFRL tests indicate that the rounded nose of a Bolt Catcher has a maximum RCS of -3.2±0.1 dBsm. The broadside and the end of a Bolt Catcher have a maximum RCS of -0.3±0.1 and 2.4±0.1 dBsm, respectively. The peak specular measured at Radar 28.14 ranged from -2 to 2 dBsm with a 3-dBsm uncertainty.

If Item #33 were a metallic cylinder, its theoretical dimensions would be similar to the dimensions of an ET Bolt Catcher. The peak specular amplitudes indicate that the item has a maximum reflective surface of 170±60 cm^2. This reflective area would be produced by a cylinder with a 20±9 cm diameter and a length of 32±9 cm. These tolerances on the Item #33 dimension estimates make it well within the possibility to be the dimensions of an ET Bolt Catcher.
