Volume II

Appendix D.13

STS-107 In-Flight Options Assessment

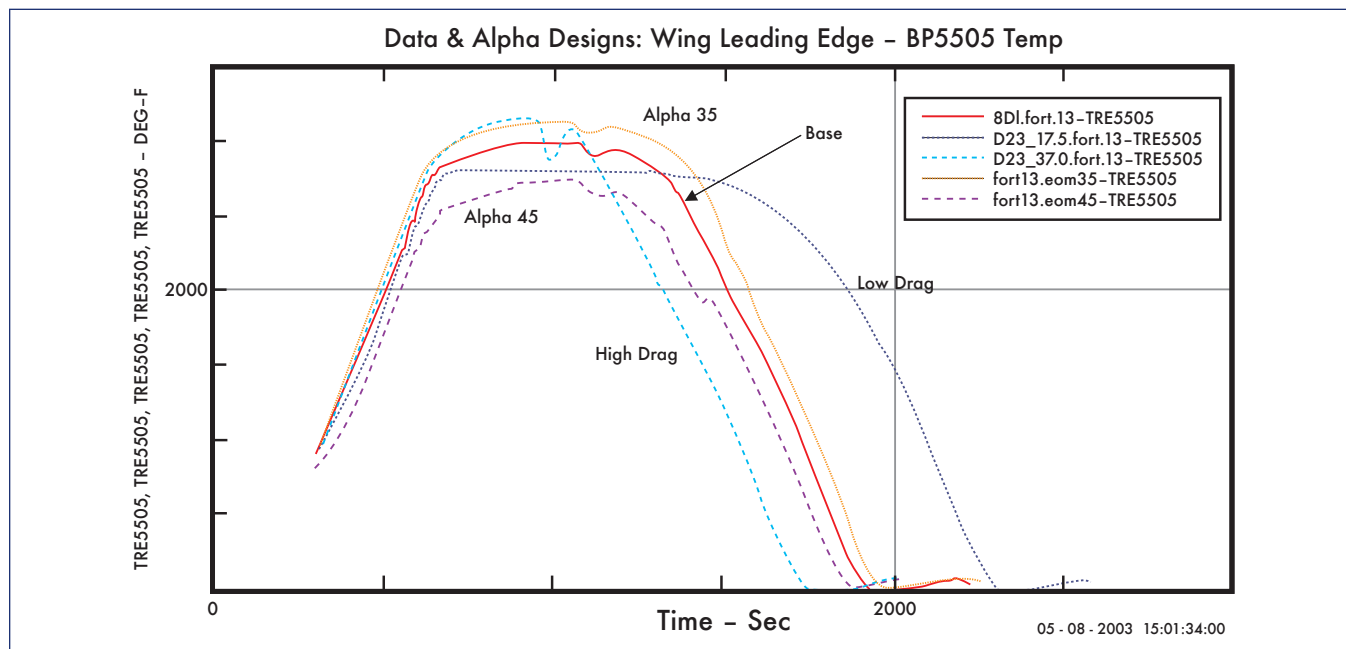
As previously stated, the team does not believe that an accurate thermal analysis can be performed to determine the effectiveness of any repair option. Rather, this is the best option relative to the other candidates, and it is possible that the combination of the repair, coldsoaking the wing, deorbiting from the minimum perigee, jettisoning available cargo bay hardware, and flying a 45 degree angle of attack could potentially provide enough relief to reach an acceptable bailout altitude. Limited thermal analysis was done on the option,

Figure 12. Relative Wing Leading Edge Temperature (No Boundary layer trip).

which assumed a flat plate of metal behind a flat plate of ice, behind a layer of AFRSI. The results while inconclusive, do not indicate this option was likely to succeed. However, the team believes it is sufficient to say that this would have been the best option to try, given the limited time and materials.
